# KILKENNY CITY WALLS

## CONSERVATION PLAN

Oxford Archaeology

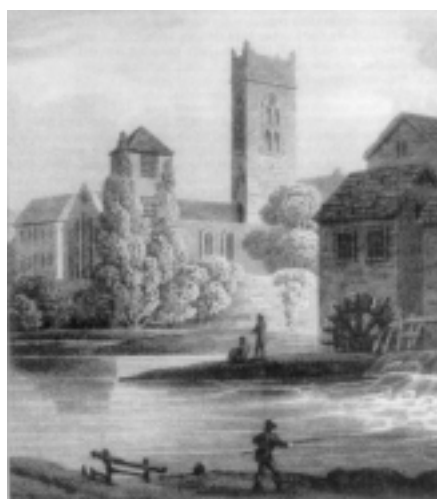
'Evans Turret' from *Robinson's Antiquities and Scenery of County Kilkenny*, 1851

The walls of Hightown were begun in the mid 13th century, and the tower was perhaps built c. 1400 on the north corner of the precinct of the Franciscan Priory. The friary passed to the Corporation in 1543; in 1598, the payment for carriage of 79 cartloads of stone 'for making up the tower at Francis Well' is likely to refer to this tower (Corporation Archives, CR/J/28). In 1650, the Civil Survey describes it as 'a little castle in the garden' of the friary (CS 6, 519). The tower became known as *Evans Turret* (Plate 1) when the land on which it stands was leased by the Corporation to an Alderman Evans in 1724. The tower and the stretch of adjoining city wall (with steps) are marked on the OS 1841 manuscript map, and the tower was illustrated in 1851 when still roofed. (For possible continuation along riverside, see Section 10.34.)

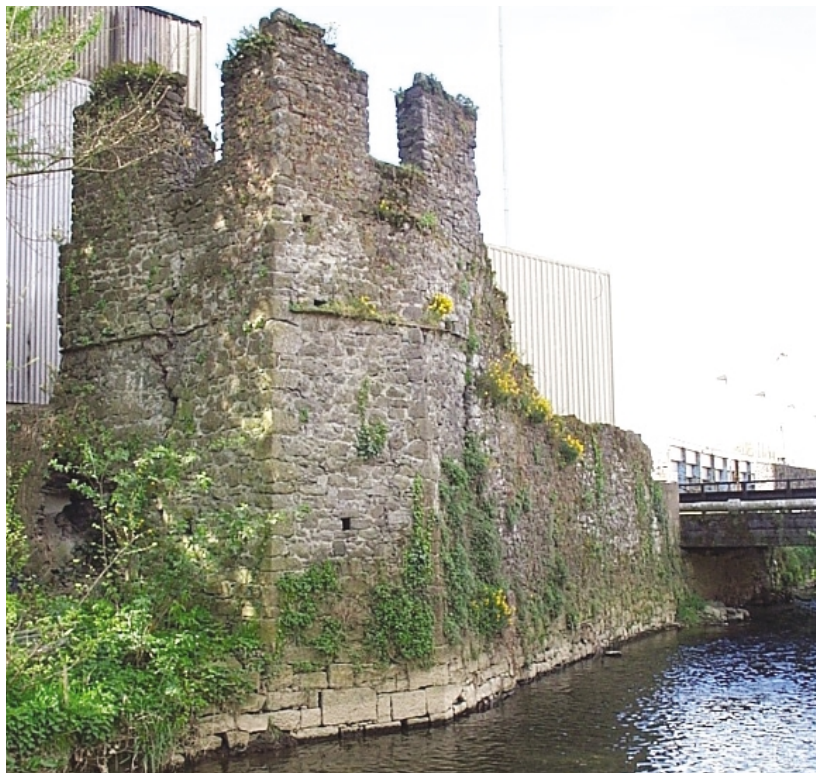
Plate 2: North-western polygonal tower (Evans Turret) and adjacent section of revetment wall from the north (May 2001)

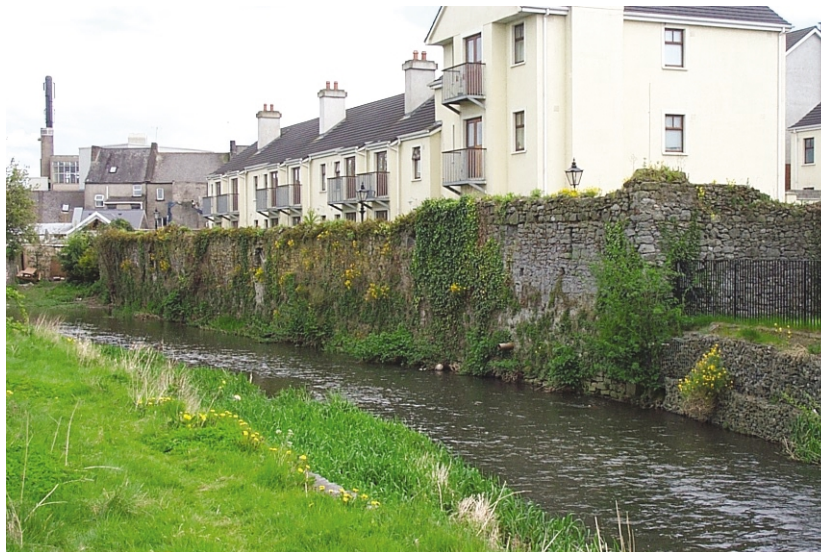
Plate 3: Section of City Wall fronting onto the River Bregagh from the west (May 2001)
