# RUSSBOROUGH COUNTY WICKLOW

## CONSERVATION PLAN

The Integrated Conservation Group for The Heritage Council and The Alfred Beit Foundation

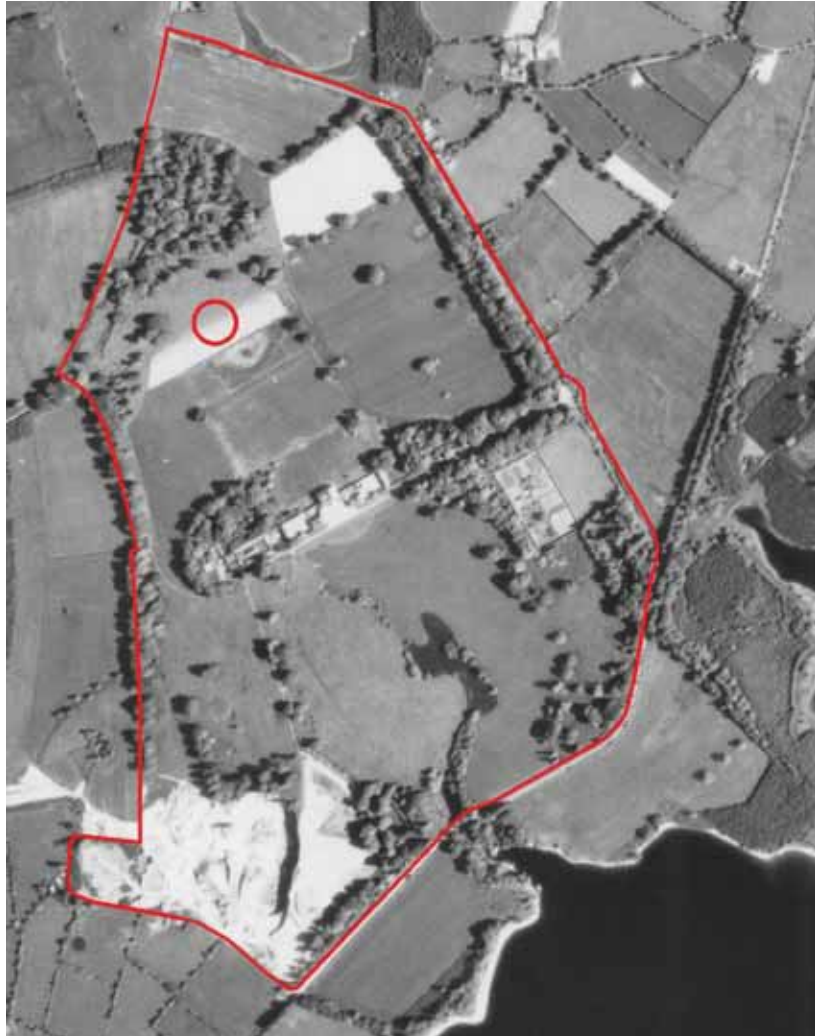
Figure 8: Detail from Ordnance Survey aerial photograph (GSIAP 332), with area of interest and RMP 5A:01 site location

On 18 February and 24 March 2001, an aerial survey was undertaken in order to define more clearly the terracing north of the house and to identify, if possible, the archaeological crop mark (RMP 5A:01) noted in aerial photographs from the 1970s (Figure 8).

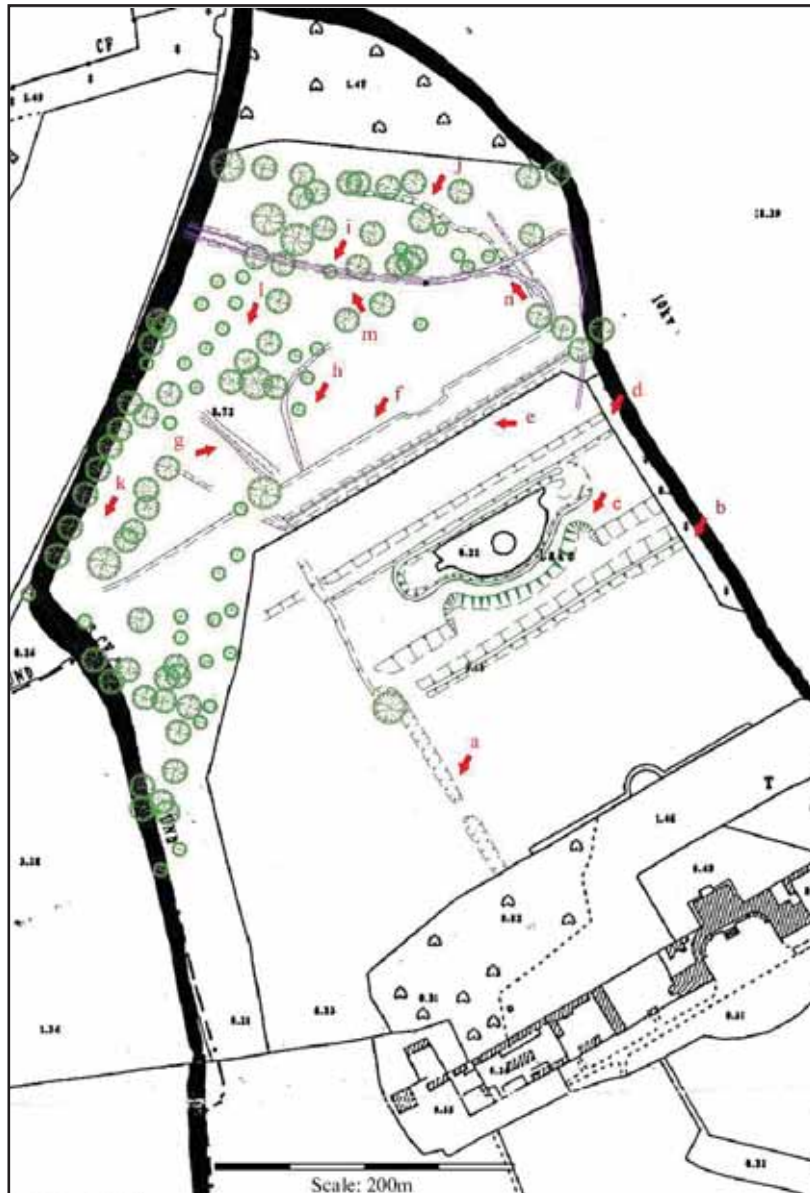
Figure 9: Ordnance Survey Rural Place Map (1997-99) with landscape features digitised from oblique aerial photography

KEY	
• Terracing digitised from aerial photographs	■
• Pathways digitised from aerial photographs	■
• Specific terraces are labelled a, b, c, d, e, f, and j	
• Specific avenues are labelled g, k, l, m and n	
• Specific pathways are labelled h and i

Oblique photographs can be calibrated using ground controls derived from Ordnance Survey mapping. The visible features are then digitised to produce CAD (Computer Aided Design) drawings of the archaeological sites/topographical features. The accuracy of the image calibration is normally dictated by the quality of the OS map sources. At Russborough, sub-metre accuracy was achieved using the Rural Place Map (1997-99) at a scale of 1:200 (Figure 9). The results were used to compare current topographical features with historic map sources. This level of accuracy is suitable for illustrative and analytical purposes, and in determining spatial extent. John Rocque's map of Dublin, depicting Russborough (Figure 10), was 'rubber-sheeted' over this map to get an impression of what features, visible in 1760, had disappeared or survived (Figure 11).

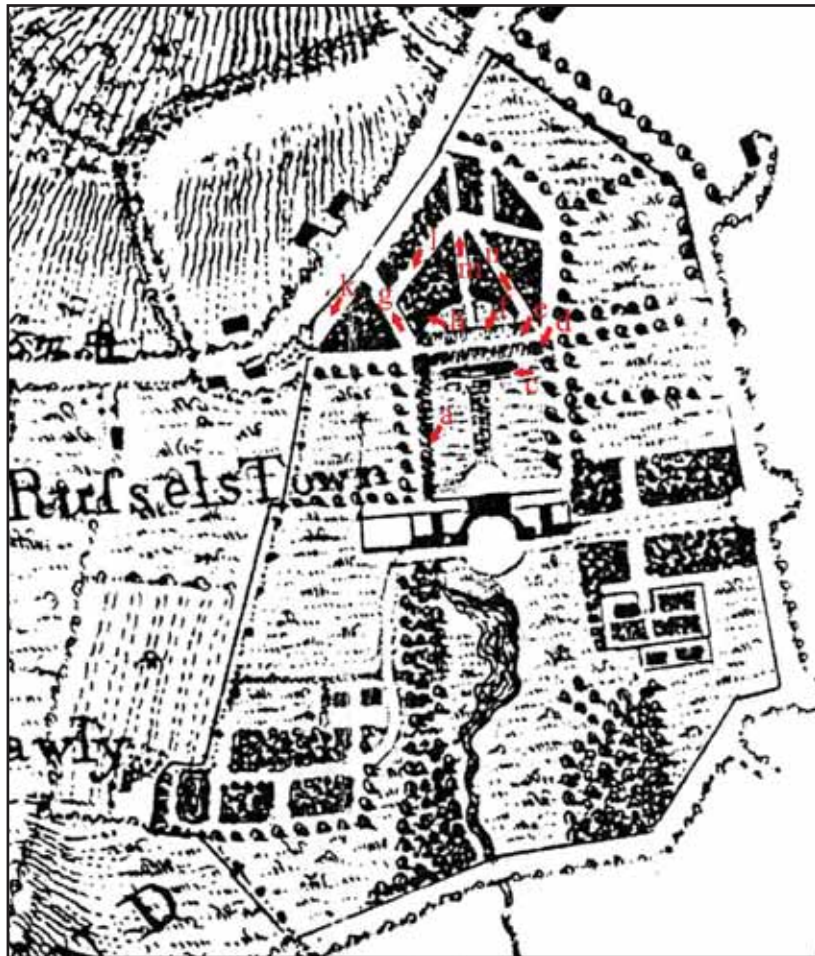
Figure 10: Detail from Rocque map (1760). Identified are: terraces (a, b, c, d, e, f, j); avenues (g, k, l, m, n); and pathways (h, i)

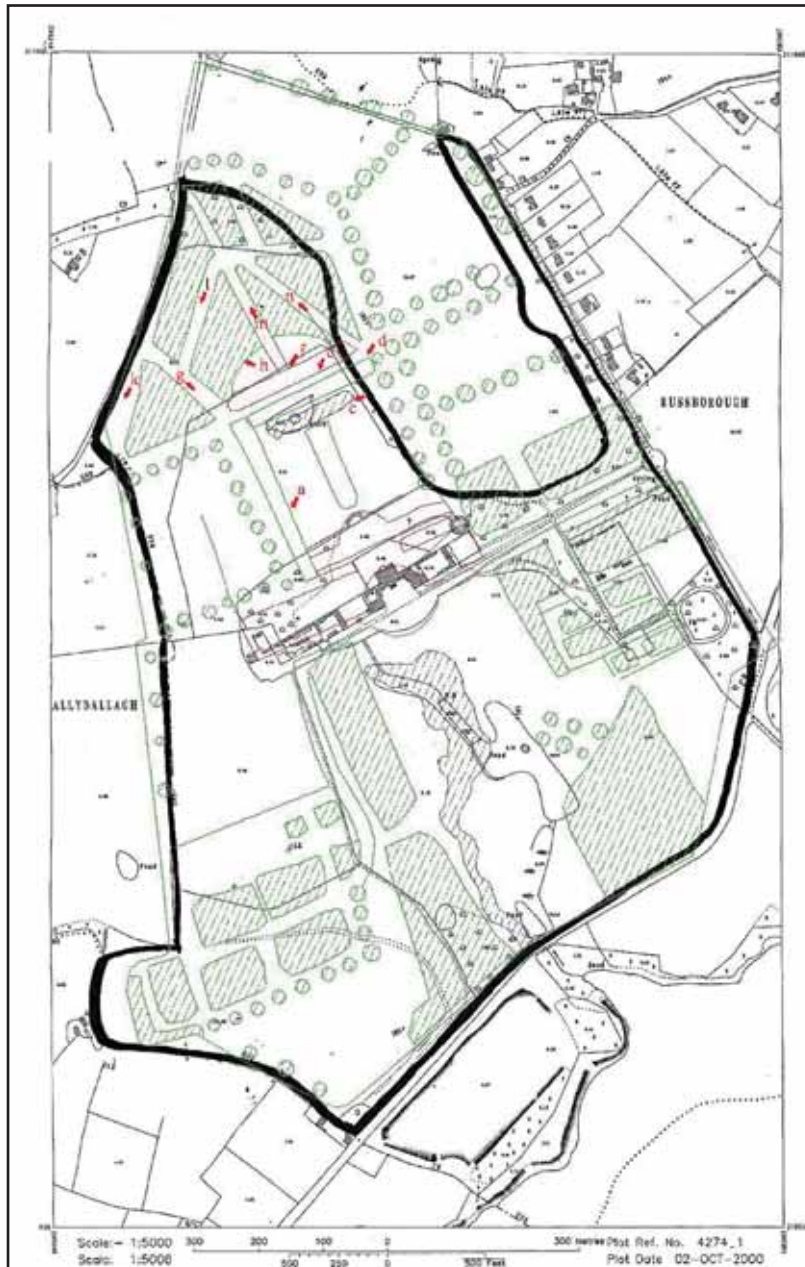
Figure 11: Ordnance Survey Rural Place Map (1997-99) and site boundary, overlaid with landscape and garden features derived from 1760 Rocque Map ('rubber-sheeted' version)

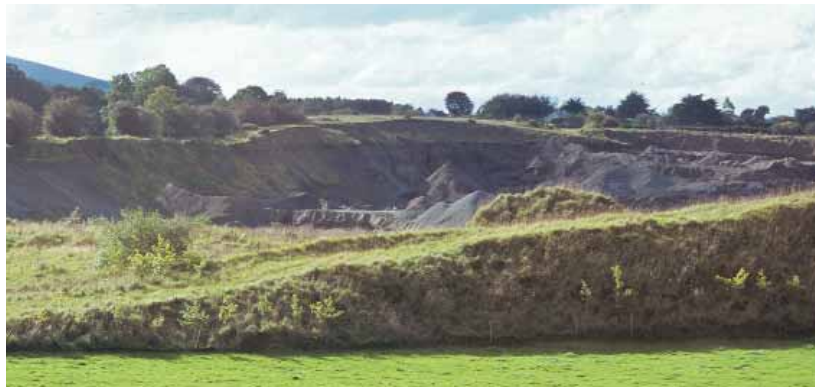
Plate 37: Part of the landscape has been lost to gravel extraction

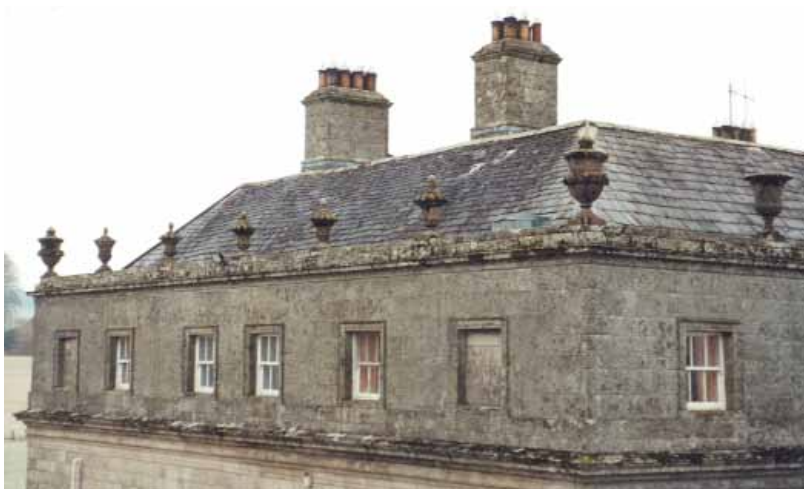
Plate 43: A general view of the main roof

There are many slipped slates (Dunphy, O'Connor, Baird, 1995). The roof lantern at the centre of the roof has been reslated recently using artificial slates. Water ingress at the roof lantern is seen as recent staining to the ceiling. It is likely that there is timber rot damage in the main beams in this area as well as valley boards etc. There is much moss, algae and lichen growing over the slates and parapet walls.

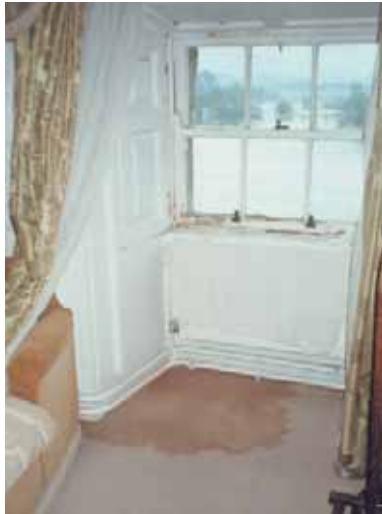
Plate 46: Water damage in a first-floor bedroom

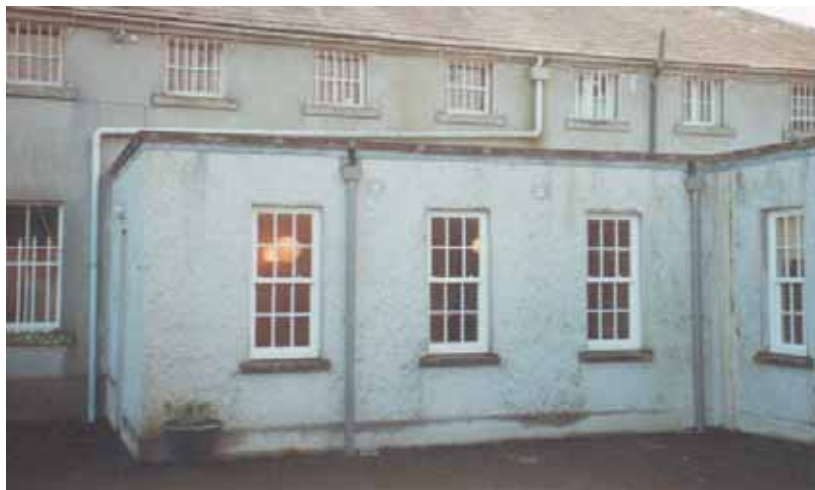
Plate 47: Ponding occurs on the flat roof of the Visitors' Centre

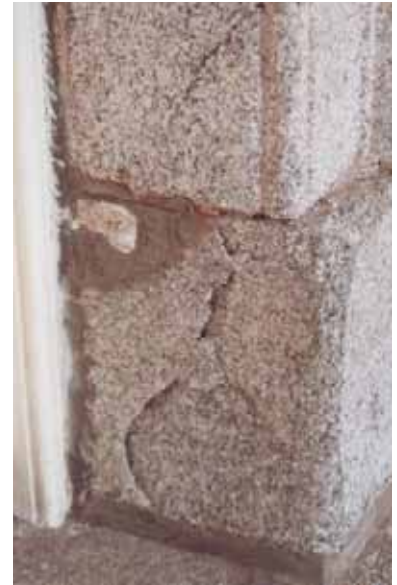
Plate 48: Scaling of granite around the main entrance door on the south elevation

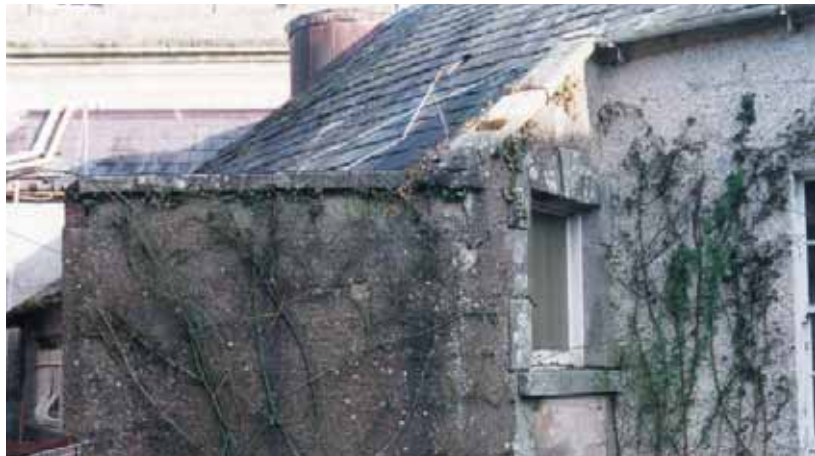
Plate 50: Vegetation on the walls surrounding Anne's Garden has damaged the render

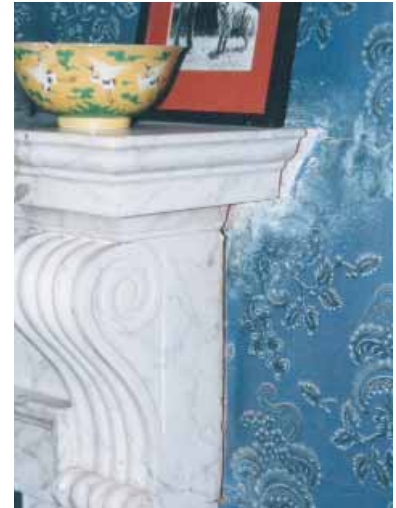
Plate 55: The mantelpiece in the Drawing Room has separated from the wall

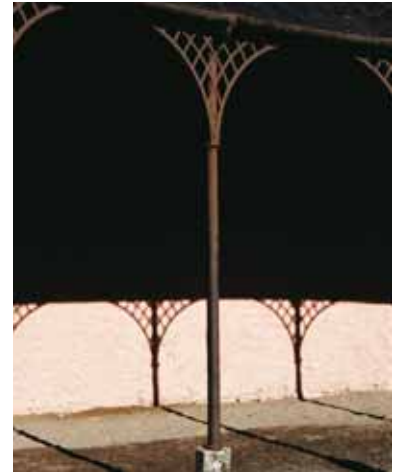
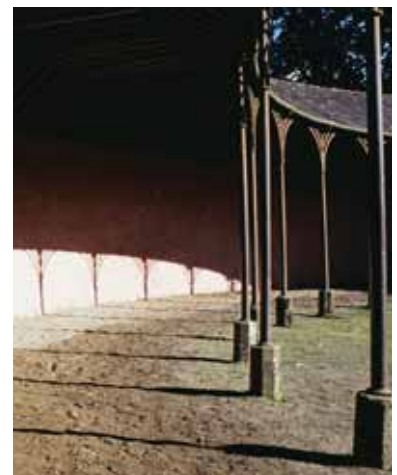
Plate 58 and 59: The cast iron columns in the Hippodrome
