SAINT LACHTAIN'S CHURCH  
FRESHFORD  
COUNTY KILKENNY

CONSERVATION PLAN

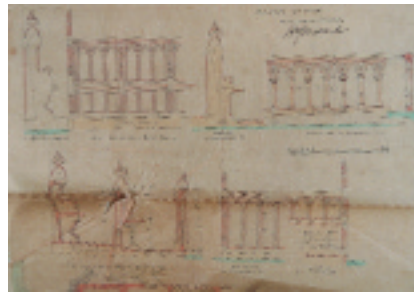
Figure 2: J. Welland's design for stalls and chancel rail. Undated (c. 1860)

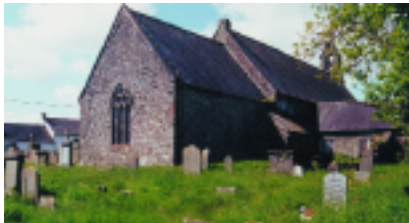
The church is a two-cell structure of roughly coursed rough-cut limestone and a significant proportion of Carboniferous sandstone, all of local origin. The 12th-century porch is made of yellow/white sandstone of the Old Red Sandstone series of the Devonian age. Nineteenth-century additions to the west façade are also of yellow/white sandstone. There is some re-use of cut stone, including a number of pieces of radially cut limestone ashlar in the south wall of the nave which may originate from the fabric of a curved structure, possibly a round tower or belfry tower. The building is roofed throughout with stone slate. A bellcote at the apex of the western gable, and chimney at the junction between nave and chancel, are 19th-century additions.

Plate 4: View from north-east, showing nave, chancel and annexe

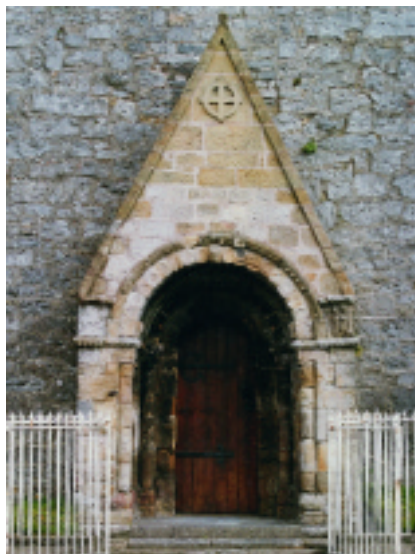
The porch comprises four orders of richly ornamented arches and a shallow barrel vault. The inner order, the plainest of the four, preserves a dedicatory inscription naming the patron and craftsman. Although asymmetrically arranged, this appears to be original to the monument. This order is grouped with a further two orders, the arches of which are decorated with chevron ornament. The outer order, carved with an elaborate step pattern and zoomorphic masks, is separated from the three orders of the doorway by a shallow barrel vault. On the west face, level with the springing of the outer order arch, are two figurative panels, one depicting a rider figure, the other two ecclesiastics. These, like a third figurative panel set into the jamb of the inner order, do not appear to be in their original locations. The porch is surmounted by a gable, the upper courses of which are a 19th-century replacement.

Plate 5: The West Porch

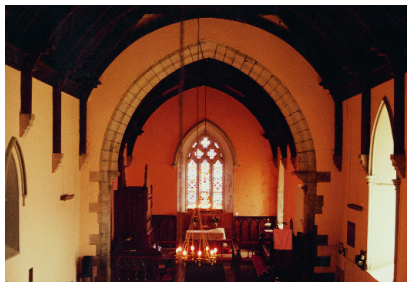
The interior of both nave and chancel have rendered and painted walls, a hammerbeam roof which is lower over the chancel, and timber floors which have been replaced in part with concrete. The division between nave and chancel is marked by a change of floor level and a 19th-century pointed arch of dressed limestone. A timber gallery across the western end of the church is reached by a timber stair. Glass and furnishings date mainly from the 19th century, with the exception of a stone font, possibly late medieval, in the south-west corner, and a memorial slab of 1711 on the north-east wall.

Plate 6: Interior of chancel looking east

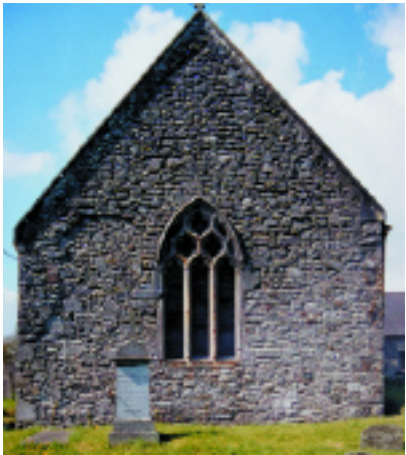
Plate 8: East gable, showing disturbance to fabric south of the window

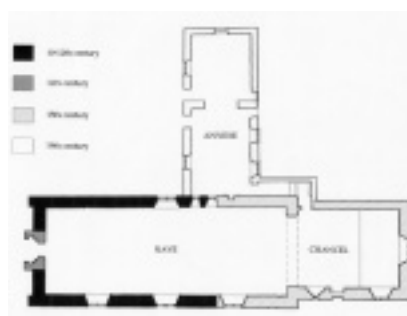
At some point during the medieval period, the nave was extended eastwards by c. 8 metres. With the possible exception of a window sill in the south wall, there are no contemporary dressed features. This phase of building, obscured on the north wall by the 19th-century annexe, incorporates a number of pieces of re-used stone both in the wall fabric and the quoins. Several of these pieces are radial ashlar, possibly from a round tower or apse.

Figure 5: Plan showing different phases of development of St Lachtain's

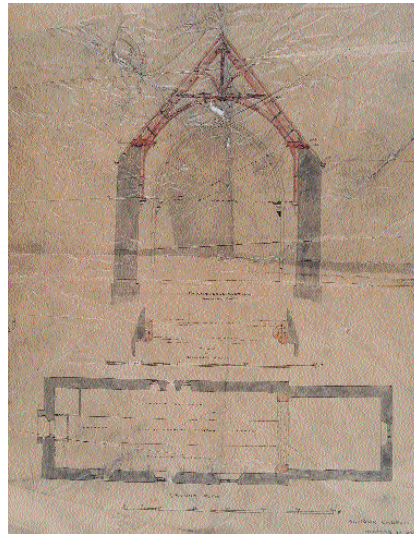
Figure 7: J. Welland elevation and plan of chancel arch. Undated (c. 1860)

Major renovations to the fabric were instigated some time towards the end of the 1850s under the auspices of the architect Joseph Welland, and following his death, the partnership of his son, William Welland and William Gillespie. It is not conclusive that certain renovations to the fabric, including the reinstatement of the apex of the porch gable, were carried out by the Wellands. The works necessitated the shortening of the gallery window, and a surviving unsigned and undated drawing in the RCB library shows the proposed insertion of a circular window to replace it. Together with the insertion of the neo-Romanesque window porch and gable apex, new capstones with Romanesque pellet ornament and made from a similar yellow sandstone were placed on the top of the antae.

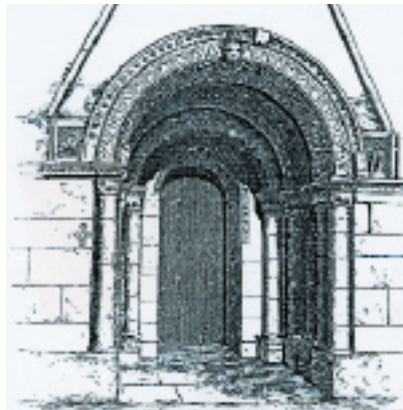
Figure 13: Engraving of St Lachtain's porch published in G. Petrie's *Ecclesiastical Architecture*, 1845
