ST MARY'S CHURCH AND GRAVEYARD
ST MARY'S LANE
KILKENNY

CONSERVATION PLAN

The Integrated Conservation Group

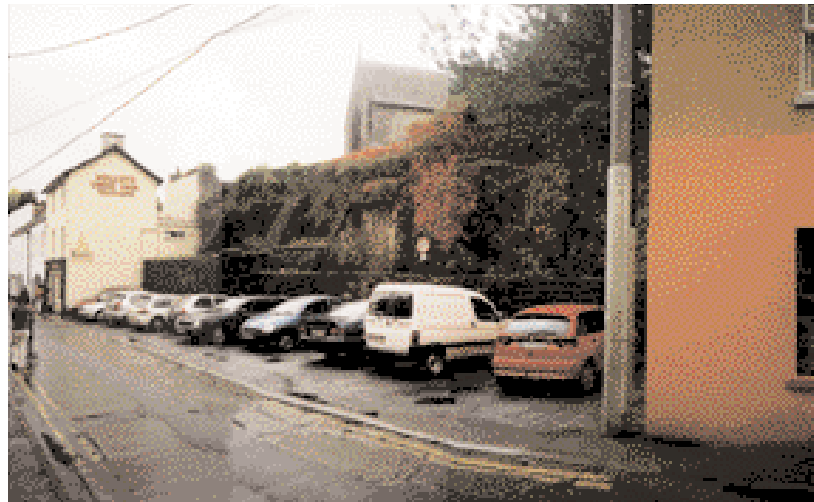
Plate 1: View of St Mary's Church and Graveyard boundary wall from Kieran Street

The site lies in the heart of Kilkenny's busiest commercial and tourist area (Figure 1) and is bounded on three sides by St Mary's Lane. Its eastern boundary is characterised by a drop in level of some 6m to Kieran Street (Plate 1) and to the rear of some properties along that street.

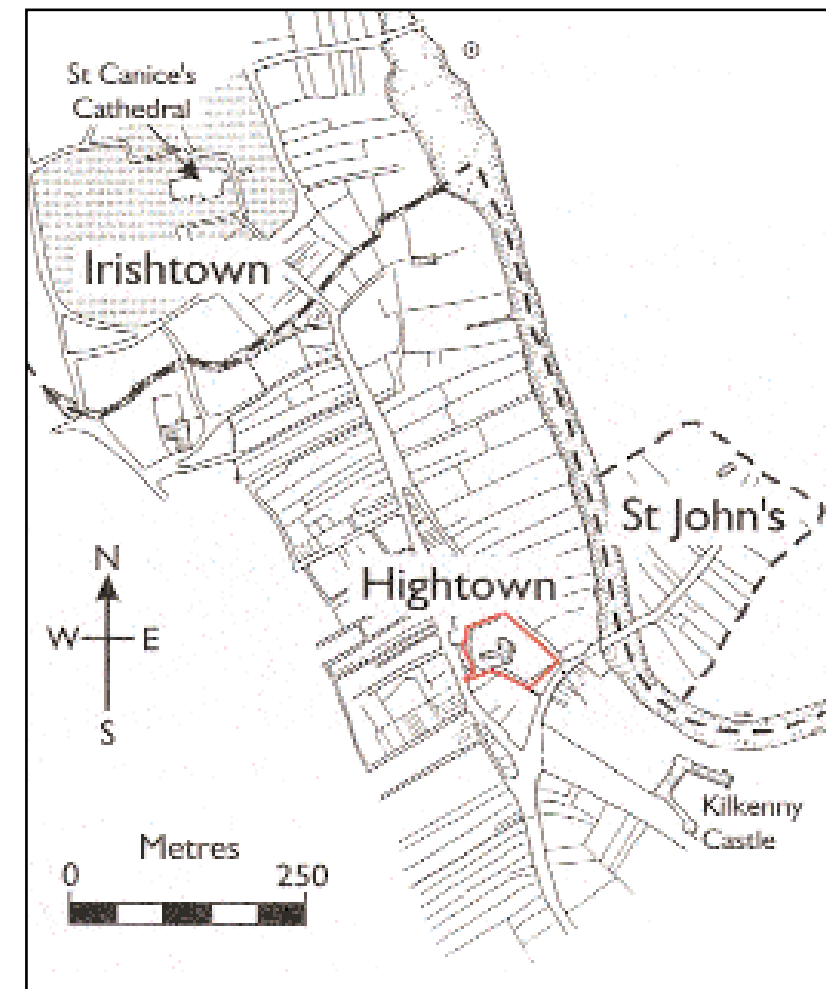
Figure 3: Map showing the medieval layout of the city (after Bradley 2000a)

The medieval walled town of Kilkenny consisted of four distinct elements (Figure 3). The northern portion was called Irishtown, site of a pre-Norman enclosed ecclesiastical settlement. The primary area settled by the Anglo-Normans extended northwards from the castle and over 400m downstream from St Canice's Cathedral. This area between the castle and Irishtown was known as Hightown, within which St Mary's Church and Graveyard are located. Later, during the 13th century, a further enclosed element called St John's was added on the other side of the river. The borough of Donaghmore was established to the south (Bradley 2000a).

‘The defences of Hightown enclosed a roughly rectangular area, with maximum dimensions of 800m by 350mm and a perimeter of about 1.45km, enclosing an area of about 28 hectares.’

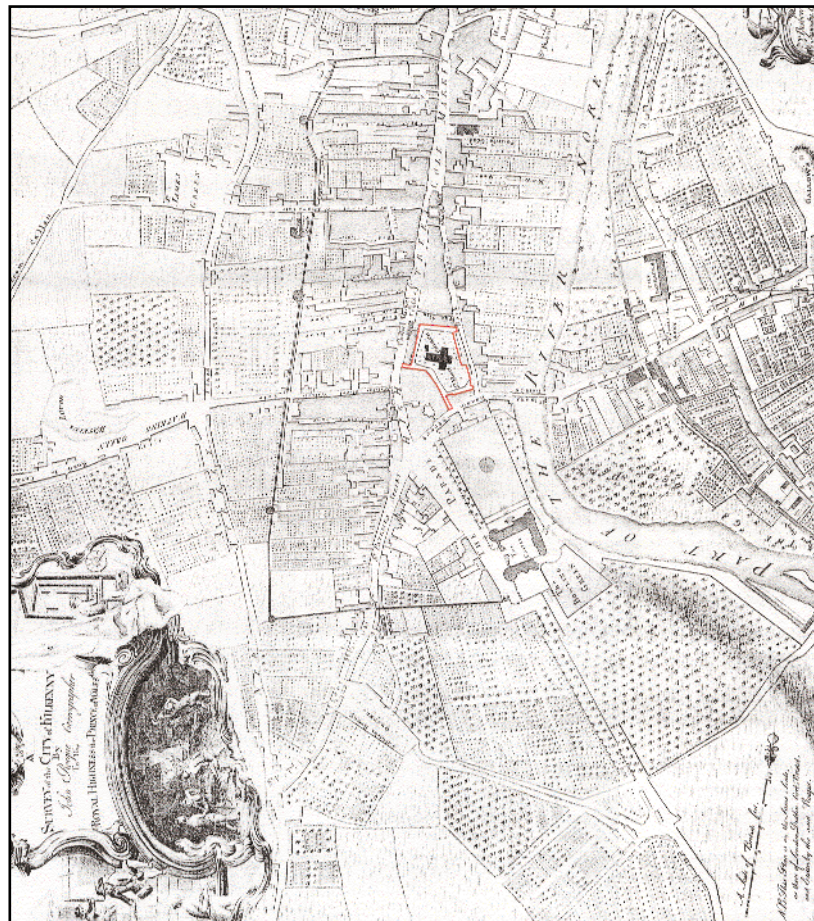
Figure 5: Rocque's Map of Kilkenny, 1758

Rocque's 1758 map of Kilkenny (Figure 5) provides substantially more detail than the Down Survey. St Mary's Church is clearly depicted to the east of High Street, at the rear of the Tholsel. The cross-shaped church is shown in the centre of an irregularly shaped site, which is completely delineated by a boundary wall. A structure, possibly a bell tower, is located near the west end of the church. Midway along the eastern side of the site, a small L-shaped structure is positioned against the boundary wall. This is most likely a vault. The remainder of the church grounds is indicated as having a covering of grass. The site is almost completely surrounded by an unnamed lane (St Mary's Lane), except along a section of its east side where part of a terrace of structures butts up against the site boundary wall.

Their architectural style, however, suggests an early 18th-century date; two buildings matching the almshouses are shown on Rocque's map of 1758 (Figure 5).

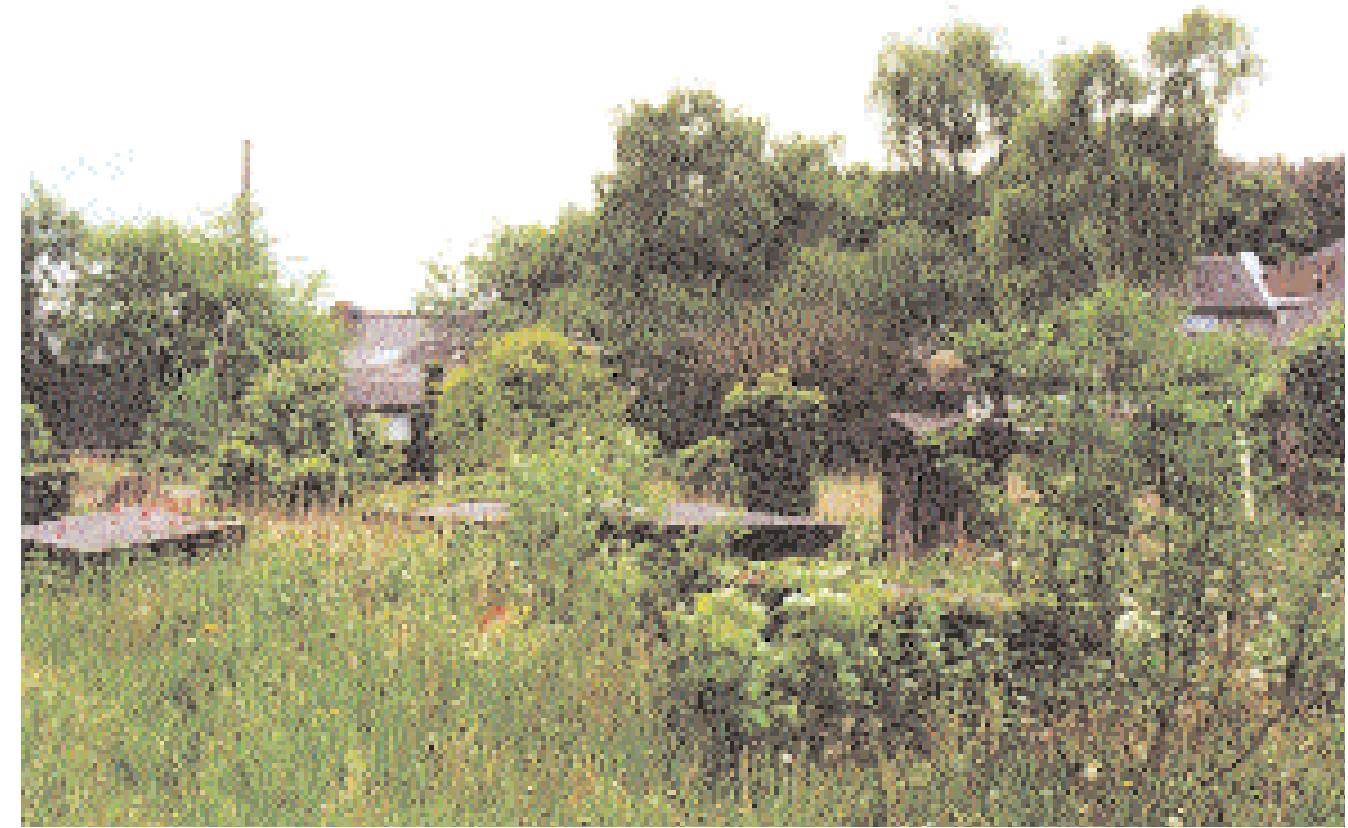
Plate 14: View of the successfully protected portion of the Graveyard at the south of the Church

According to the documentary sources, the graveyard appears to be contemporary with the church and has always been associated with it. It has remained largely intact (Plates 13, 14 and 15), and its boundary has remained unchanged. The graveyard possesses some of the finest Renaissance-style and later tombs in the country (Plate 19). Several very important arcaded, altar-type monuments to the east of the church were probably originally housed inside the church (John Bradley pers. comm). The gravestones and memorials are of immense historical, social and artistic interest. They provide an important record of local historically important families, as well as particular changes in stylistic and representational religious art at the beginning of the 17th century in Ireland. Unfortunately, it is these tombs and some of the mausoleums which have suffered most from vandalism (Plates 16, 17, 18 and Appendix 8).

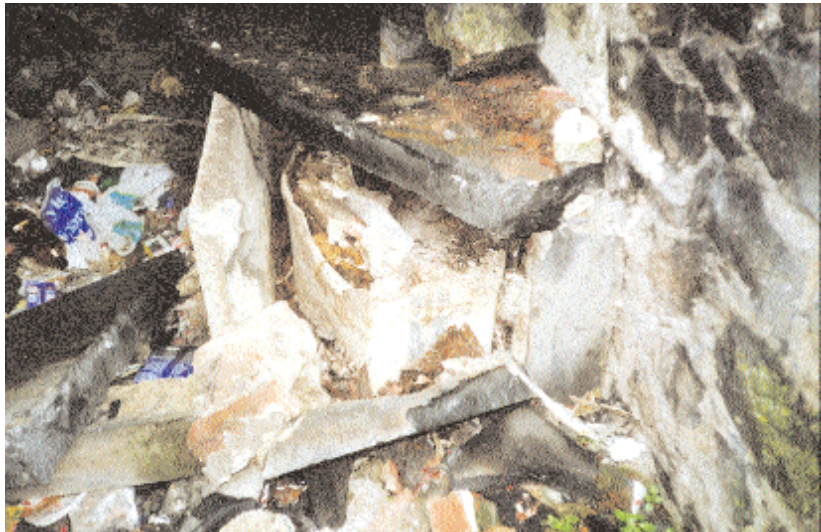
Plate 18: Attempted opening of a lead coffin (now blocked by cemented breeze blocks for security purposes)

Many of the finest early 17th-century monuments have been spray-painted with graffiti. They have also been subjected to repeated and concerted damage in an attempt to demolish and destroy their most beautifully carved columns and arcading. Of particular concern is the recent attempt to break open one of the lead coffins exposed by the dismantling of a mausoleum (Plate 18).

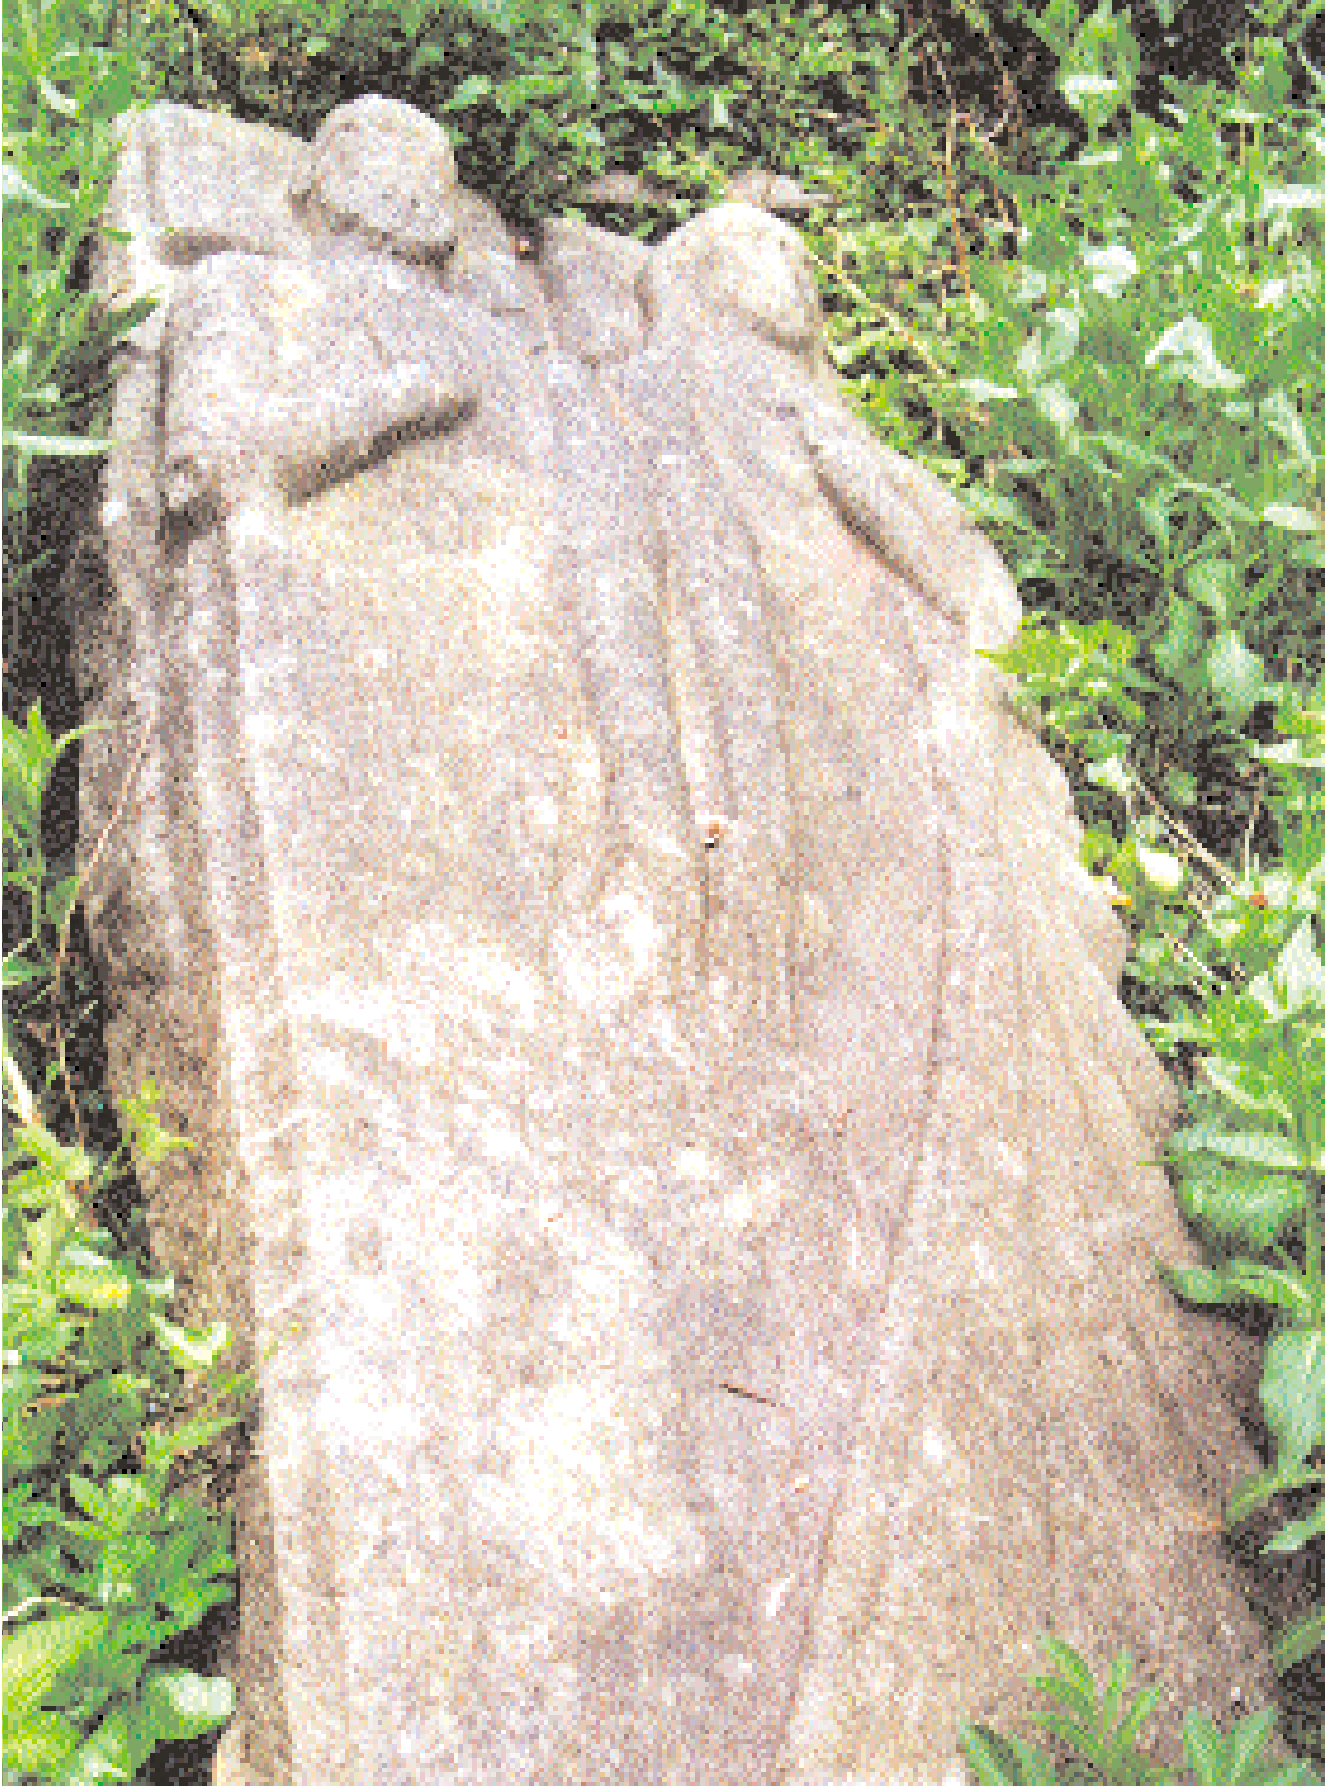
Plate 19: Renaissance-style tombstone at the west of the Church

To the west of the church, the handsome tomb of William and Margaret (or Margareta) Goer (c. 1350) ‘provides a record of the costume worn by the burgesses of Kilkenny in the second half of the fourteenth century’ (Bradley 2000a: 17; Lanigan and Tyler 1987) (Plate 19).

The graveyard has a unique collection of unusual and elaborate grave slabs, including 'the effigial one to William Goer and his wife Margareta (or Margaret) (c. 1350)' (Plate 19) and 'the slab to Helen, wife of William of Armoyle... inscribed in Norman-French' (Lanigan and Tyler 1987: 23). Prominent Kilkenny families like the Shees and the Rothes are well represented within the church and graveyard at St Mary's (Section 4). The Shee mausoleum and a number of Shee family altar tombs (Plates 11, 22, 23, 24, 25 and 28) are located to the east of the church, including the tomb of Sir Richard Shee (d. 1608) (Lanigan and Tyler 1987). Evidence suggests that the tomb of John Rothe FitzPiers and his wife, Rose Archer, was moved to its current location in the graveyard north of the church (Lanigan and Tyler 1987). Their tomb was constructed in 1612 but was not used until John Rothe's death in 1619 (Lanigan and Tyler 1987). The tomb of Richard Rothe (d. 1637) is another fine funerary monument.

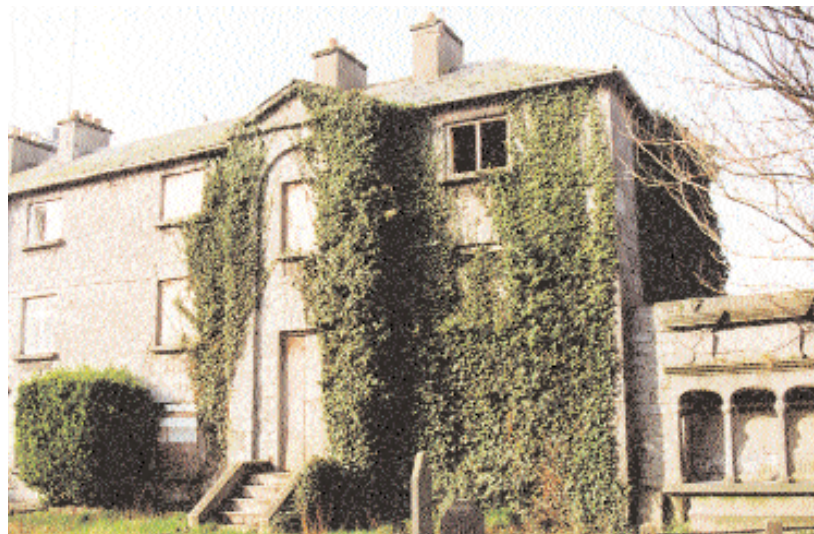
Plate 21: The derelict Almshouse

The site incorporates the two three-storey-over-basement St Mary's Almshouses which date to at least the early 18th century; they may indeed be of medieval origin. One is unfortunately derelict (Plates 20 and 21), and there are considerable problems relating to the original trust (Section 7.8).

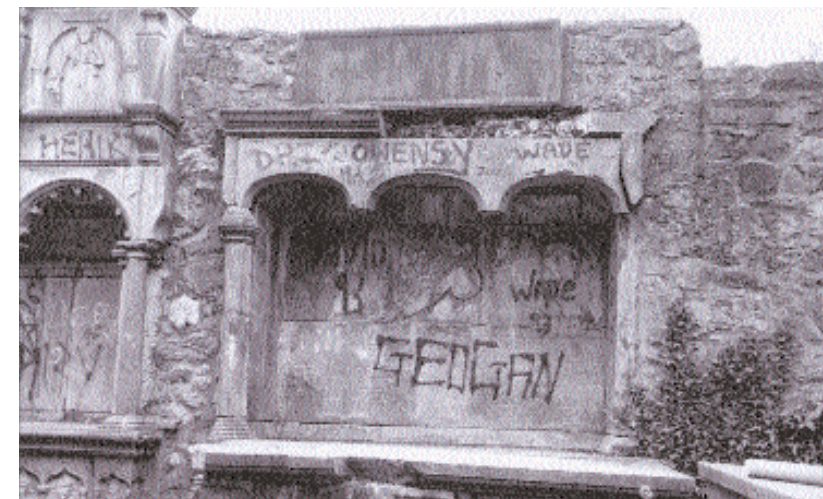
Plate 22: Tomb of Elias Shee c. 1613 located to the east of the church. Photo taken 2000-2001

The graveyard has been quite systematically vandalised over the past few years (Plates 22, 23, 24 and 25). In the very recent past, the problem appears to have become more extreme for a number of reasons: the use of the church building has slowed; street-based drinking and drug-taking have increased; the vacancy of the second almshouse continues and its dereliction accelerates.

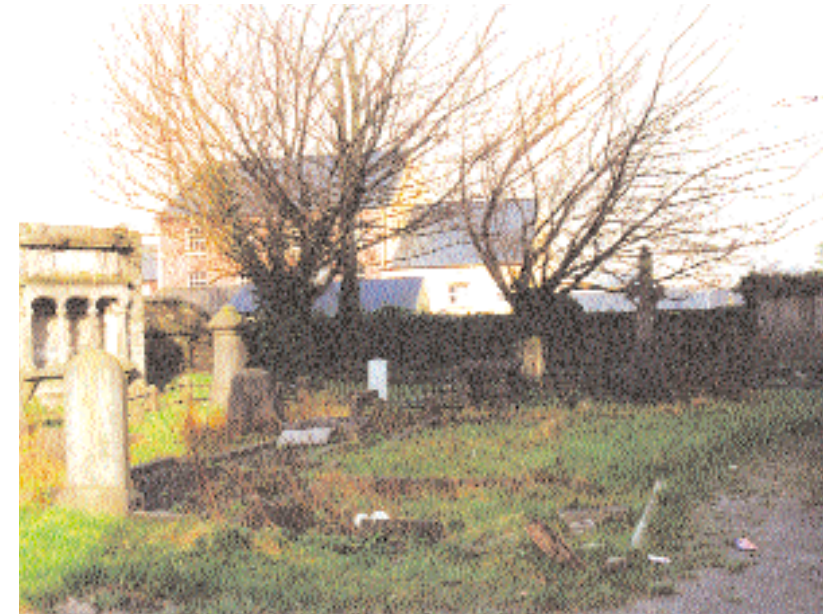
Plate 26: Ground in front of derelict almshouse

The vacant almshouse formerly looked out over what has become the most vulnerable part of the site (Plate 26 and Figure 2). It is now absolutely hidden from all view and provides a quiet retreat for those involved in drinking and drug-taking.

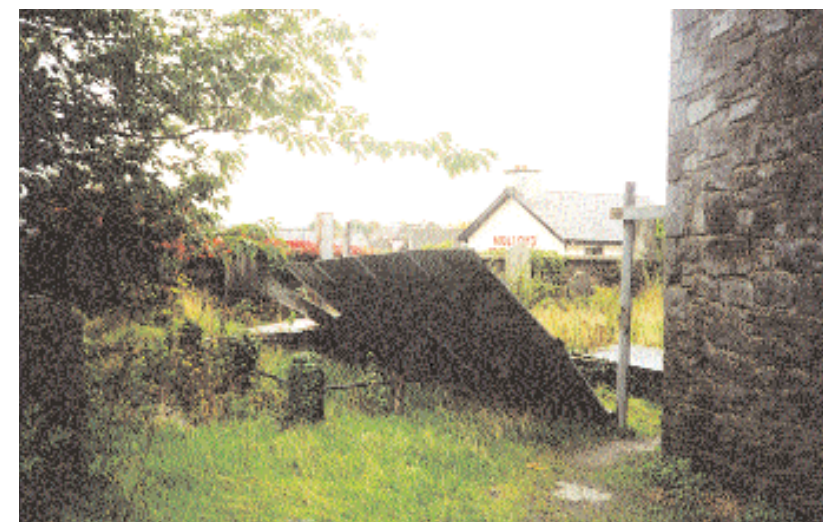
Plate 27: Vandalised hoarding

Litter, broken bottles and other items (syringes have not been noticed) have been discarded throughout this favoured 'haunt'. The most hidden area of the graveyard at its eastern side is easily accessed, despite the parish's efforts to secure it with plywood hoarding (Plate 27).

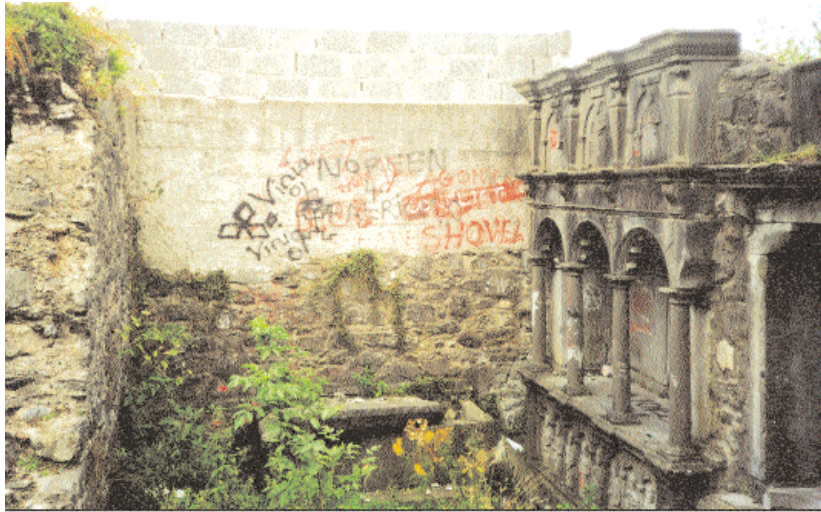
Plate 28: Heightened perimeter wall

Attempts have been made to protect the most vulnerable and important monuments by increasing the height of the boundary wall (Plate 28) and building a hoarding across the portion of the graveyard in which they are located. These efforts, however, have simply strengthened the resolve of those perpetrating the damage. Each time the site has been visited in the past year, the hoarding has been easily breached with a crowbar or something similar. Like the tombs, it too has been subject to concerted damage.

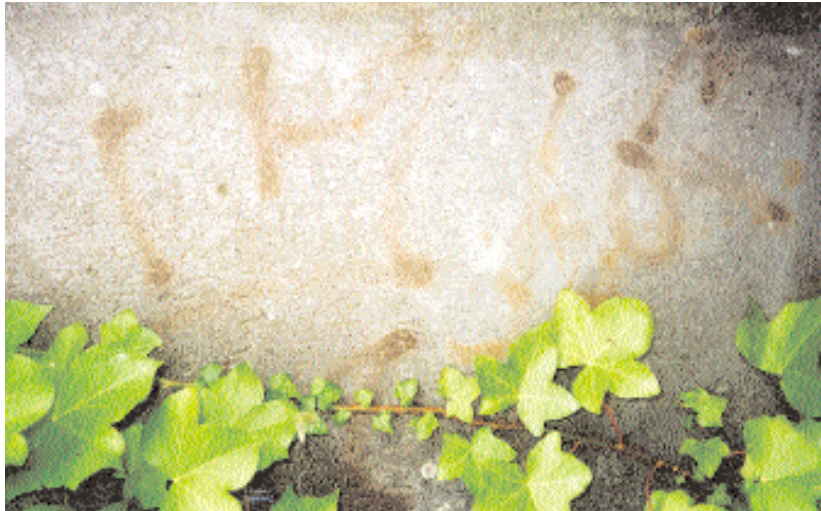
Plate 29: Damage caused as a result of cleaning off graffiti

In the past, attempts to clean the monuments have led to a significant loss of the stone surface and of carving/inscription detail (Plate 29). The Rothe tomb with its very fine incised decoration and the Shee tomb have been very badly spray-painted with graffiti. This will have to be treated with the greatest care during any cleaning exercise. (For more information, see Appendix 1.)

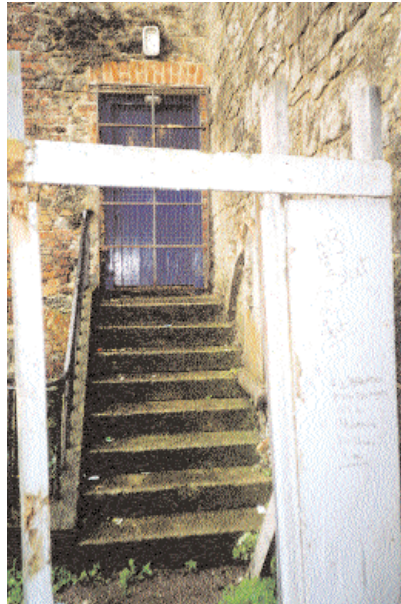
Plate 30: Neglected rear entrance doorway

There has been a consistent and marked decline in community use of the parish hall in recent years. The Freemasons only meet several times a year; the hall is no longer used for indoor sports such as badminton; amateur theatrical events are rarely held there; and its Arts Week use may no longer be sustained. The functional requirements of the parish hall within the modern city are no longer what they used to be. The building is now rather 'tired' and requires very significant refurbishment (Plates 30 and 31).

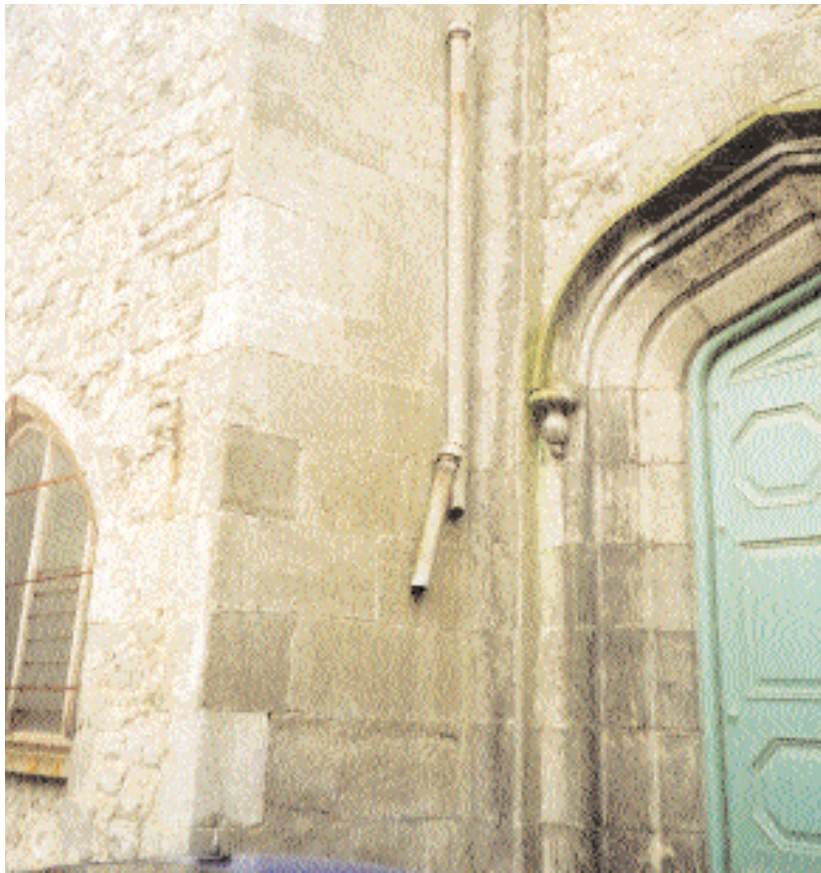
Plate 32: Damaged downpipe

The funds generated by the use of the site as a car park are clearly not adequate for its upkeep (Plate 32).

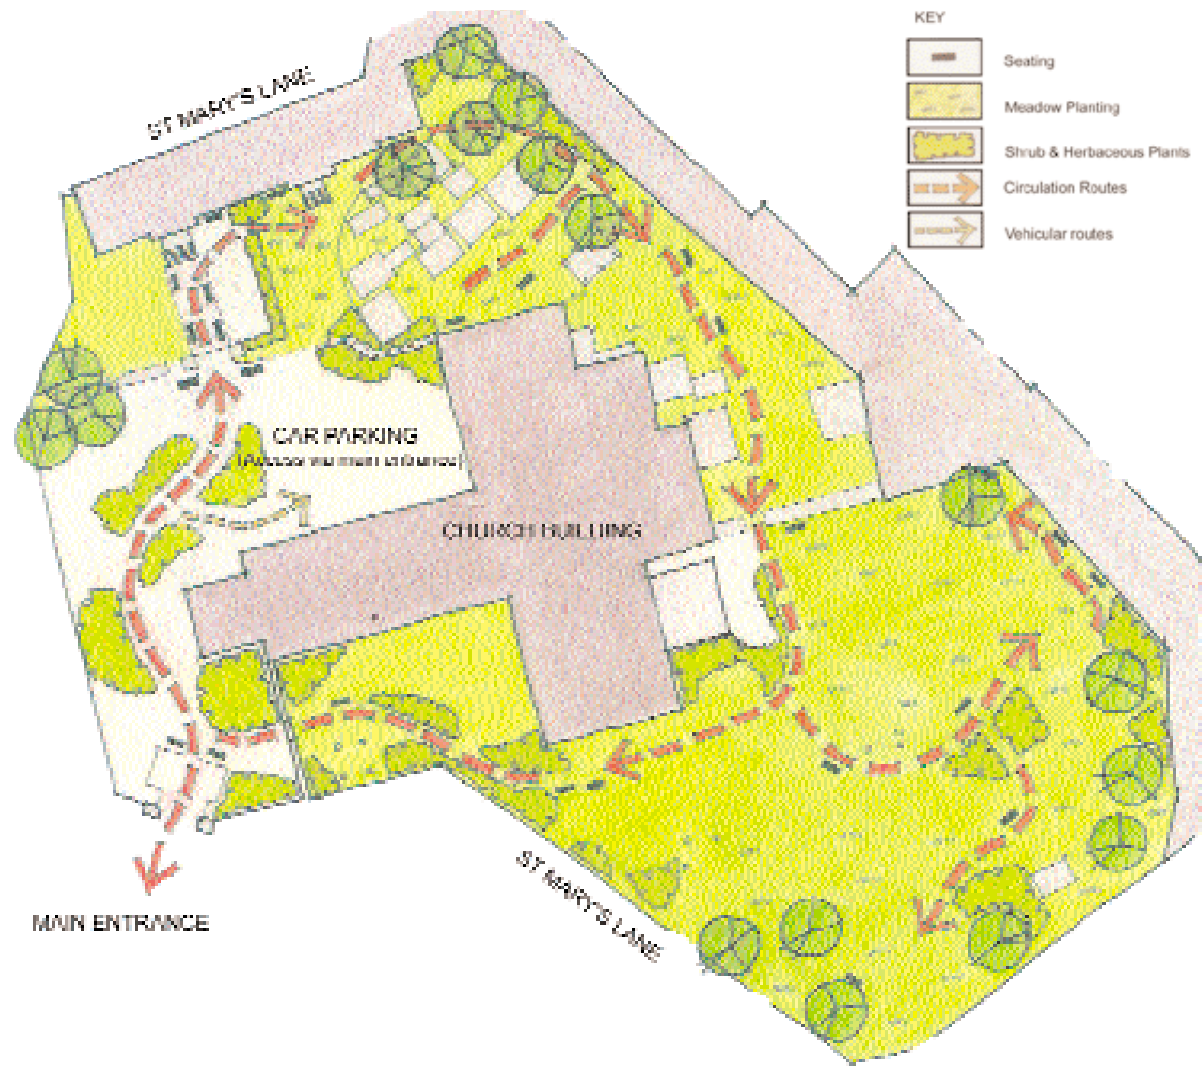
Figure 13: Conceptual landscape proposals

The conceptual landscape proposals for St Mary's Graveyard, Kilkenny (Appendix 2), seek to conserve the inherent historical character of the site whilst simultaneously creating a landscape that is suitable for contemporary civic use (Figure 13). The key elements of the design are: Planting, Architectural and Historic Character, Ecology and Users. However, it should be noted that the plans are conceptual only and that further detailed ecological surveys and landscape management plans may be required.
