**EXCAVATION AND ARCHAEOLOGICAL  
BUILDING SURVEY AT THE ROBIN  
ROOM, BISHOP'S PALACE,  
CHURCH LANE, KILKENNY 2011 (11E157):  
*PRELIMINARY REPORT***

**KILKENNY ARCHAEOLOGY**

<b>Client</b>	The Heritage Council, Church lane, Kilkenny
<b>Document title</b>	Excavation and Archaeological Building Survey at the Robing Room, Bishop's Palace, Church Lane, Kilkenny 2011 (11E157): <i>Preliminary Report</i>
<b>Document type</b>	Building recording and limited excavation
<b>Issue number/date</b>	draft 1/25 <sup>th</sup> September 2011
<b>Irish national grid</b>	250292 156423
<b>Archaeological licence reference</b>	11E157
<b>Planning reference</b>	06/01; PL 62.131051
<b>Kilkenny Archaeology job no.</b>	11/034
<b>RMP reference</b>	RMP KK 019-026123 <i>ecclesiastical remains</i>
<b>Archive location</b>	Kilkenny Archaeology, Threecastles, Kilkenny
<b>Finds location</b>	Kilkenny Archaeology, Threecastles, Kilkenny
<b>Archaeological licence holder</b>	Cóilín Ó Drisceoil MA, MIAI
<b>Excavation team</b>	Dr. Richard Jennings DPhil, Philip Kenny
<b>Building survey drawings</b>	Phelim Manning
<b>Report author</b>	Cóilín Ó Drisceoil MA, MIAI

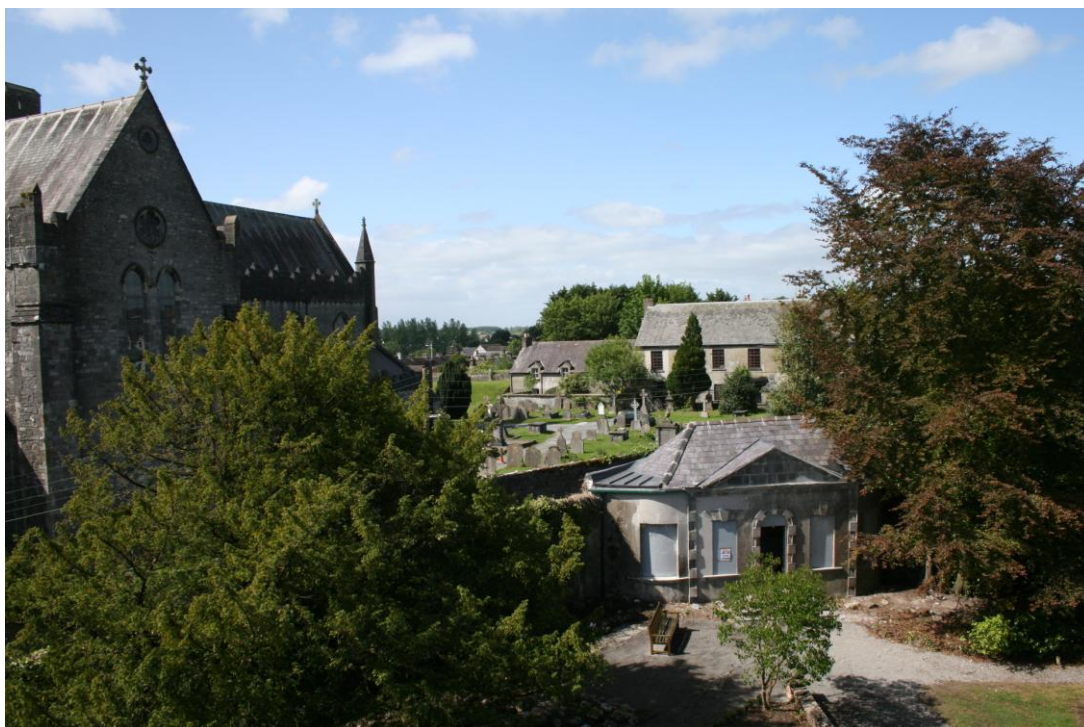
*Figure 3: The Robing Room beneath the north transept of Saint Canice's Cathedral. In the background are the thirteenth century Manse house of the Prebendary of Blackrath, which became a public school founded by the eighth Earl of Ormond (died 1539), and Saint Canice's library. This structure was built in 1679 and incorporates the mural tower 'Black Rath castle' (photo: C. O Drisceoil).*

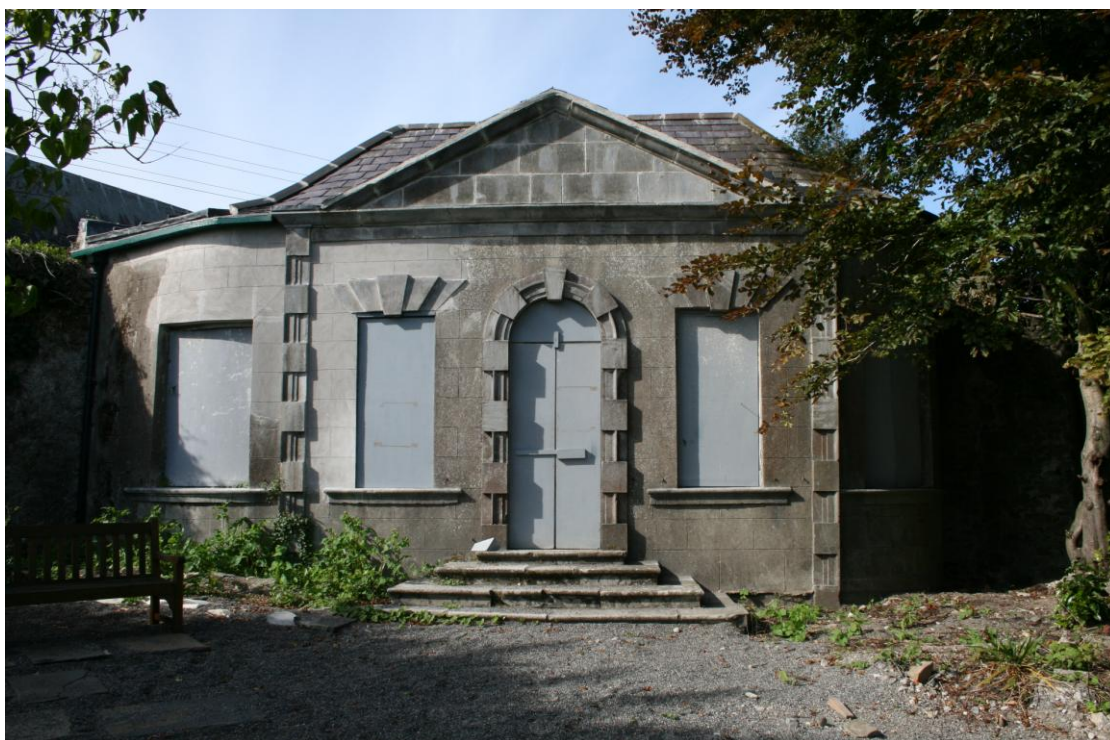
*Figure 4: The Robing Room from north (photo: C. O Drisceoil)*

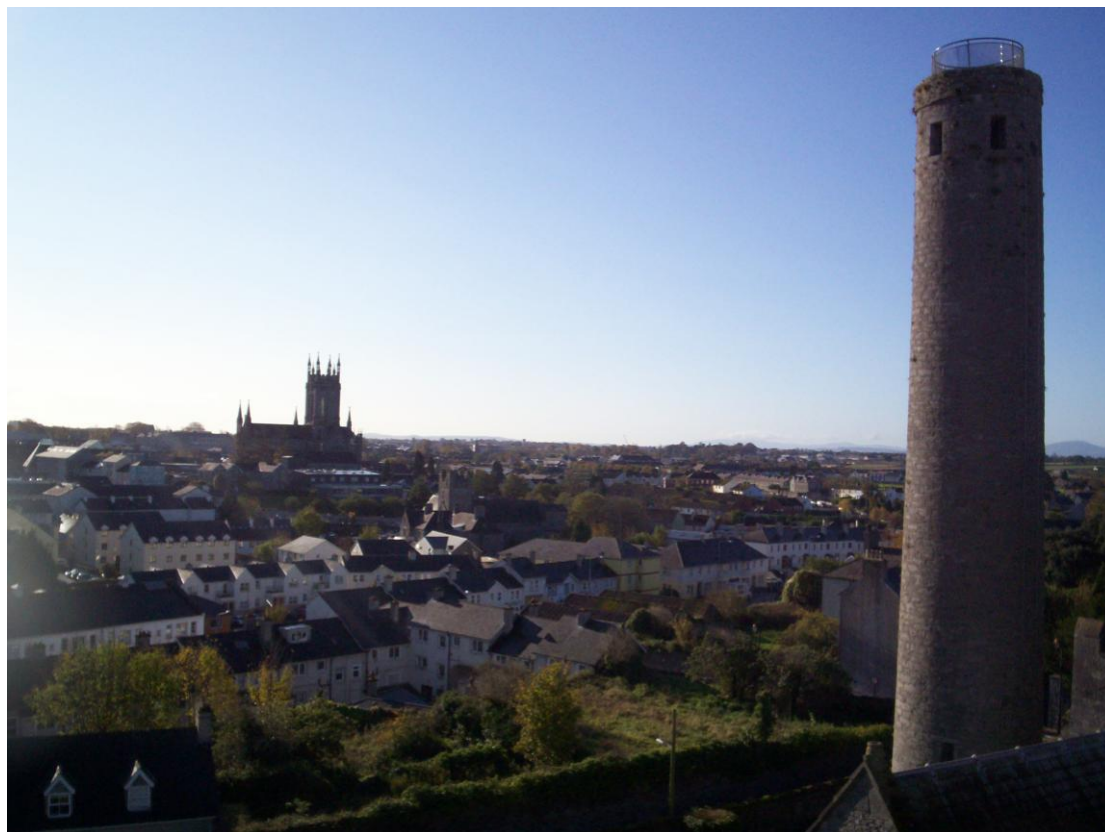
*Figure 8: The round tower at Saint Canice's Cathedral is Kilkenny's oldest standing building and was probably built to celebrate Kilkenny's status as episcopal see at the synod of Rathbrasil in 1111 (photo: C. O Drisceoil)*

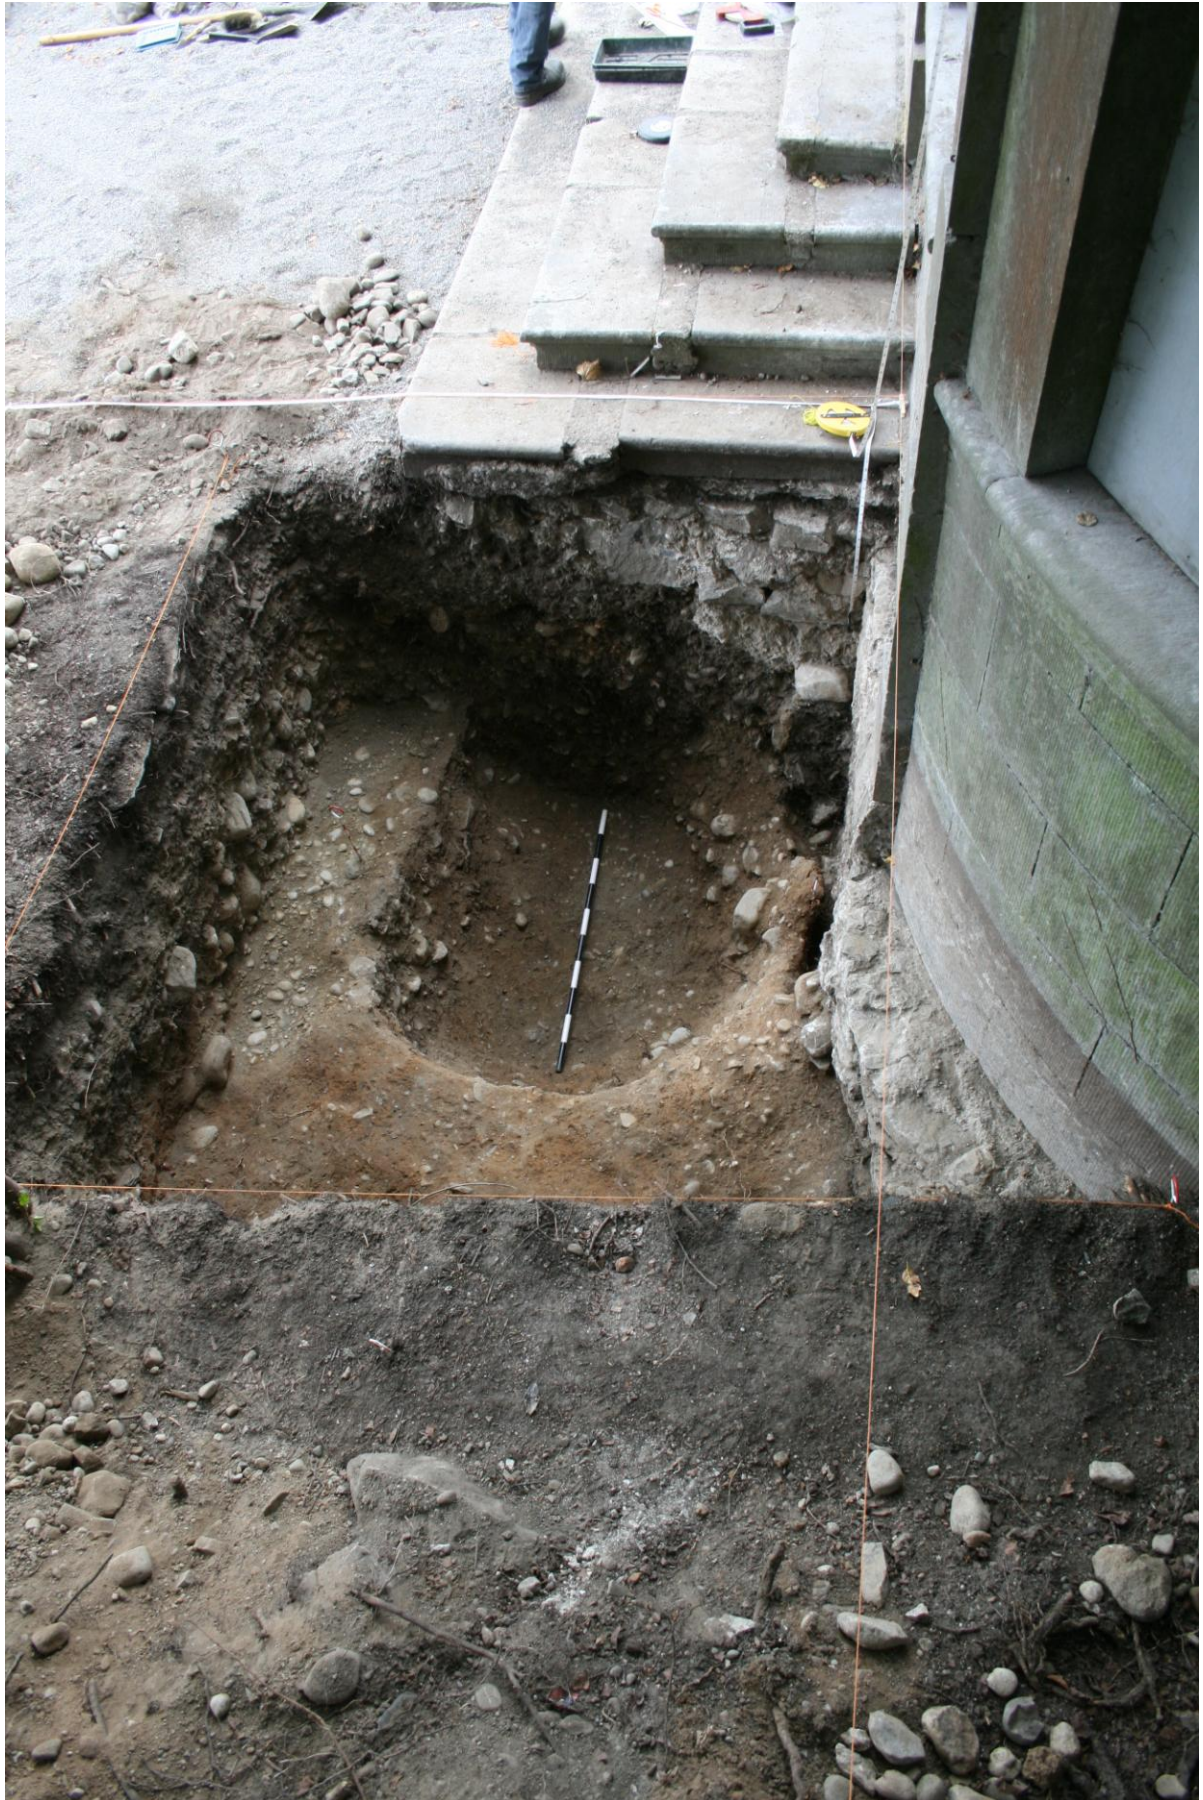
*Figure 10: Photo of pit [010], post-excavation, from west (photo: C. O Drisceoil)*

At the base of Cutting 1 and cutting the gravel and clay glacial subsoil was an oval pit [010], 1.45m north-south x 1.25m x 0.65m deep (Figures 9, 10). Around 95% of its extent was exposed in the cutting, a further c.0.1m extended outside the northern limit of excavation. Two deposits filled the pit, the earliest was a 0.32m deep, dark-brown (10 YR 3/3) sandy-clay dump of burnt 'pot-boilers' (21kg) and animal bone (much of it burnt) [019] (Figure 11). One sliver of an antler tine was also recovered and will be radiocarbon dated. Lumps of lime-mortar were present in small quantities, as were fragments of slate. The secondary fill [011] had a similar content but differed in colour, being an olive brown (2.5 Y 4/4) sandy-clay dump of burnt pot-boilers (20kg) and animal bone, both burnt and unburnt. A hollow cut bone cylinder, three antler tines and a beam were within the deposit and again occasional lime-mortar lumps and flecks of charcoal were noted.

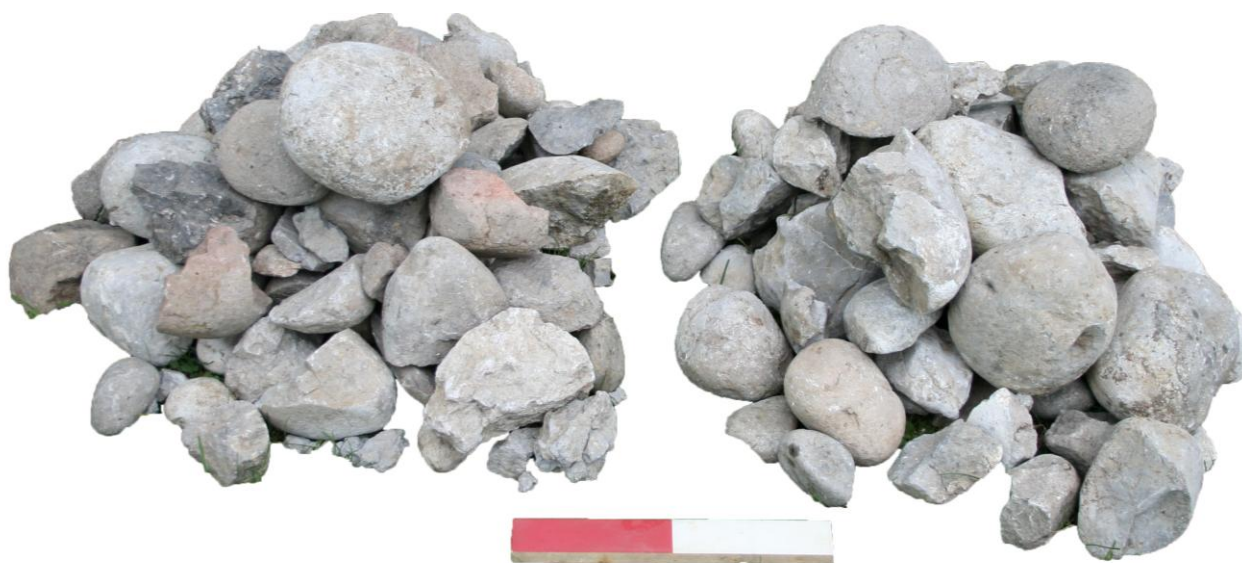
*Figure 11: Pot-boilers from the fills [019] (left) and [011] (right) of pit [010], scale 20cm*

thought to have been first heated on a fire – many of the examples from the Bishop's Palace show clear evidence for burning – and were then immersed in a container or trough of water (Edwards 1990, 83). The resultant hot water was used to soften the bone, allowing it to be manipulated more easily. A cursory inspection of the Bishop's Palace animal bones shows no diagnostic evidence (such as saw-cuts) for working but analysis by a specialist may alter this (MacGregor 1991, 363). Given the fact the material was in a pit and it is the third find of antler tines from the northern sector of the Close, there is a growing likelihood that a bone and antler workshop, like those excavated at Armagh and Clonmacnoise, was located somewhere close by.

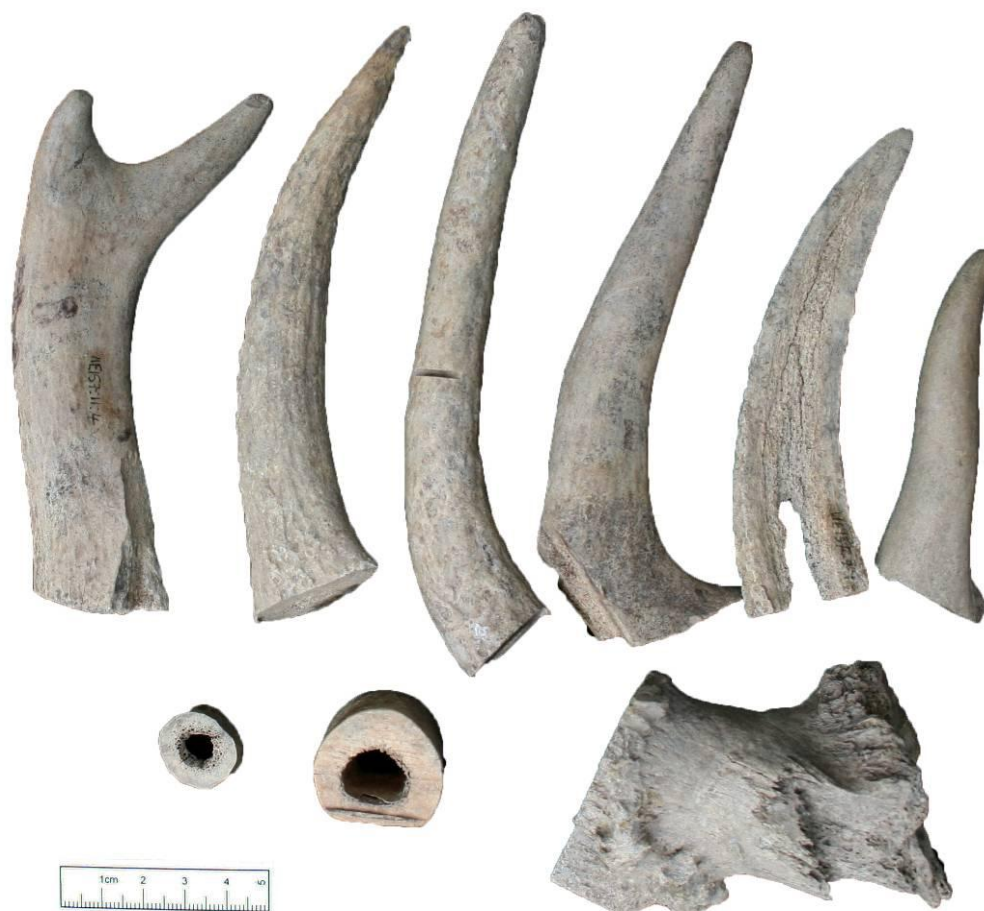
*Figure 12: Antler tines and cut antler from pit [010] and deposit [007]*

**11E157:011:1**-Antler tine (red deer). Sawn-off, polished from natural wear. L. 85mm. Diam. 30mm (max).

**11E157: 007:003**-Antler tine (red deer). Waste from antler working. L: 157mm. Diam: 24mm (max), one saw nick on tine, 1.5mm thickness.

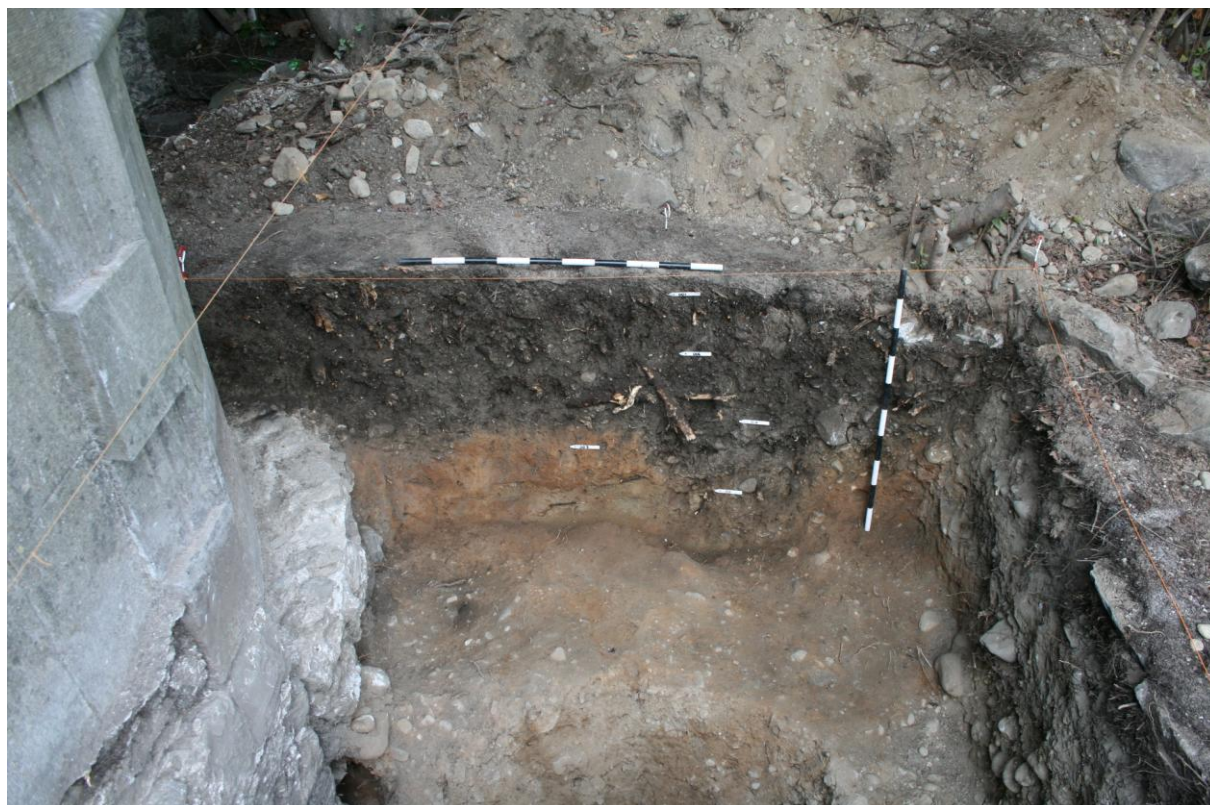
*Figure 14: Cutting 1 east-facing section showing the distinctive orange clay [007] of what is probably the levelled Early Medieval monastic bank (photo: C. O Drisceoil).*

Sealing the pit [010] and overlying the natural subsoil was a 0.3m thick layer of bright orange (2.5YR 6/8) sandy clay [007] (Figure 13). Within it were four antler tines, as well as animal bone. One sherd of eighteenth-nineteenth century glazed red earthenware and a small sherd of post-medieval window glass were the only other finds recovered and given the many tree-roots that infiltrated the deposit it is reasonable to deduce that these were introduced from later layers. Though only a small sample of this deposit was uncovered, its distinctive bright orange colour and the presence of antler working waste

within it is exactly what has been recorded previously on the opposite side of the Cathedral (Neary 2009; Ó Drisceoil 2009a). Here it was interpreted as the levelled clay bank of the inner monastic enclosure, the *sancticivimus*, and although a larger sample would be required to validate this theory it is possible a similar scenario pertains with regard to layer [007]. If it is correct it helps to reconstruct the line of the northern inner enclosure as having been roughly along what is now Church Lane.

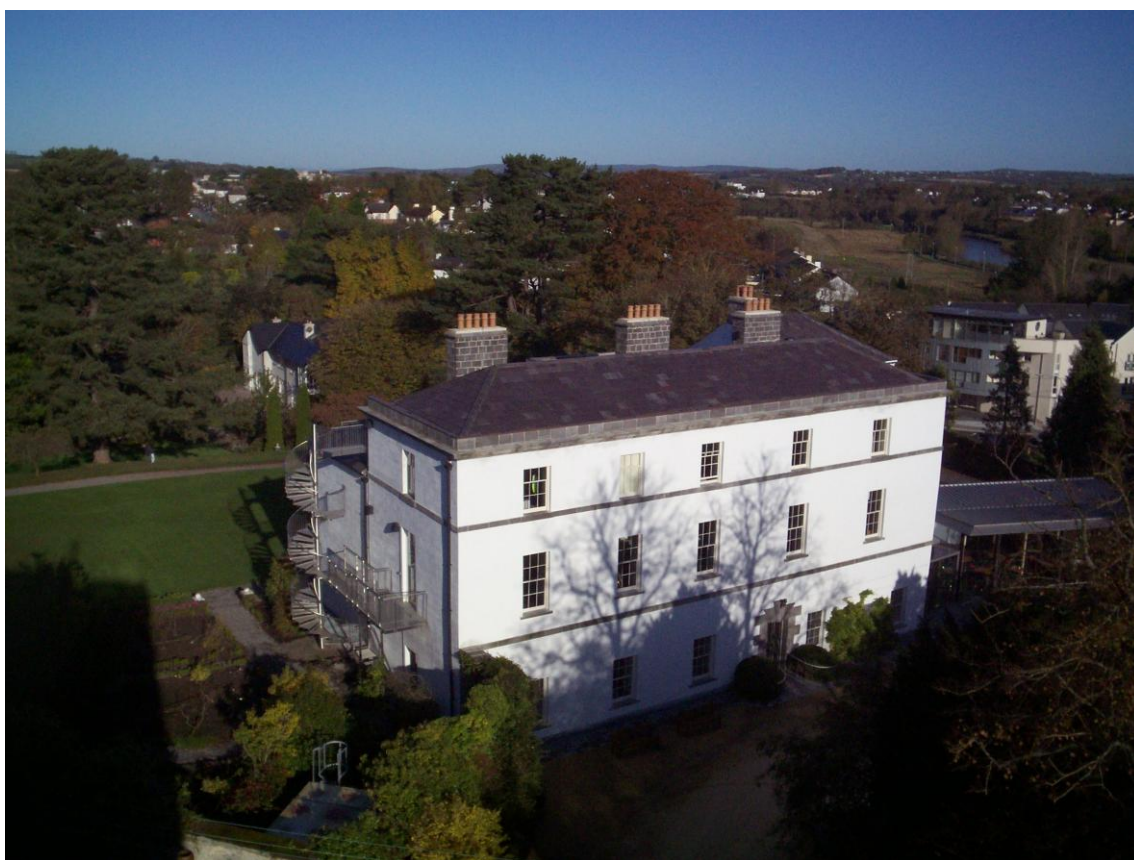
*Figure 15: The rather austere Georgian façade to the Bishop's Palace hides a complex series of building phases, beginning as a mid-fourteenth century medieval hall and tower, with substantial alterations in the seventeenth, eighteenth and early nineteenth centuries. The location of the episcopal mills on the river Nore at Bishop's meadows can be seen in the background (photo: C. O Drisceoil).*

The bishop's move to the site of the Bishop's Palace occurred in the late 1350s during the episcopacy of Richard Ledred (1317-*c.*1361) who replaced the Oldcourt with the Nova Curai or New Court and famously, he knocked three suburban churches to build his new residence (Carrigan 1905 i, 281; Murphy 2006, 13). Much of Ledred's palace, a three-storied fortified tower (with solar) that, in the manner of a fortified church, was attached to an earlier two-storey hall-house, has been documented in various archaeological and architectural investigations and survives today incorporated into the Georgian residence (*see* Table 1).

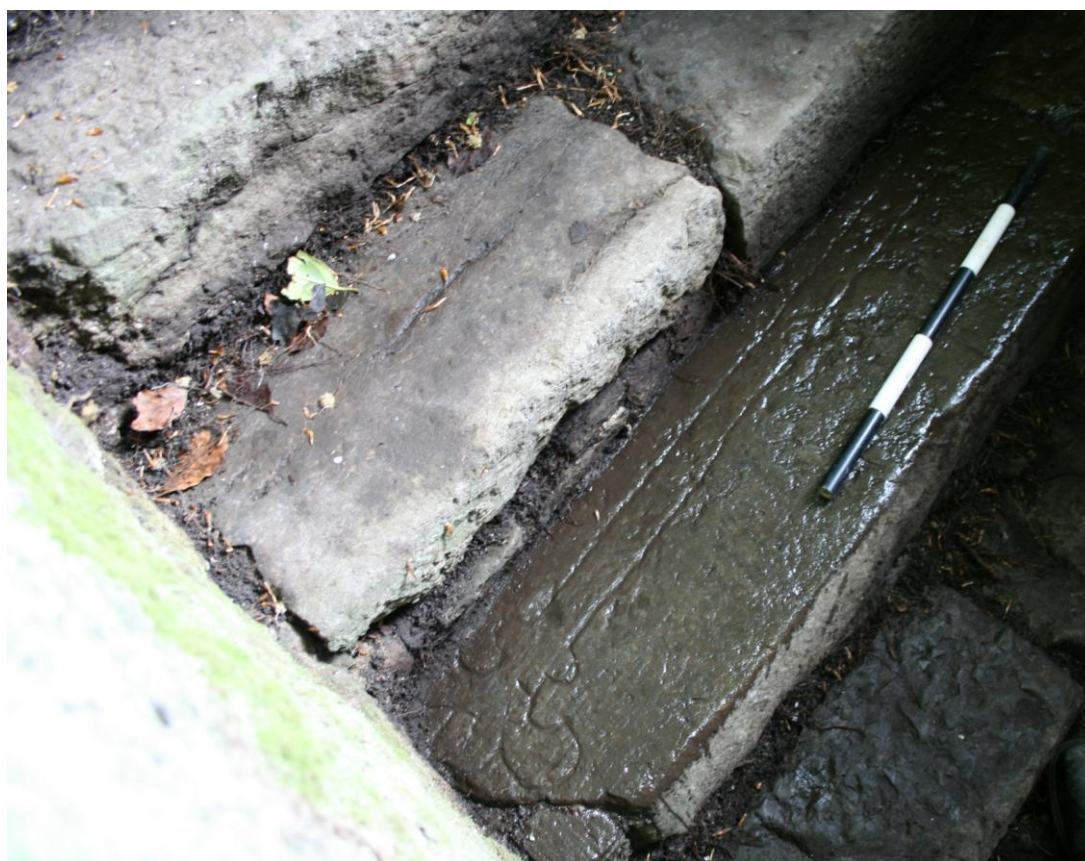
*Figure 17: A thirteenth-fourteenth century cross-slab reused for a step on the west side of the Robing Room (photo: C. O Drisceoil).*

A thirteenth-fourteenth century limestone cross-slab was found reused for one of the steps that descended to the basement level of the Robing Room (Figure 18). The stone was about 80% of what was originally a coffin-shaped graveslab that presumably was taken from the adjoining Cathedral, where some six similar examples are still to be seen (Bradley 1995). It was incised with the shaft of a cross, which terminated in a fleur-de-lis.

No inscription was visible and its top cross-head was missing; the dexter had been cut back to form a rectangle.

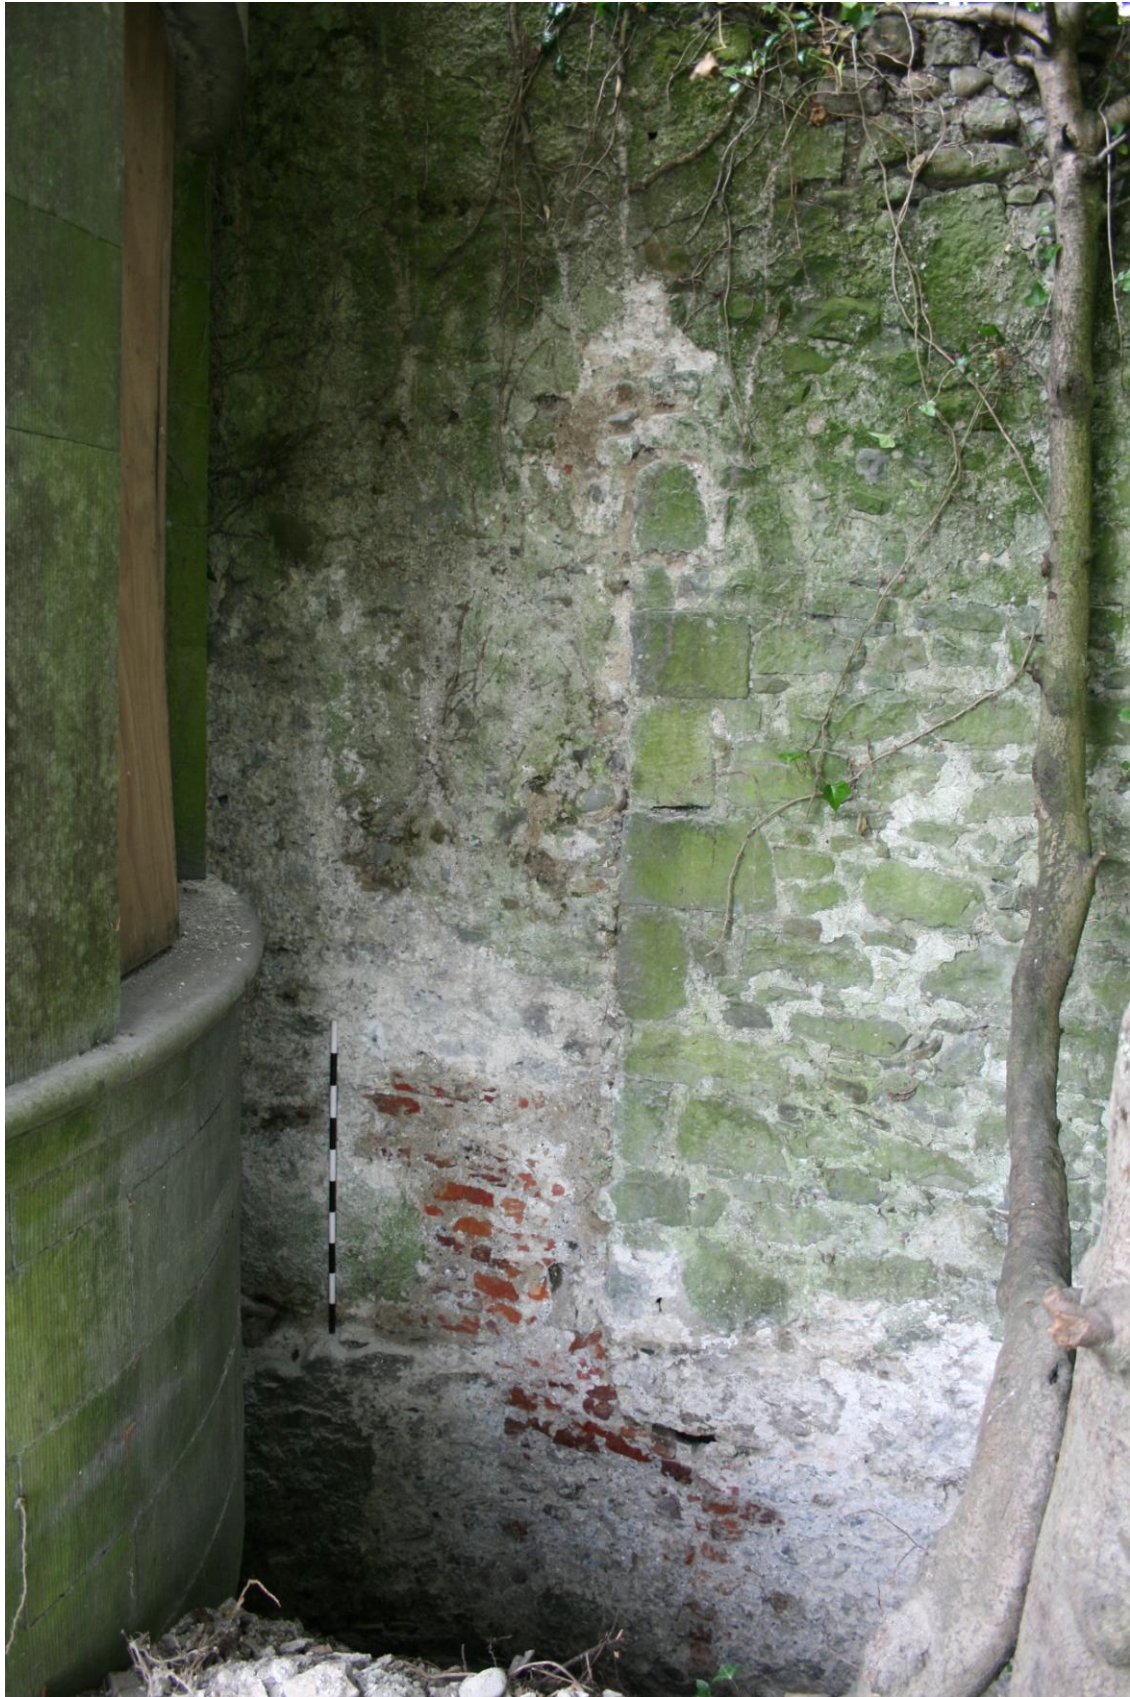
*Figure 21: 1739x48 jamb for one side of a gate that gave access to the Bishop's Palace grounds and was subsequently blocked for the Robing Room, the 'dragged' ashlar bow of which can be seen on the left (photo: C. Ó Drisceoil)*

The precinct wall to the north of the Robing Room terminates at a 2.2m high jamb [047] 1.5m before the Period 4B ashlar bow (Figures 21, 38). No diagnostic dressing was visible on the jamb; its external face was covered over by modern render. As argued above, this part of the enclosure wall probably dates to between 1739 and 1748 and was built at the same time as the wall with pilasters to the south-east. The jamb represents one side of an opening for a gate that gave entry from the lane into the See grounds. The opposite jamb of the gate was not found and is either concealed beneath later masonry or more likely, was removed for the construction of the Robing Room. It is almost certainly the gate that 'leads out of the Church-yard' that Chetwood referred to in 1748. Rocque shows the opposite gate into the Cathedral precinct around 1758 and prior to the construction of the 'covered way' for the Colonnade (Figure 22-3). The foundations [070] for the wall and jambs had been undermined in Period 4A. It was possible to work out from the base of the jamb that ground level in Period 3 was 0.65m above modern ground level, an indication that this area had been scarped in the past, probably during Period 4. No layers were excavated that could be dated to Period 3. However Seville coarseware was recovered from a later gardening layer [006].

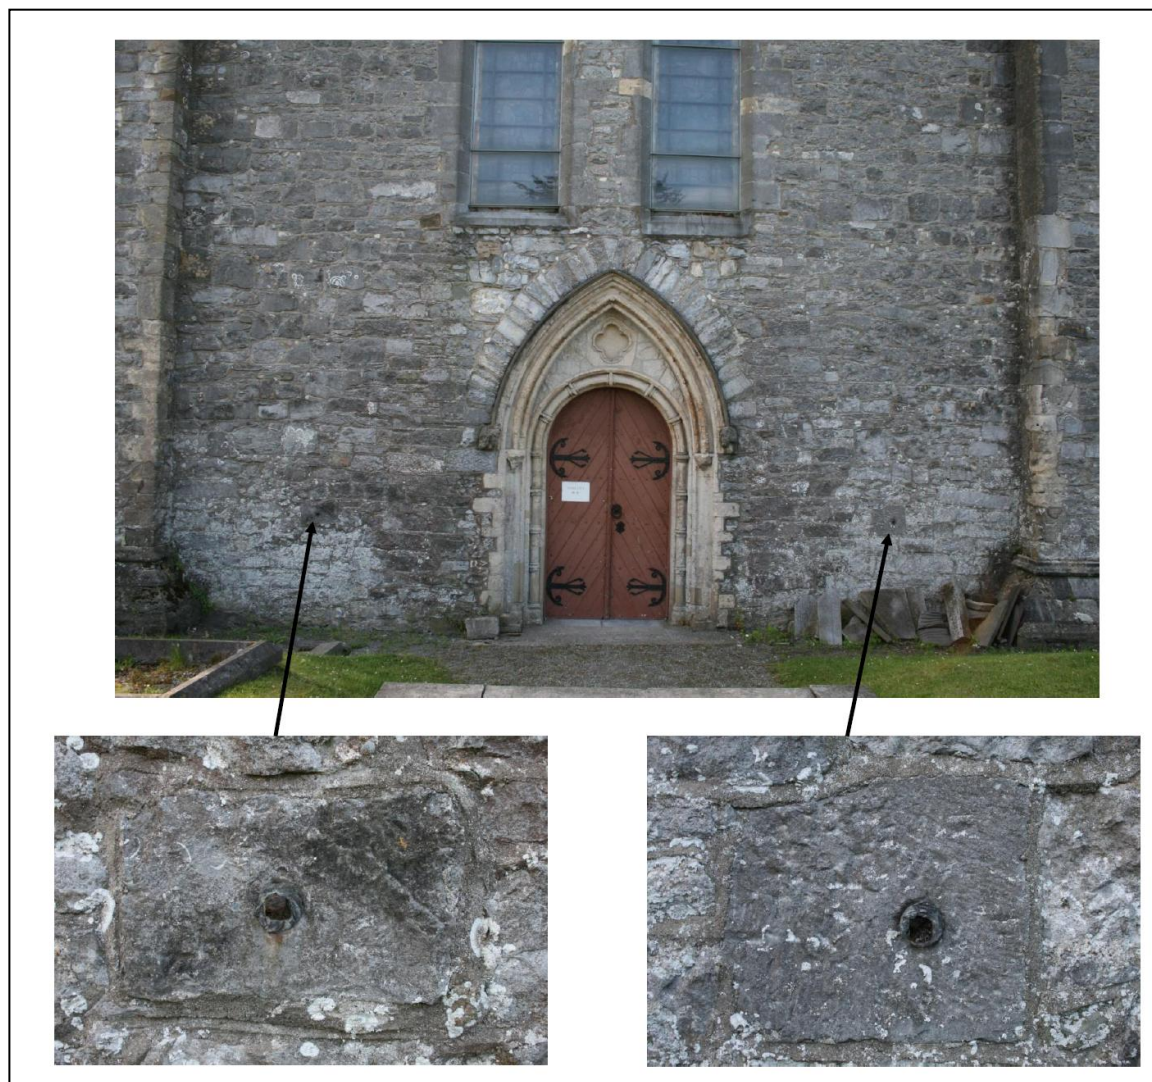
*Figure 25: The remains of iron bolts that tied the Colonnade into the walls either side of the North door of the North transept at Saint Canice's Cathedral (photo: C. Ó Drisceoil)*

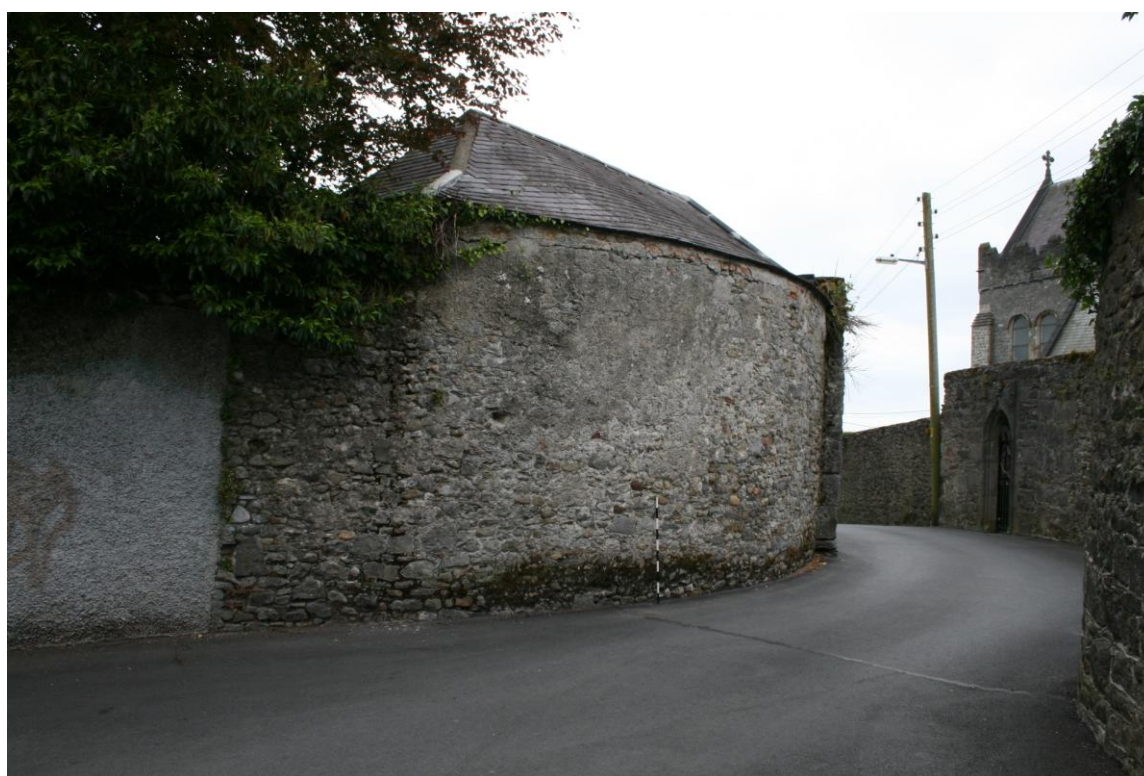
*Figure 41: The curving exterior of the Period 4A wall [048], taken from north (photo: C. Ó Drisceoil)*

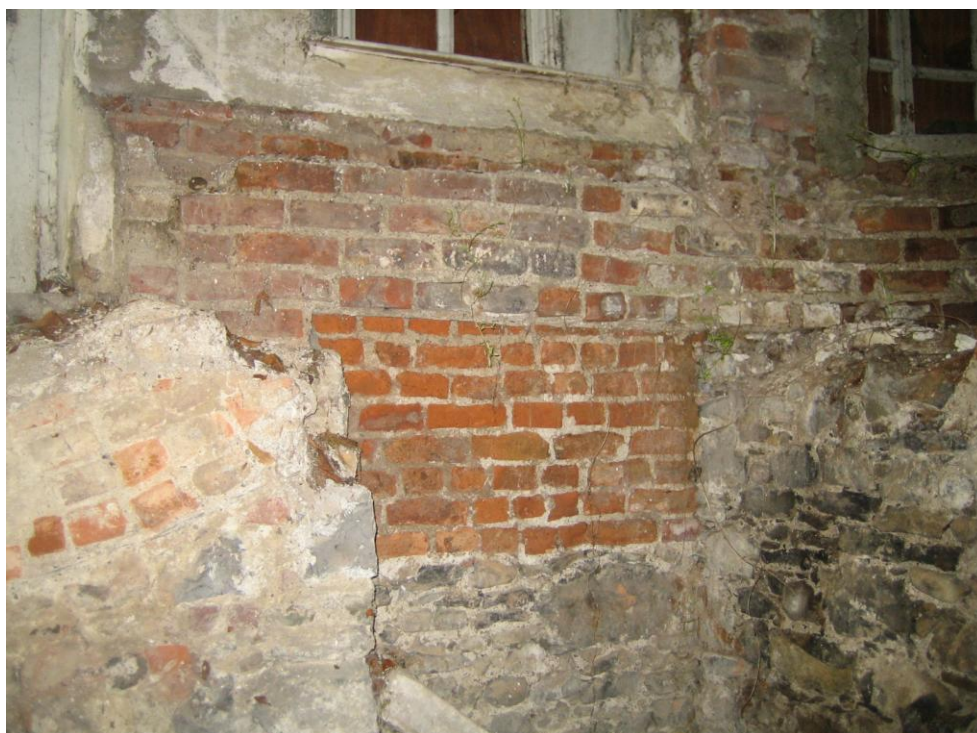
*Figure 42: North-east (front) wall of the Robing Room showing the Period 4A brickwork [034], which had been truncated in Period 4B (photo: Colm Murray)*

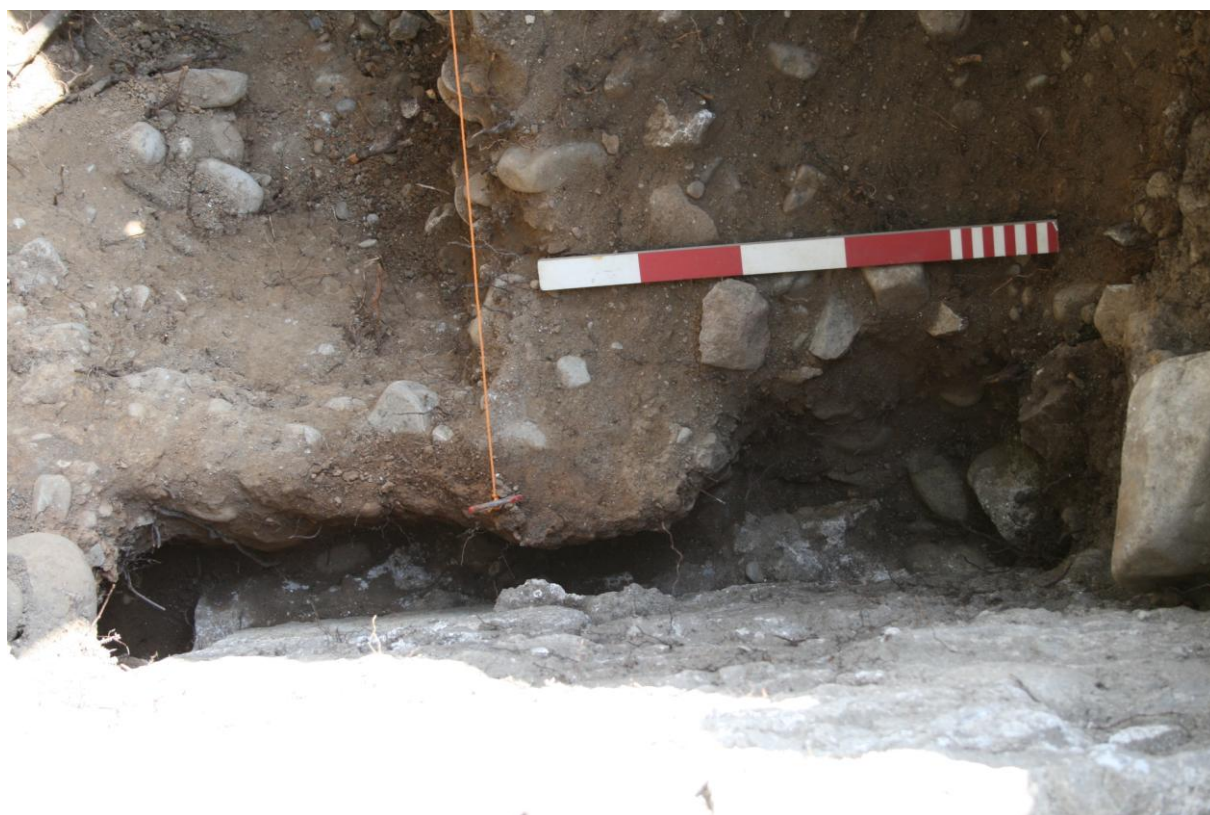
*Figure 43: Cutting 1, construction trench [008] and stone footings [042] for Period 3 wall of Robing Room, from south-west (photo: C. Ó Drisceoil).*

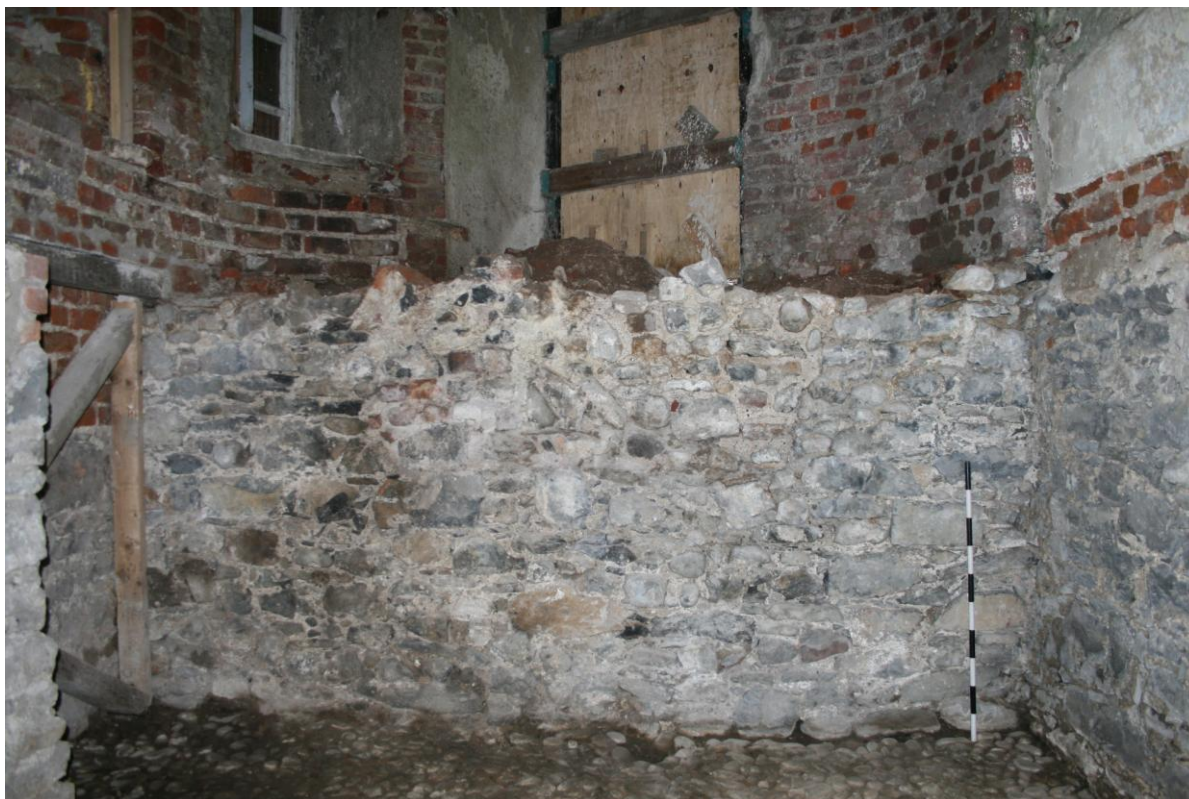
*Figure 44: The south wall [029] of the semi-basement with the extensive repair infill [030] visible to the left of the ranging rod, photo taken from the south (photo: C. Ó Drisceoil)*

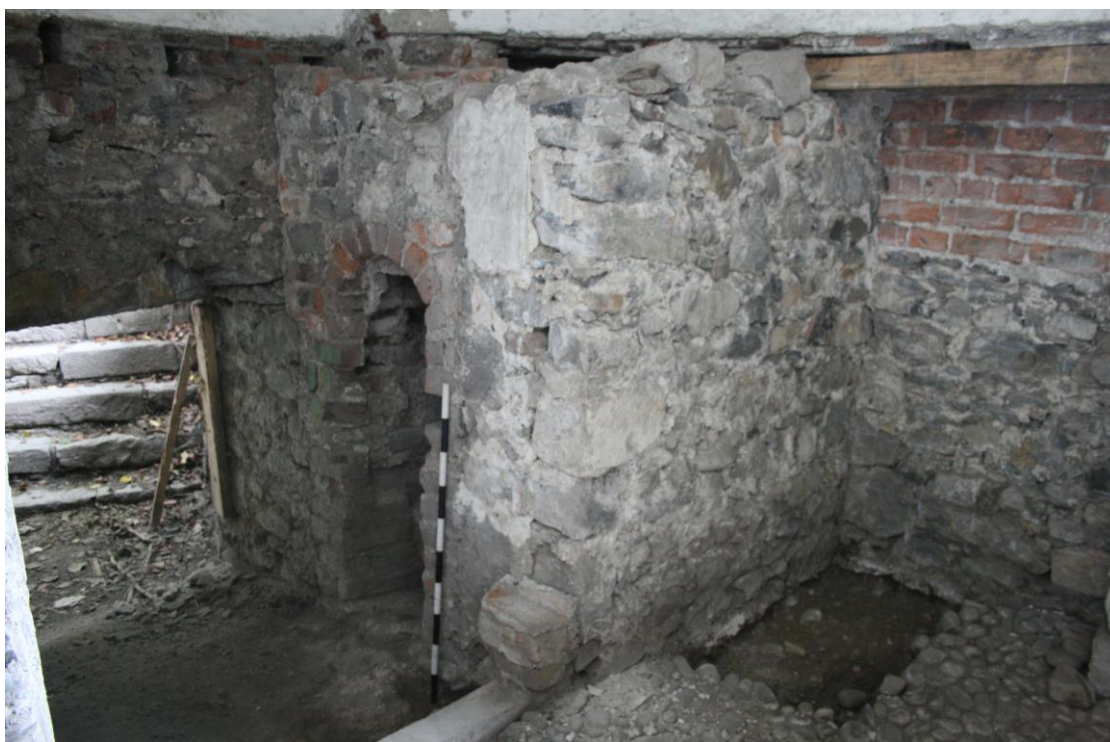
*Figure 45: Photograph of the north side of the basement level showing Cutting 3, the Period 4A wall [037] and entrance [051]. To the left of the ranging rod is the Period 4B fireplace [054] (photo: C. Ó Drisceoil).*

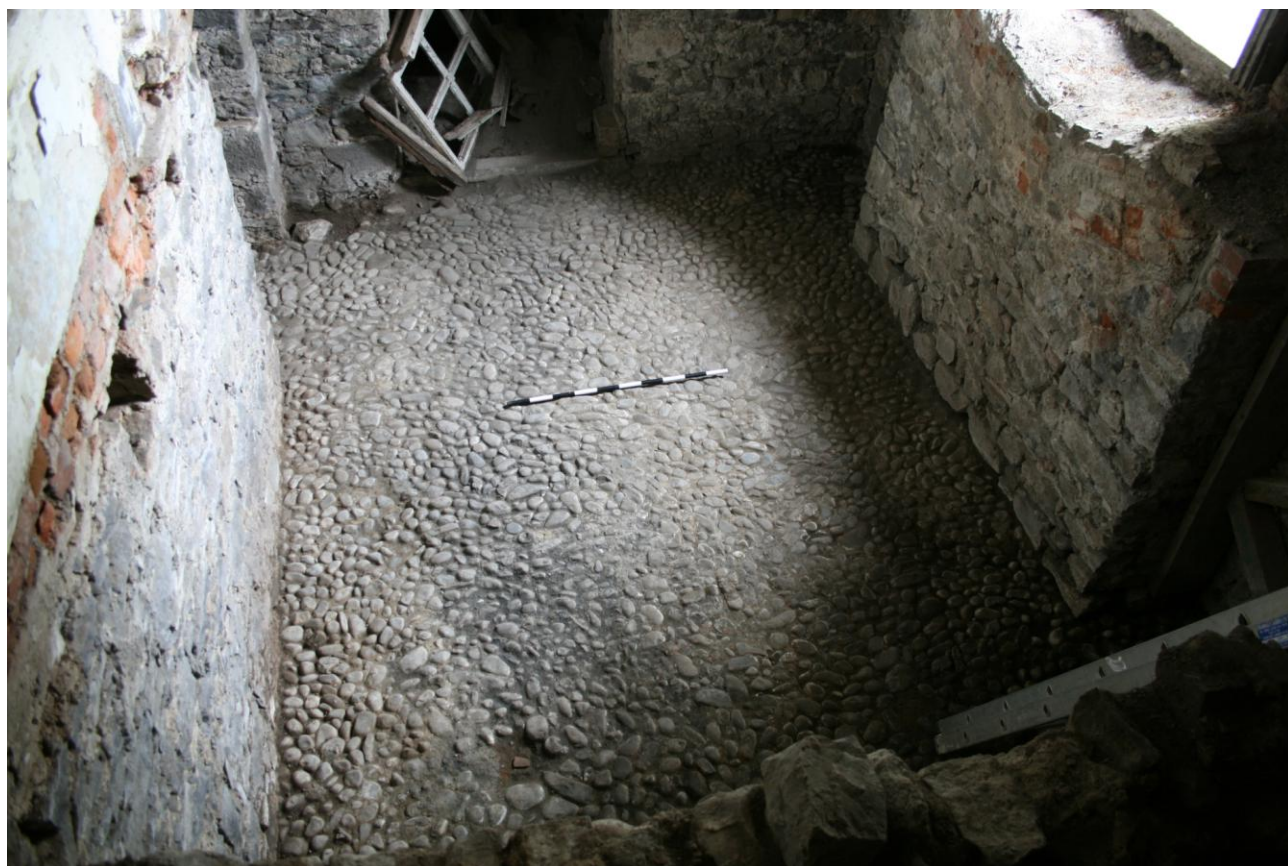
*Figure 46: The cobbled floor [021] of the Robing Room basement, taken from east (photo: C. Ó Drisceoil)*

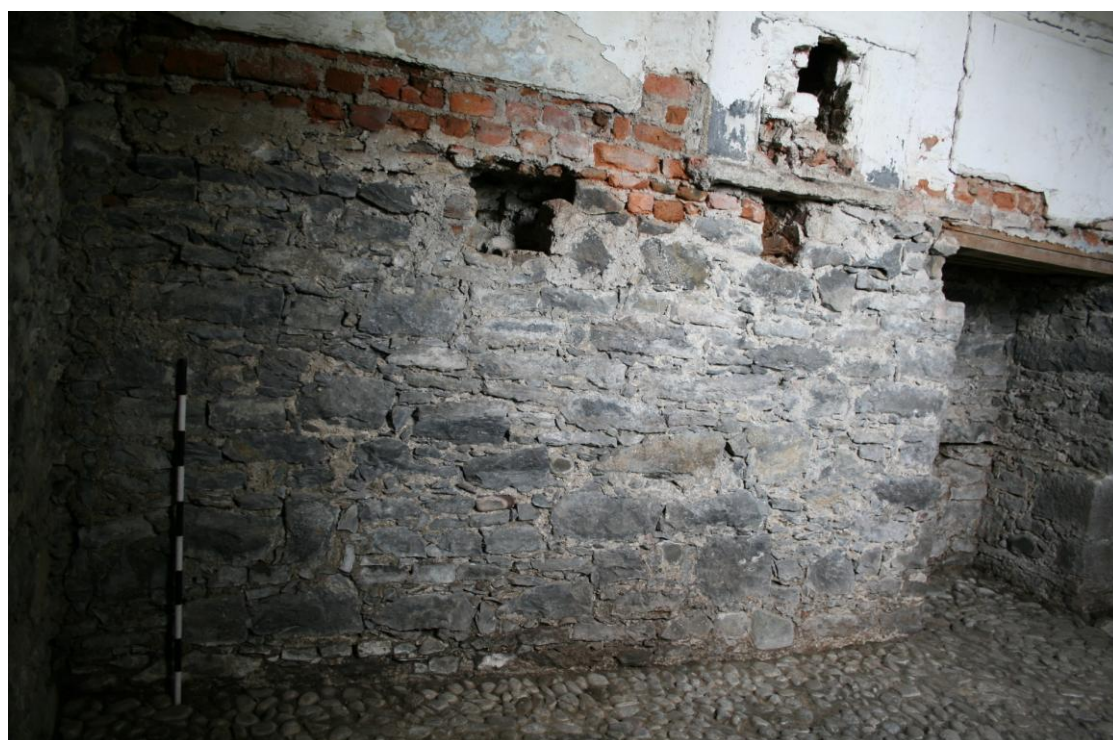
Figure 47: Period 4B wall [045] with store-cupboard niche [056] to the right, taken from south (photo: C. Ó Drisceoil)

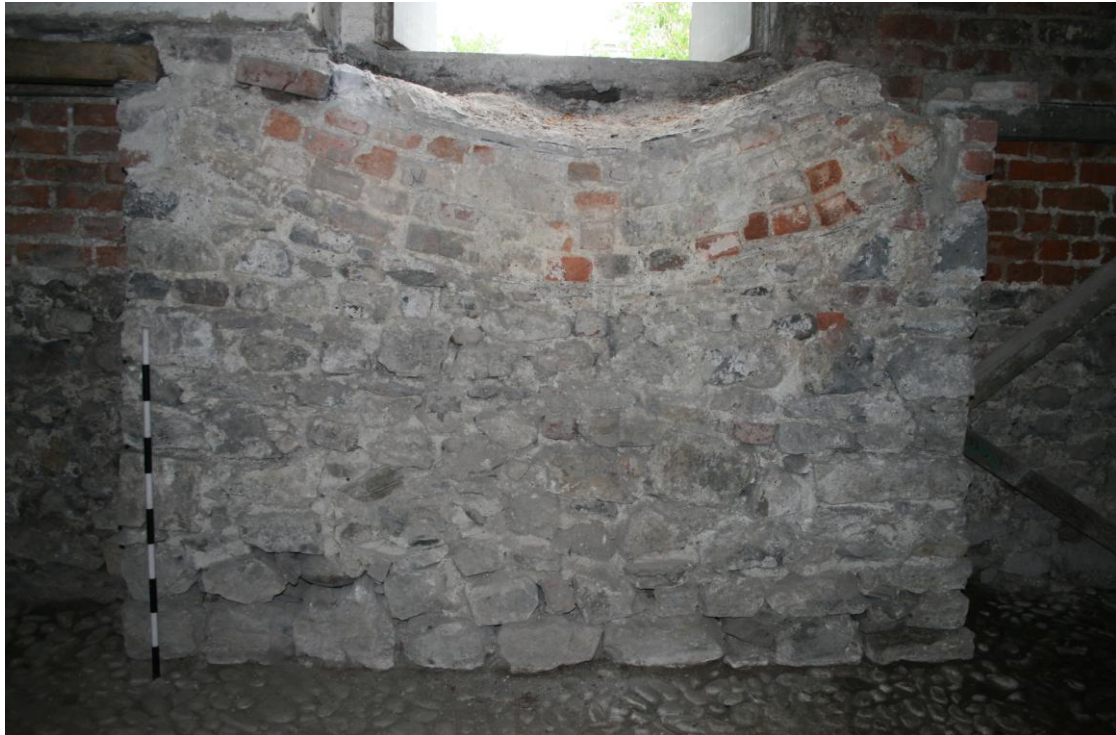
*Figure 48: Inverted brick arch [058] containing heating flue within the masonry block [057], taken from west (photo: C. Ó Drisceoil)*

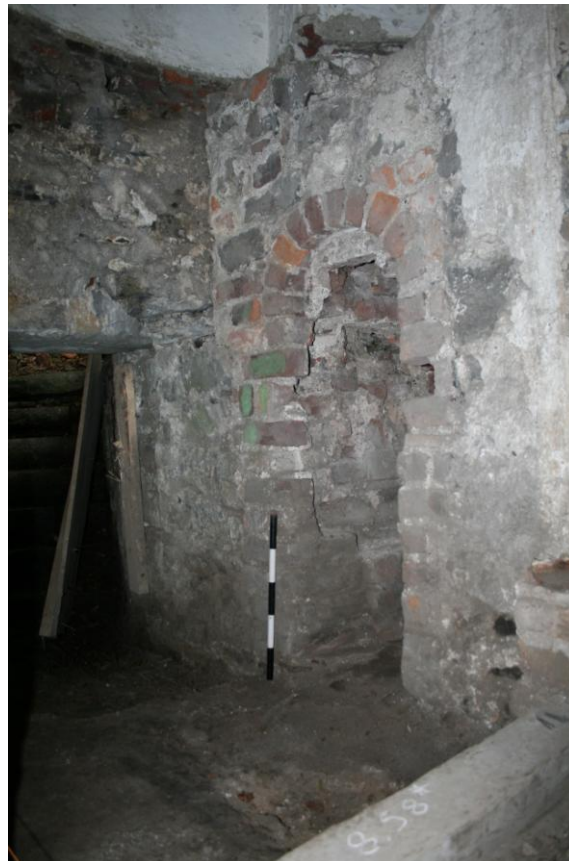
*Figure 49: Fireplace [054] on the north side of the entrance passage to the basement. This was connected to a flue that brought the heated to the timber benches at ground floor level (photo: C. Ó Drisceoil).*
