**EXCAVATION AND ARCHAEOLOGICAL  
BUILDING SURVEY AT THE ROBIN  
ROOM, BISHOP'S PALACE,  
CHURCH LANE, KILKENNY 2011 (11E157):  
*PRELIMINARY REPORT***

**KILKENNY ARCHAEOLOGY**

<b>Client</b>	The Heritage Council, Church lane, Kilkenny
<b>Document title</b>	Excavation and Archaeological Building Survey at the Robing Room, Bishop's Palace, Church Lane, Kilkenny 2011 (11E157): <i>Preliminary Report</i>
<b>Document type</b>	Building recording and limited excavation
<b>Issue number/date</b>	draft 1/25 <sup>th</sup> September 2011
<b>Irish national grid</b>	250292 156423
<b>Archaeological licence reference</b>	11E157
<b>Planning reference</b>	06/01; PL 62.131051
<b>Kilkenny Archaeology job no.</b>	11/034
<b>RMP reference</b>	RMP KK 019-026123 <i>ecclesiastical remains</i>
<b>Archive location</b>	Kilkenny Archaeology, Threecastles, Kilkenny
<b>Finds location</b>	Kilkenny Archaeology, Threecastles, Kilkenny
<b>Archaeological licence holder</b>	Cóilín Ó Drisceoil MA, MIAI
<b>Excavation team</b>	Dr. Richard Jennings DPhil, Philip Kenny
<b>Building survey drawings</b>	Phelim Manning
<b>Report author</b>	Cóilín Ó Drisceoil MA, MIAI

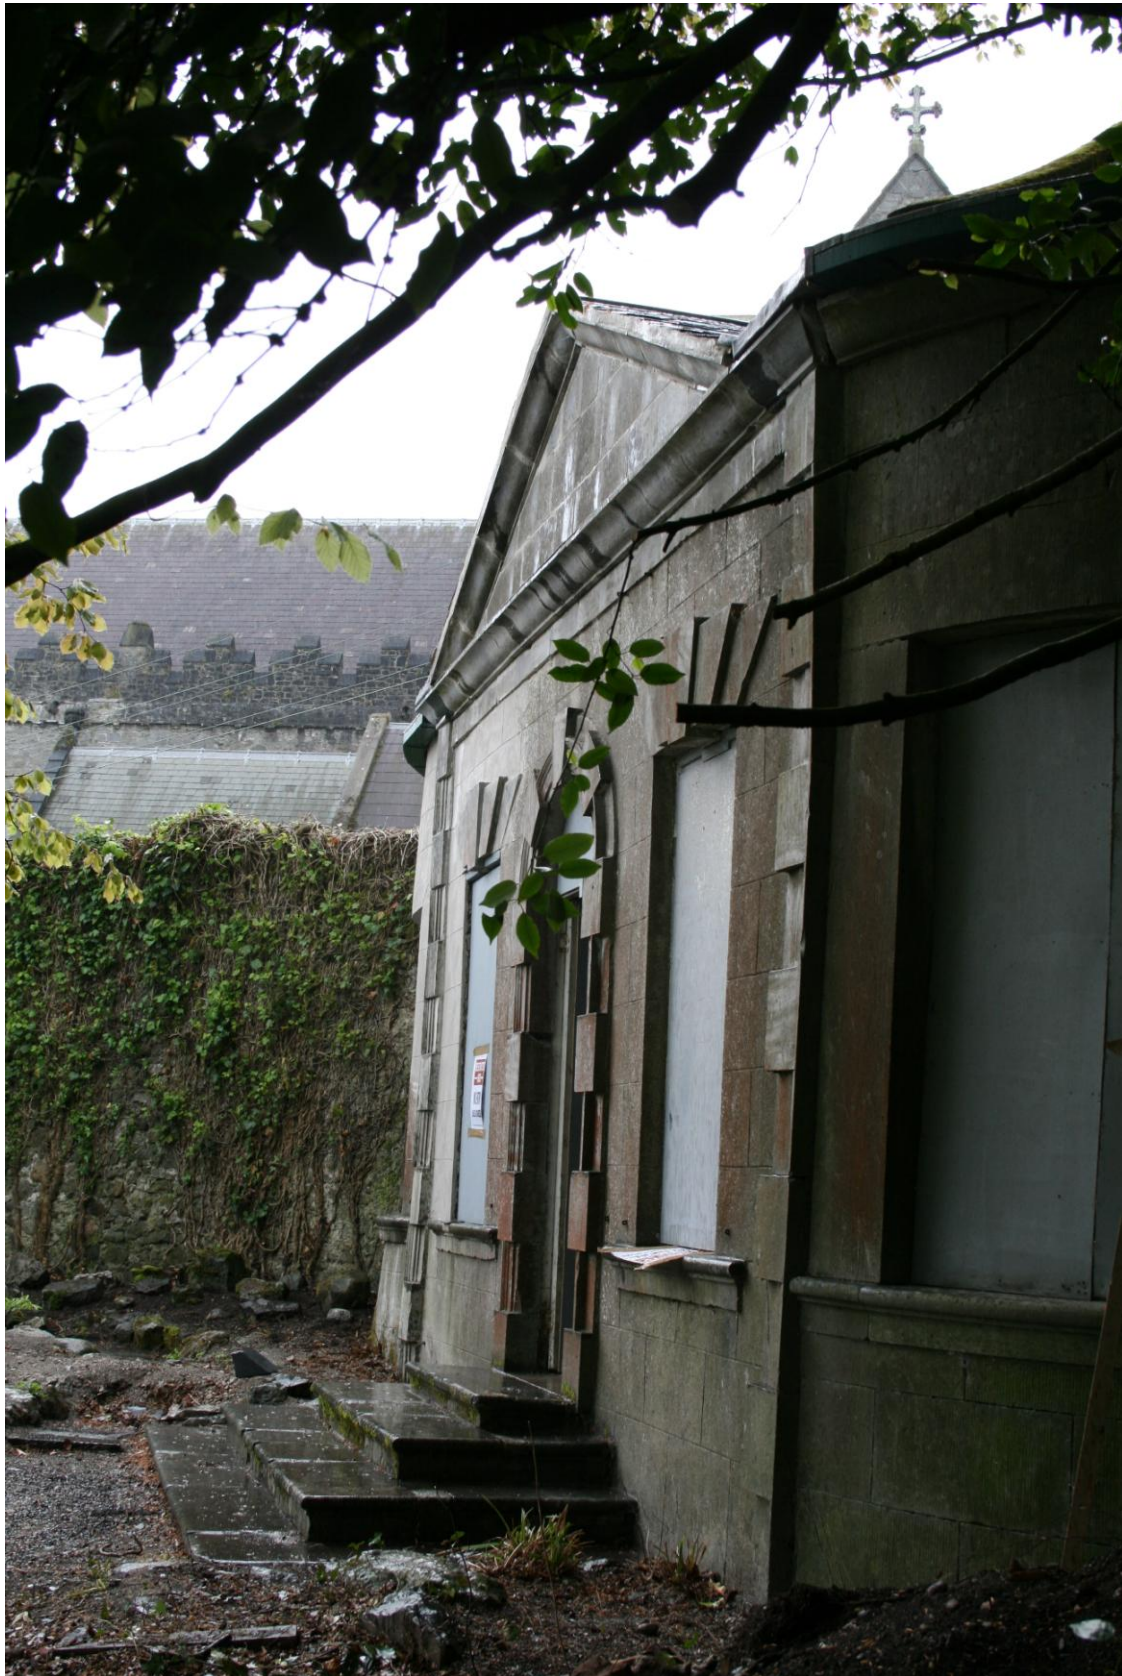
*Figure 50: The garden façade of the Robing Room, from north. Part of the northern ashlar bow can be seen on the right (photo: C. Ó Drisceoil). The remainder of the structure is rendered in ruled Portland cement.*

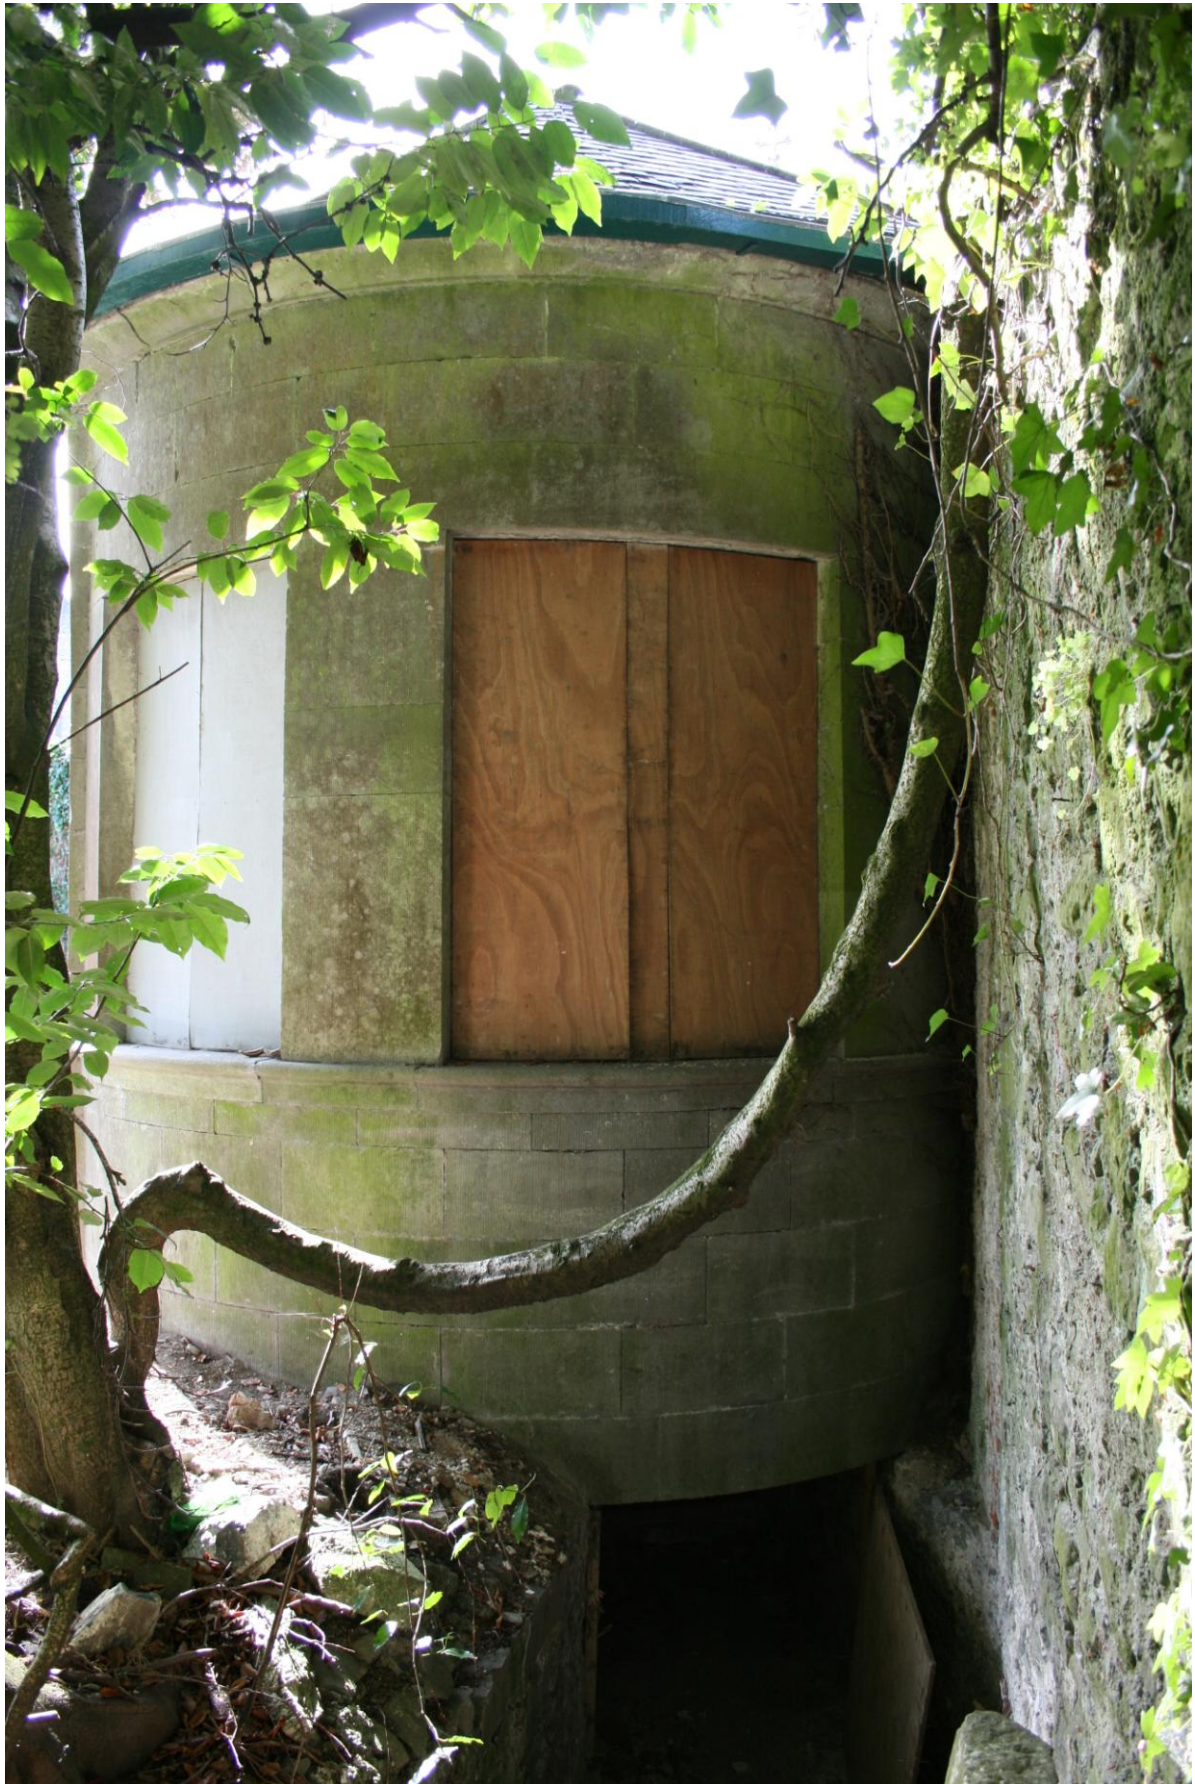
*Figure 51: The ashlar bow at the Robing Room (photo: C. Ó Drisceoil)*

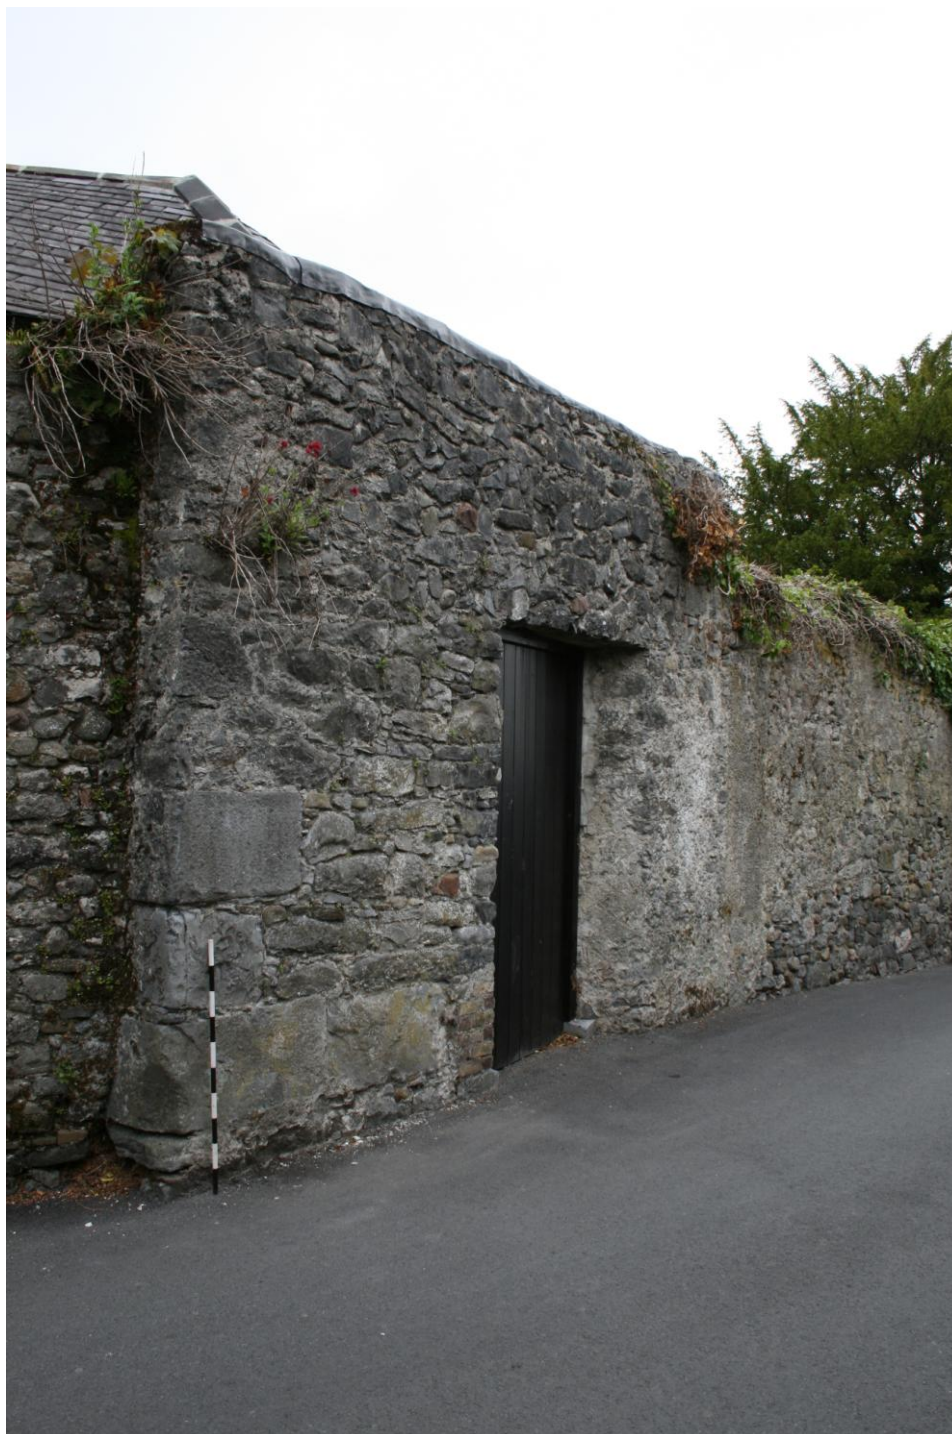
*Figure 52: Quoins [046] and former entrance door to the Colonnade built by Bishop Pococke from the Robing Room to Church lane.*

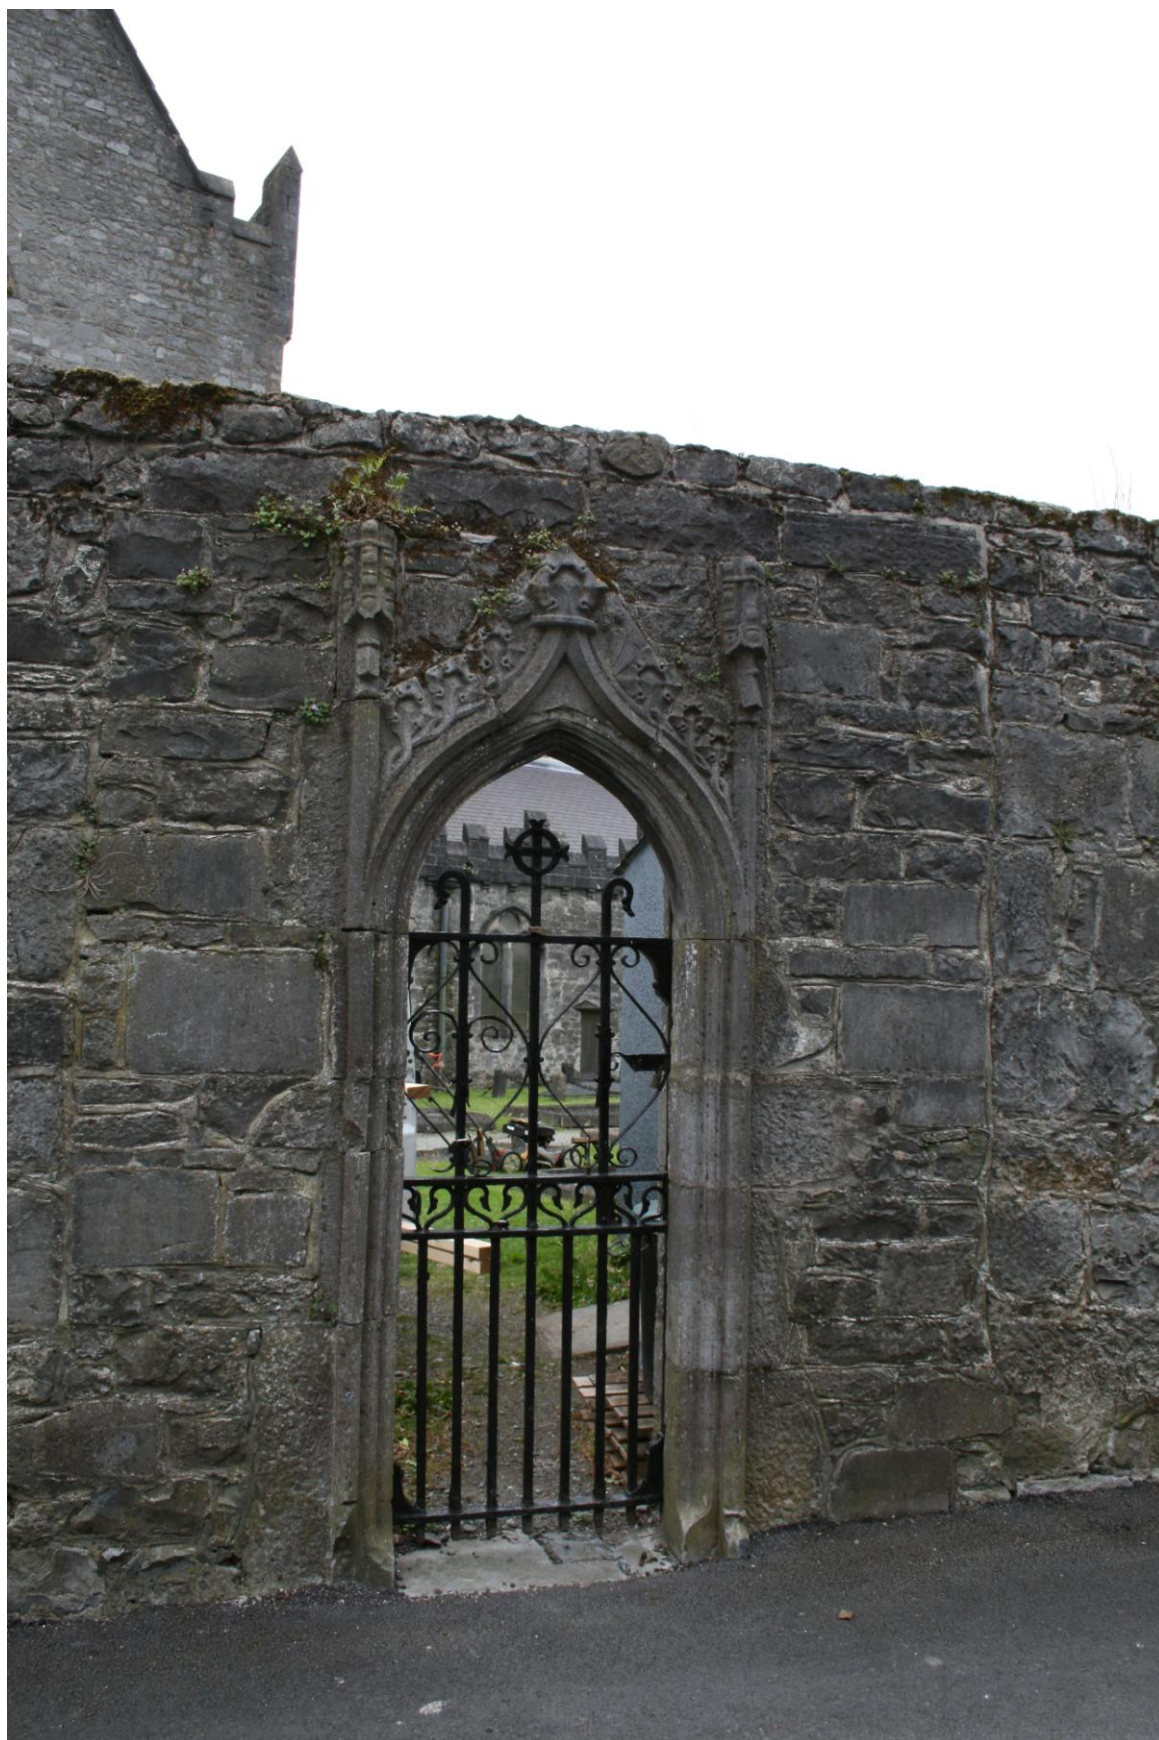
*Figure 53: This sixteenth century ornamental doorcase is the work of the famous O'Tunney school of stone carvers. It was placed here along with a section of walling to fill the gap left by the removal of the Colonnade after 1865. The door probably derived from one of the ecclesiastical houses of the Close.*

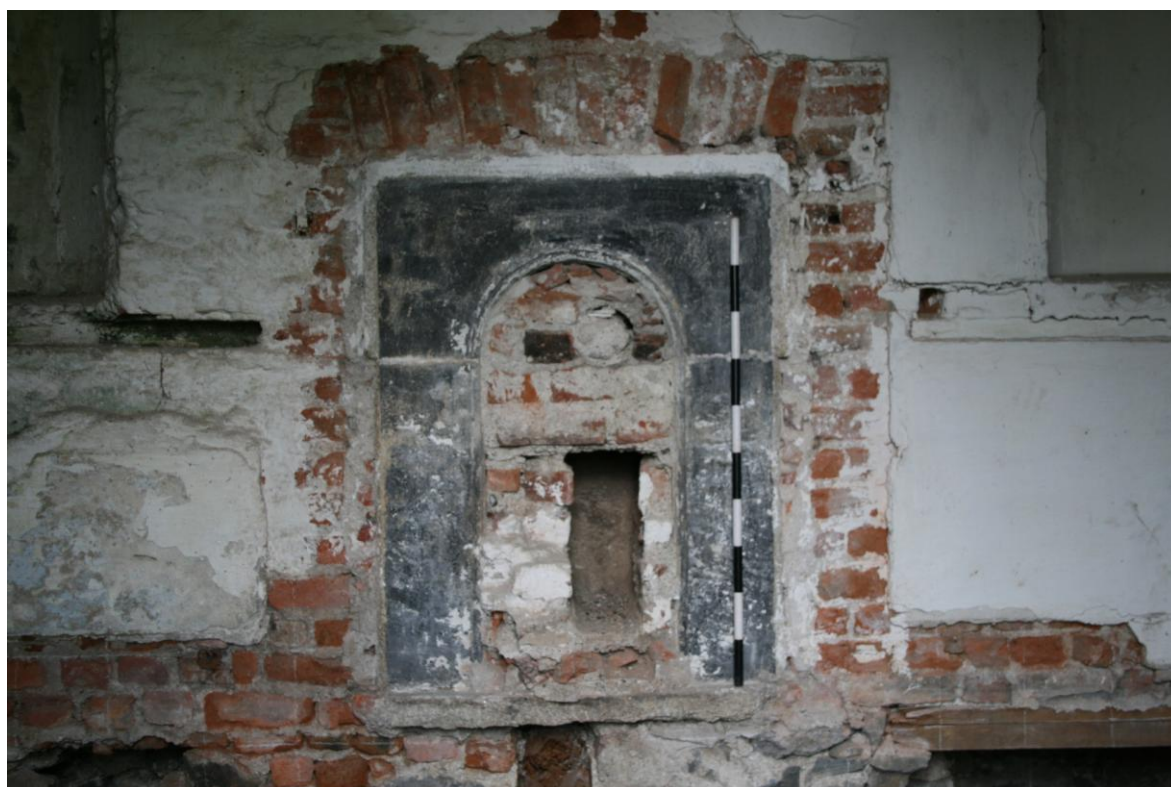
*Figure 54: Blackened granite fireplace in the south-west wall of the Robing Room (photo: C. Ó Drisceoil)*

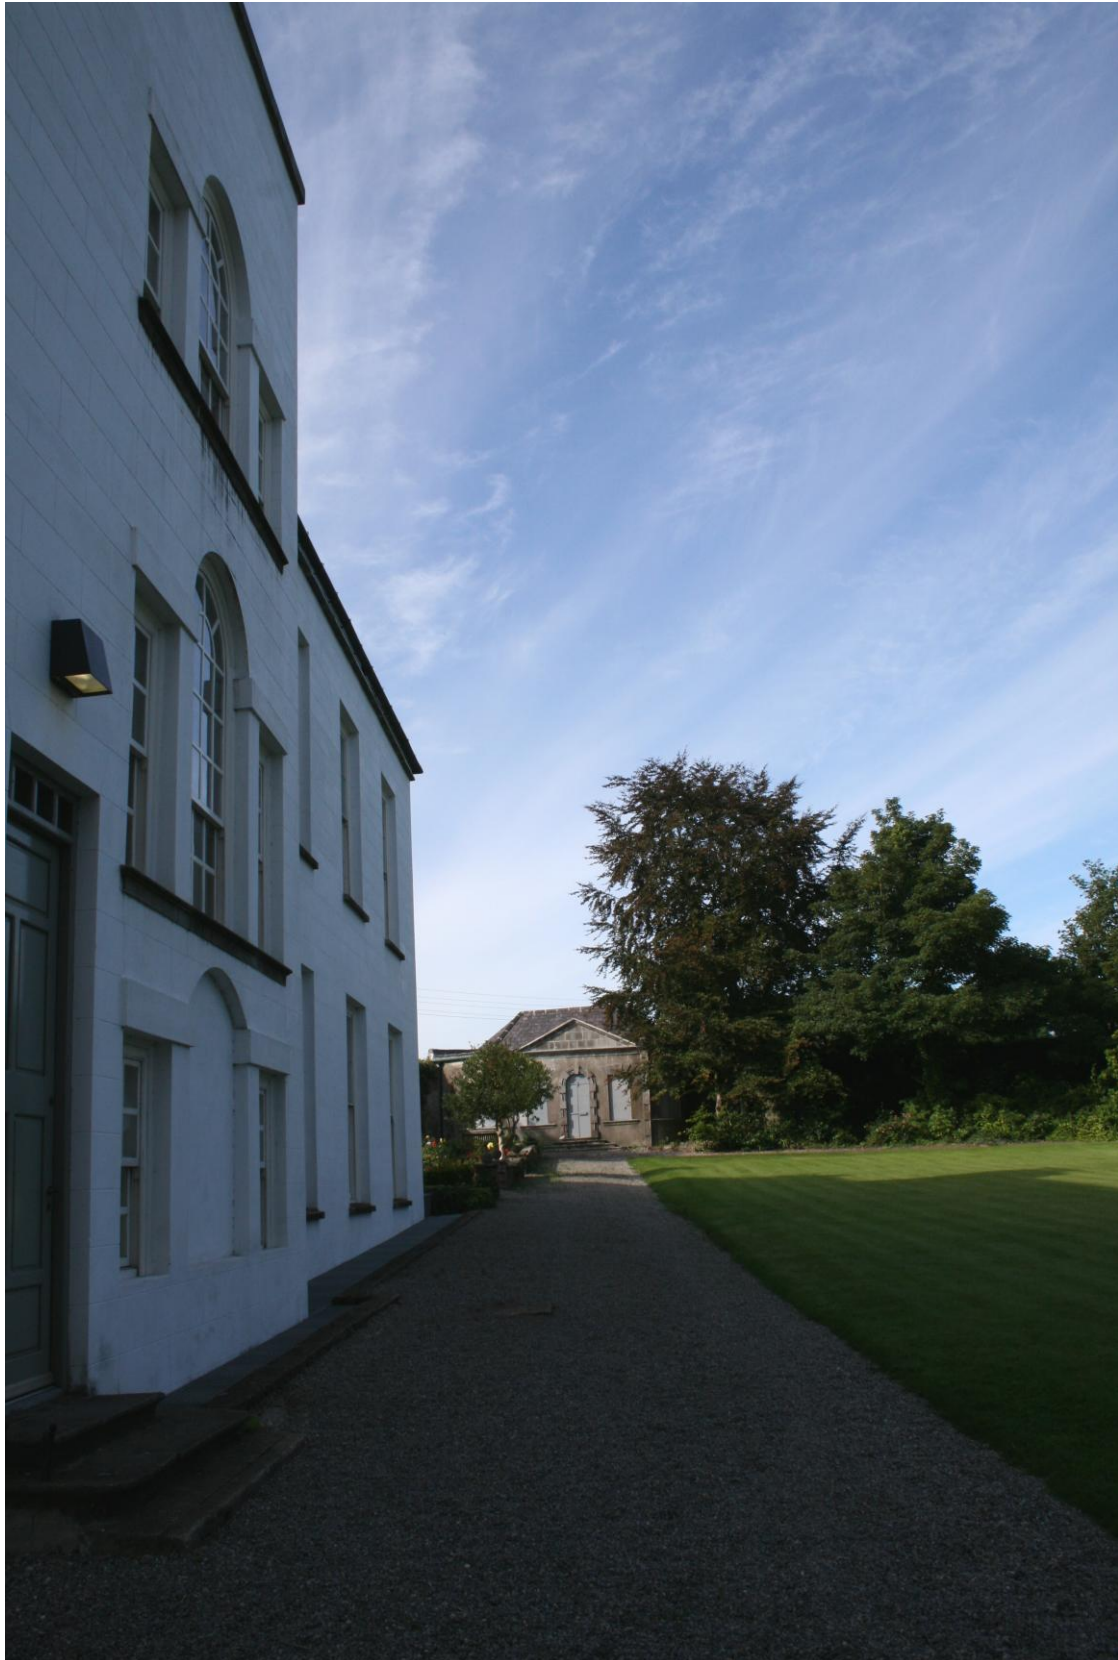
*Figure 55: The Robing Room at the end of the axial gravel walkway of the Bishop's Palace garden (photo: C. Ó Drisceoil)*

The Robing Room in Period 4B, and probably in its Period 4A guise, can be considered a 'summer-house'. These buildings have their origins in the mid-fifteenth century and are generally isolated structures, 'intimate pleasure pavilions' in a garden or park designed to provide a cool shady place in the heat of the summer (Howley 1993, 120). Summer-houses were also used for taking sweet-breads and wine as part of the social round and this was the role it held for Bishop Newcome when he described it as such in 1775. As such it would make sense to have a store for the required accoutrements, wine and suchlike, within the building, rather than having to bring them over each time it was used. This would explain the function of the semi-basement with its cup-boards and cobbled floor that would have assisted in keeping the place dry. Such an arrangement is quite common in summer-houses and is also to be found, for example, in the contemporary pleasure house (the 'tea-house') on Bateman quay in the city (Lanigan and Tyler 1977, 40). Summer-houses often formed integral components, 'prominent garden ornaments', of Georgian gardens and it is within this context that the Robing Room should also be seen. Its location at the end of an axial walkway of the eighteenth century garden, resting beneath the Palace and Cathedral, presents an impressive set piece when viewed from the exterior and enhanced the view beyond the boundary walls (Figures 55-6). Of equal importance was its prospect from the west window of the Palace's first floor (Figure 58-59). In around 1740 this was a private chamber, adjacent the withdrawing room, and it is tempting to speculate that the well-framed view of the Robing Room from its window also influenced its siting.

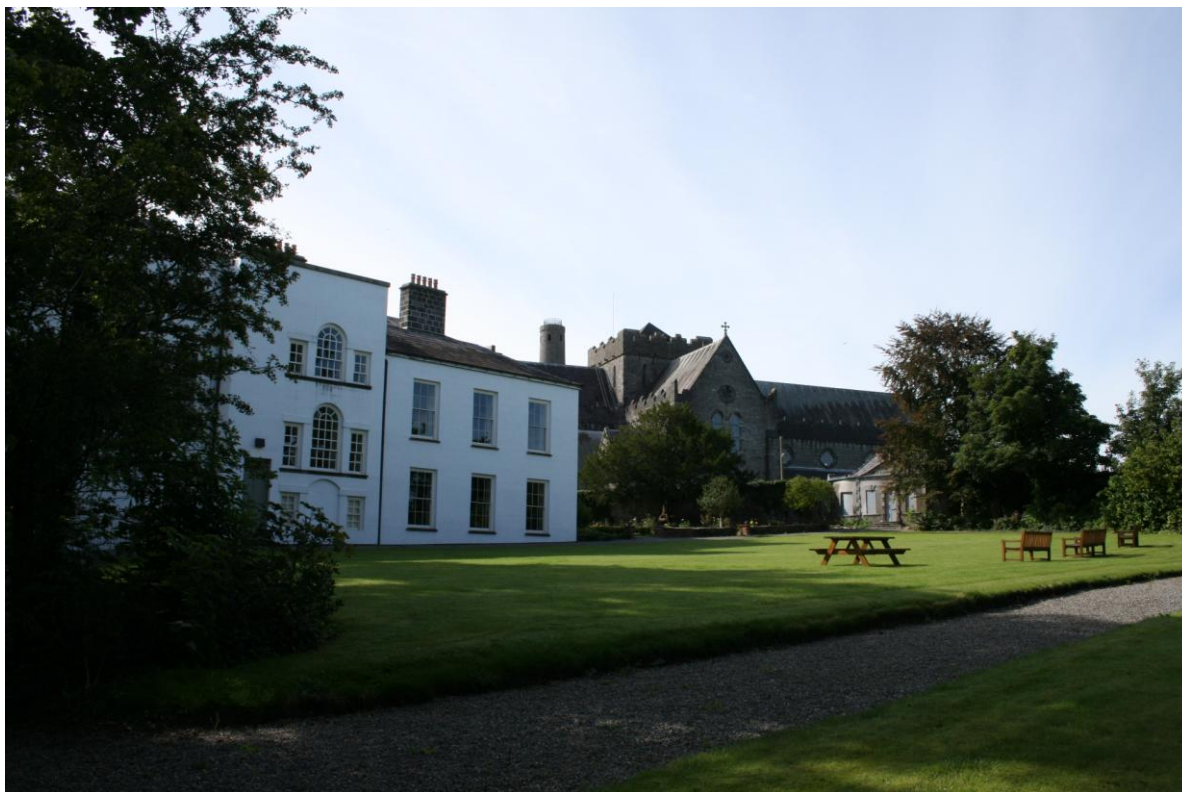
*Figure 56: The Robing Room (far right of picture) forms a critical element in the designed landscape that was constructed around the Palace in the first half of the eighteenth century (photo: C. Ó Drisceoil)*
