ST BRENDAN'S CATHEDRAL CLONFERT COUNTY GALWAY

CONSERVATION PLAN

Prepared by
Dermot Nolan and Pat Ruane
Conservation Consultants

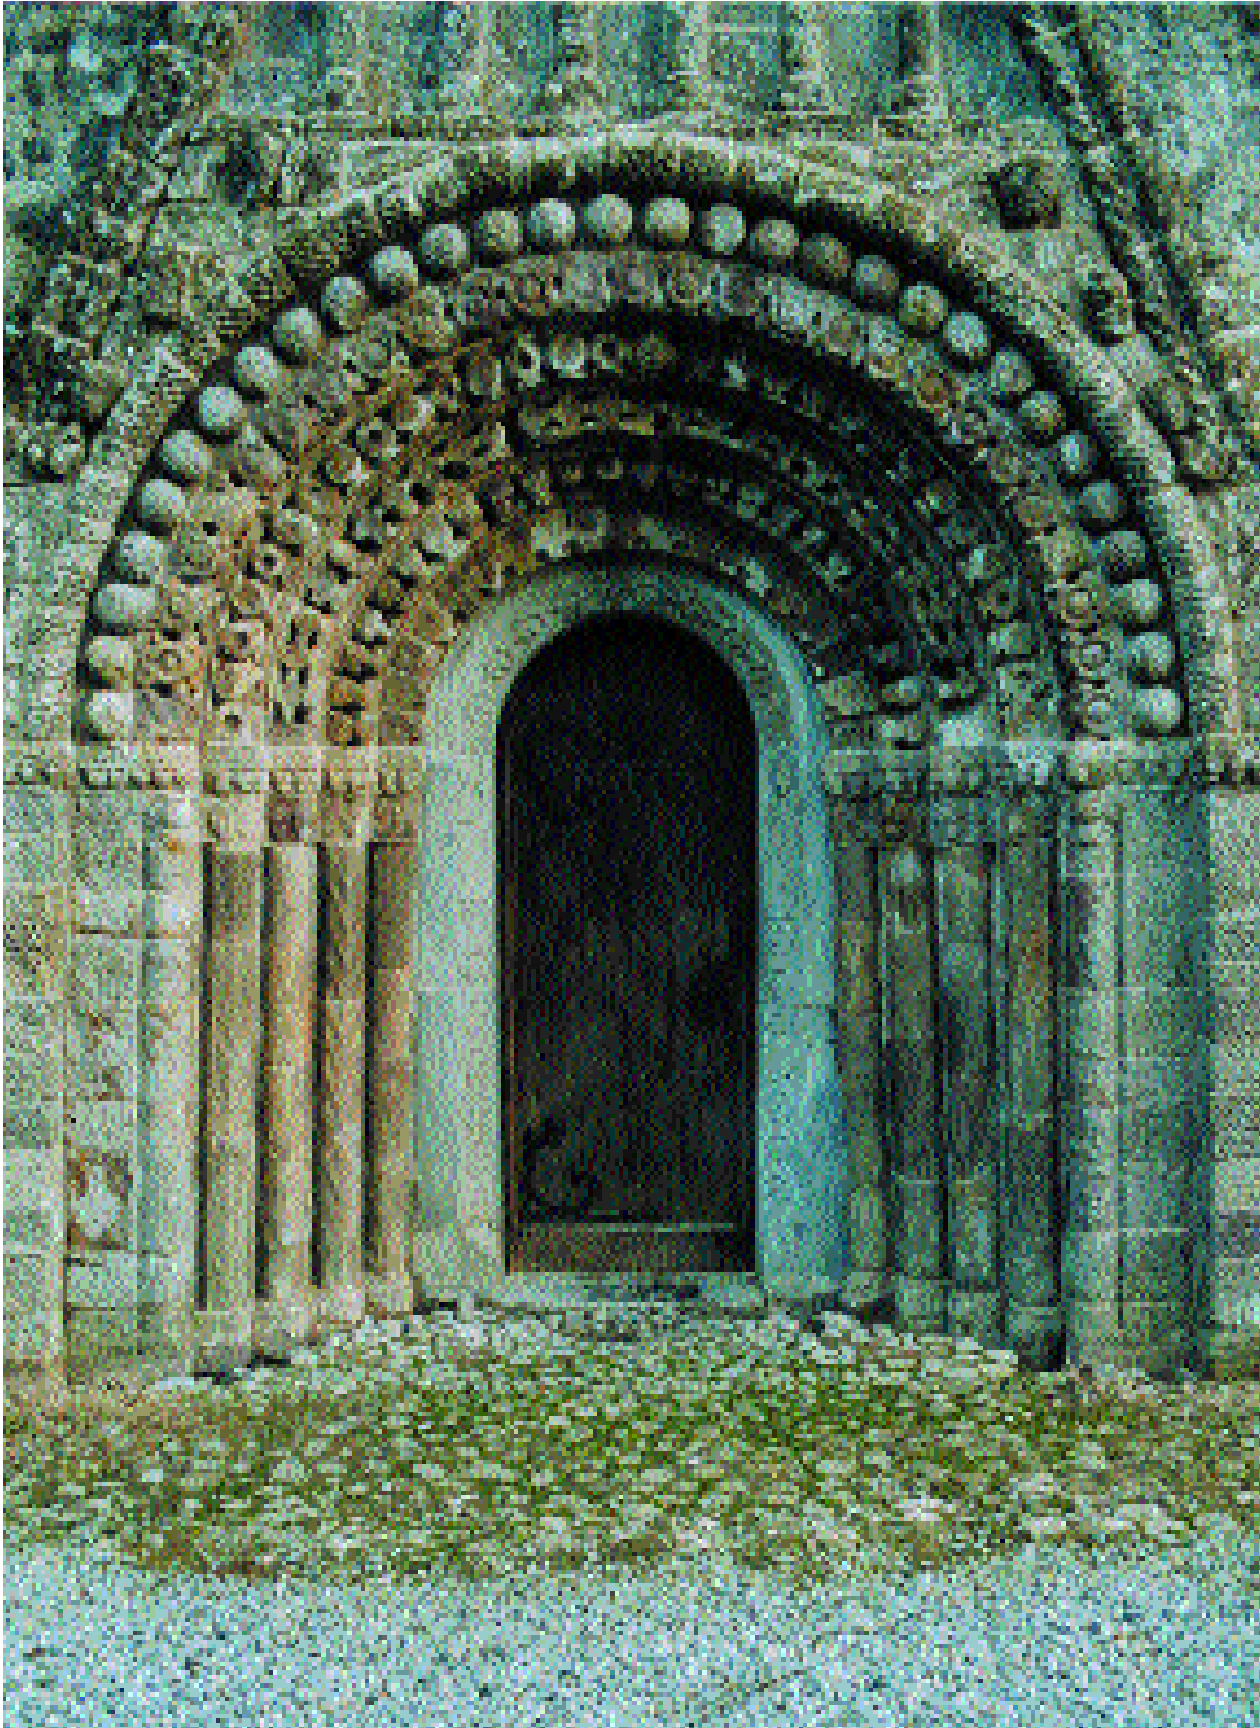
Plate 2: The Romanesque portal

After being burnt in 1164, the cathedral was re-built in 1167 under the patronage of O'Kelly of Uí Máine, a local king. Clonfert was again reported burnt in 1179. In the same year, a synod was convened at Clonfert by St Laurence O'Toole as papal legate. It is generally accepted that the west portal of Clonfert was an addition to an existing building. Various dates have been proposed, with the latest work (Tadhg O'Keeffe, 1994) suggesting a date of *c.* 1180, based on stylistic analysis and historical inference. If this date is correct, the installation of the portal may have been associated with the synod of 1179. It is also noteworthy that the Treaty of Windsor (1175) between Henry II and the high king, Rory O'Connor, introduced a period of relative peace in the West of Ireland after the turmoil which followed the Norman invasion of 1169. It is likely, therefore, that the planning and construction of this Romanesque portal, the most complicated in Ireland, would have occurred during such a period.

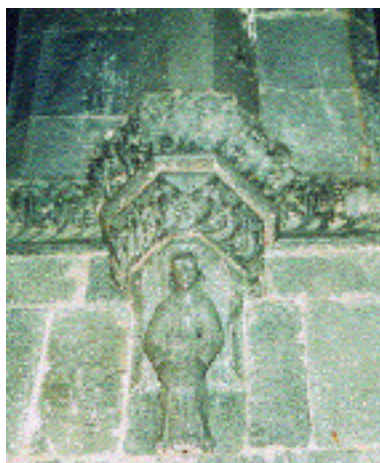
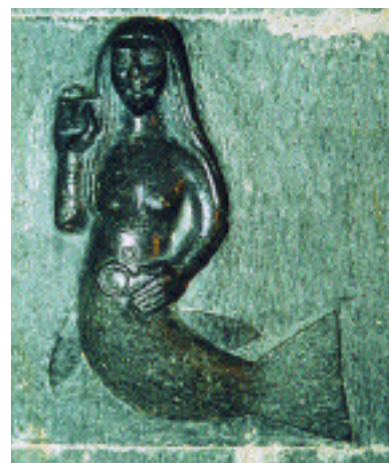
Plates 3 and 4: Carvings in the chancel arch: an angel (left) and a mermaid (right)

The new stonework is decorated with symbolic motifs and figurative sculpture. The coat of arms of the Butlers of Ormond appears in two places on the chancel arch, indicating that they may have been the patrons for this work. The decorations include carvings of ecclesiastical figures (unidentified), a wyvern, a mermaid and floral motifs typical of mid to late 15th-century work. There are also coffin-shaped late medieval grave slabs, some still in the graveyard and some mounted on the walls near the church entrance.

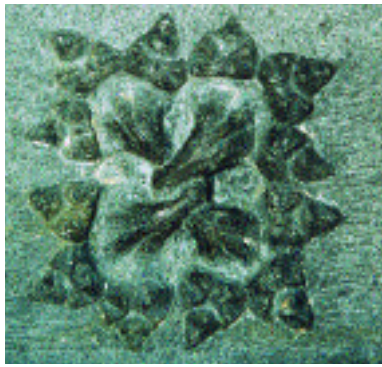
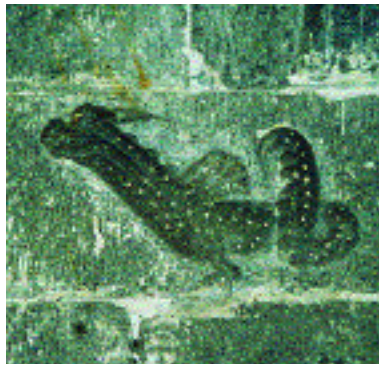
Plates 5 and 6: Carvings in the chancel arch: a knot (left) and a dragon (right)

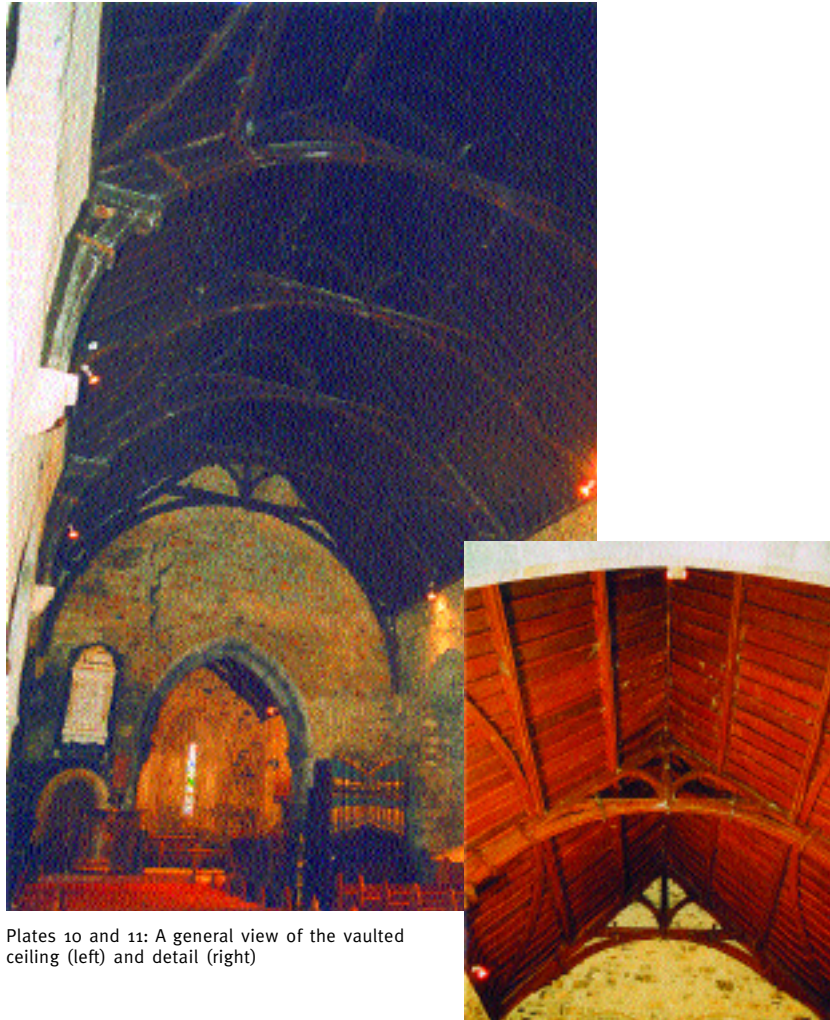
Plates 10 and 11: A general view of the vaulted ceiling (left) and detail (right)

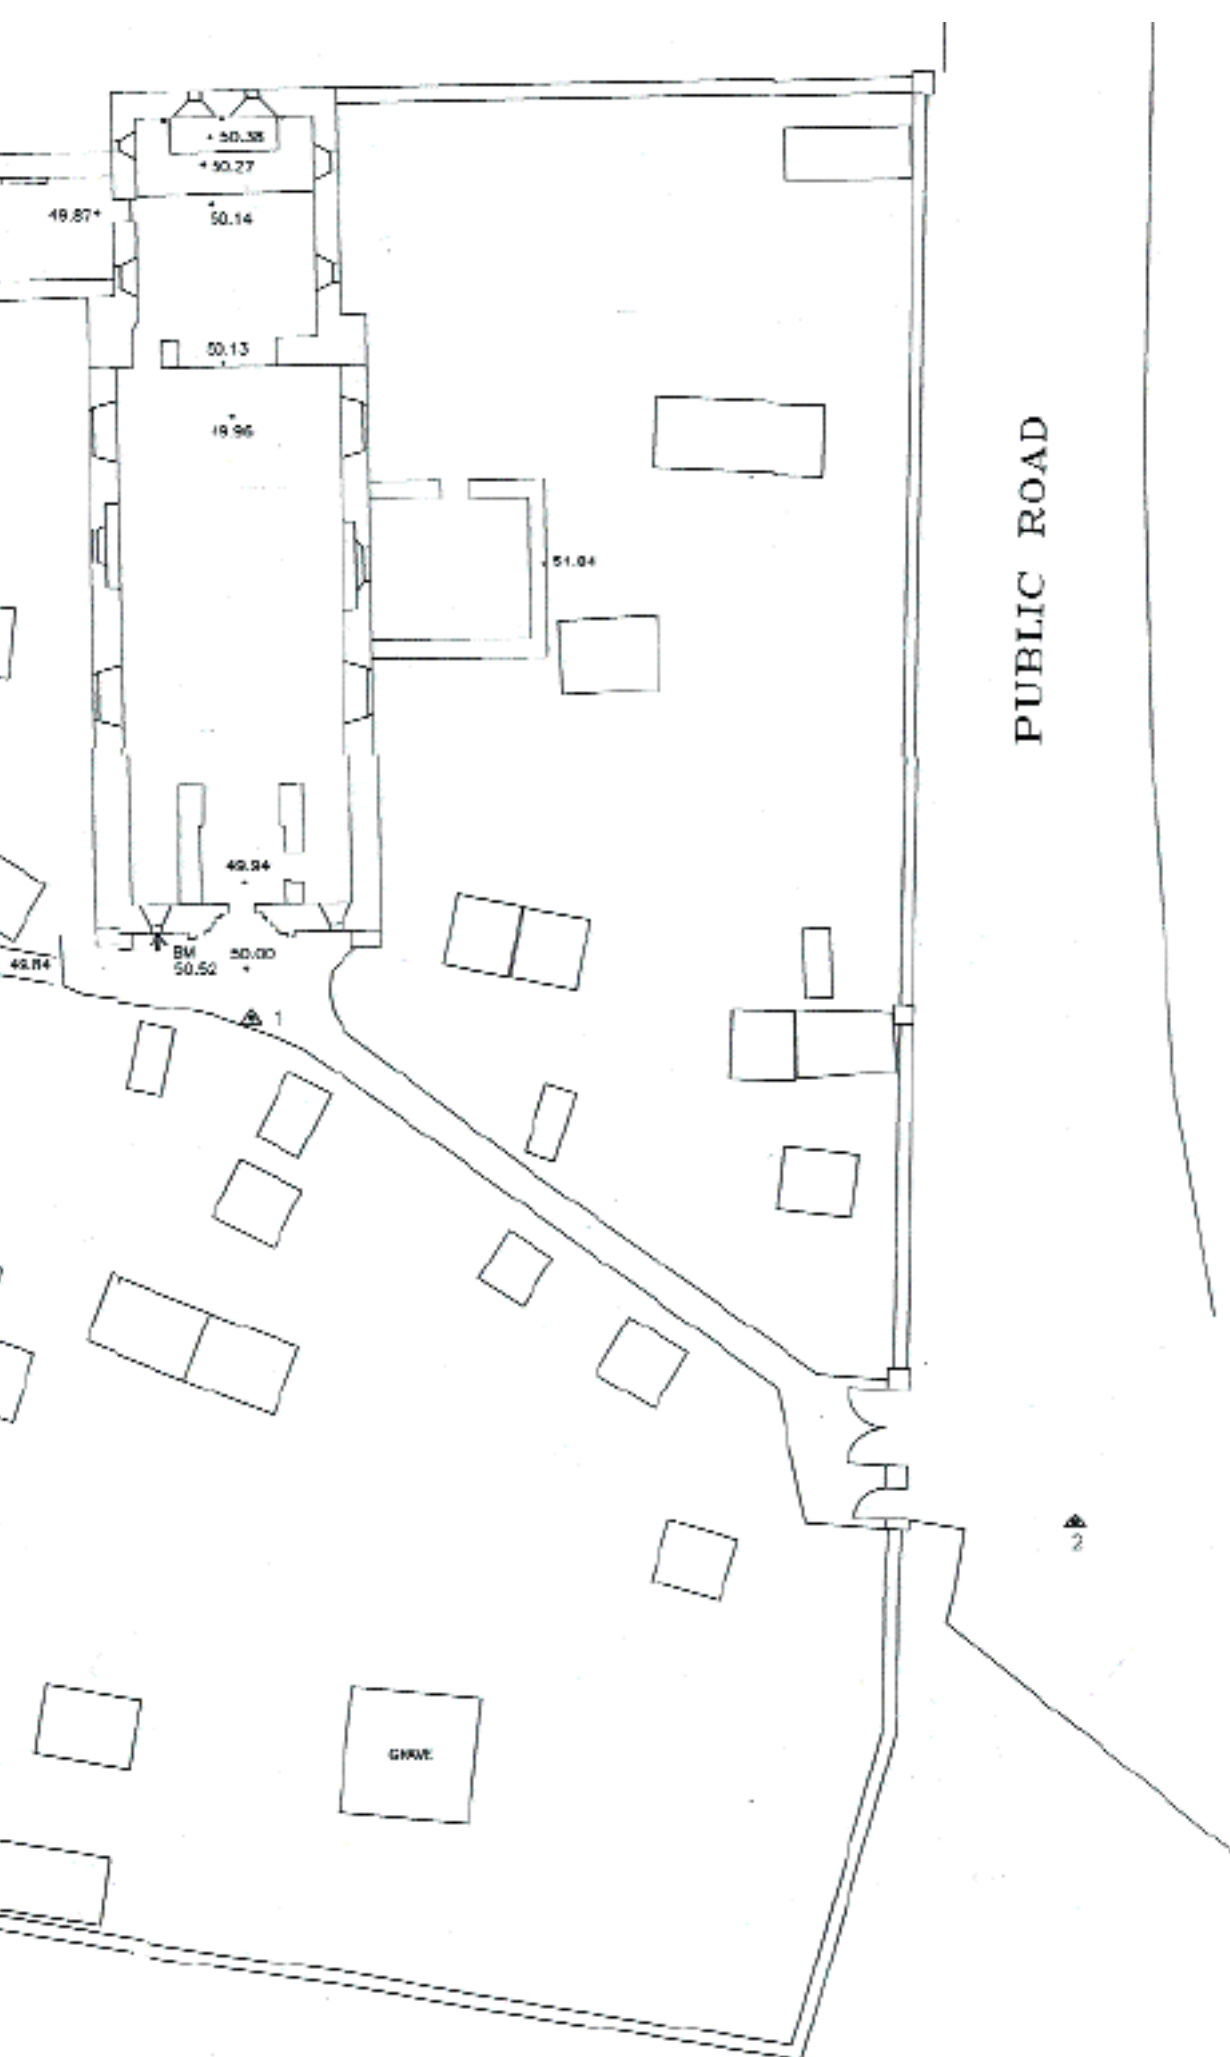
Figure 4: St Brendan's Cathedral Complex as it exists today

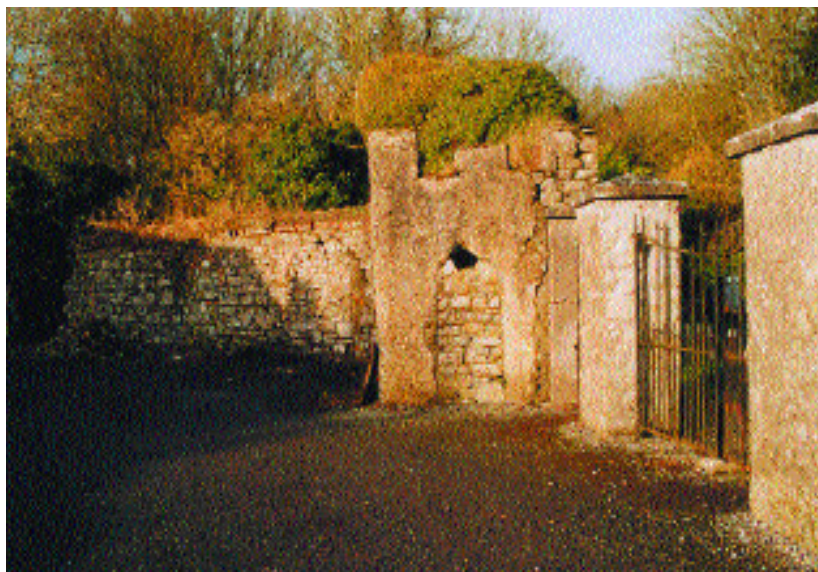
Plate 15: The ruins of the former Sacristan's House

Although it is an important element in the setting of the entrance to the graveyard and cathedral, the house is completely overgrown and inaccessible. Its provenance, history and purpose are not known, although it is commonly referred to as the 'Sacristan's House'. The following policies are recommended to the present and future owners.

Policy 19.1 Prior to proposals for repair or redevelopment of the house, the vegetation should be removed to permit access. A full appraisal of the existing structure should be carried out.

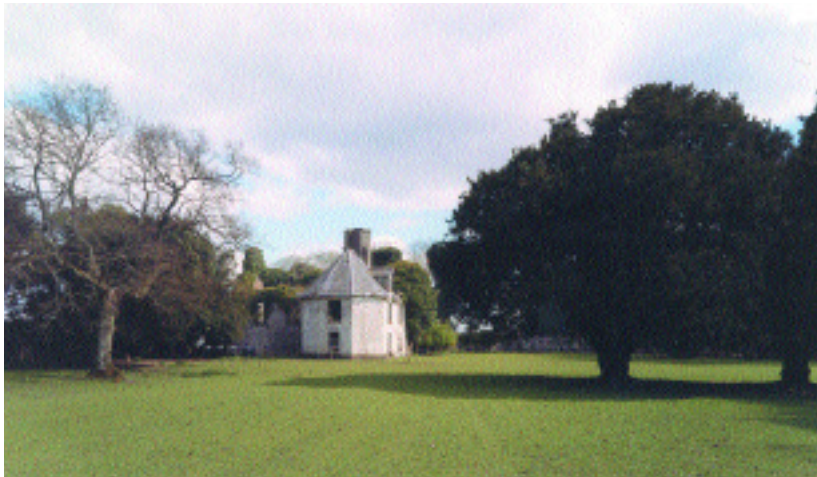
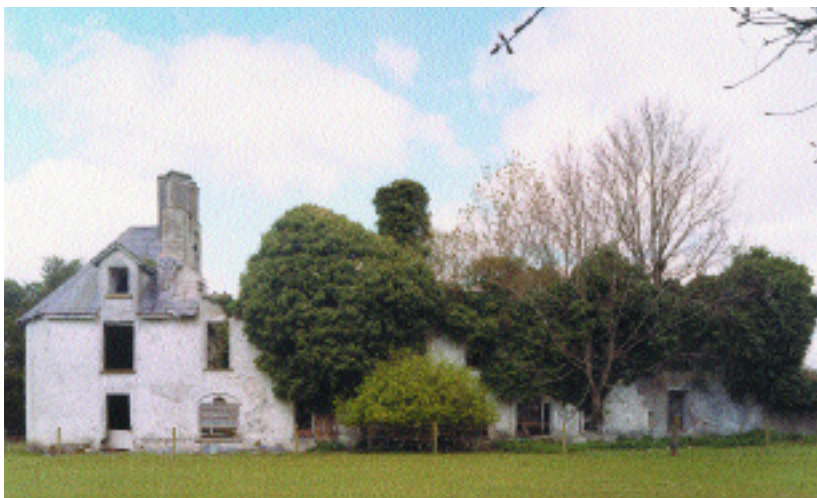
Plates 18 and 19: The Bishop's Palace

The Bishop's Palace was continuously occupied from at least the 16th century until 1954 and contains elements dating from the 16th, 17th, 18th and 19th centuries. It retains surviving material, including floor and roof joinery dated to c. 1638 by dendrochronology, and a rare oak-framed window which had been covered up until recently. The joinery has recently been investigated in detail by Caimin O'Brien. The decorated timber panels and the decorated timber post, both of which have been removed for conservation, are very rare examples of 17th-century decorative work on timber.

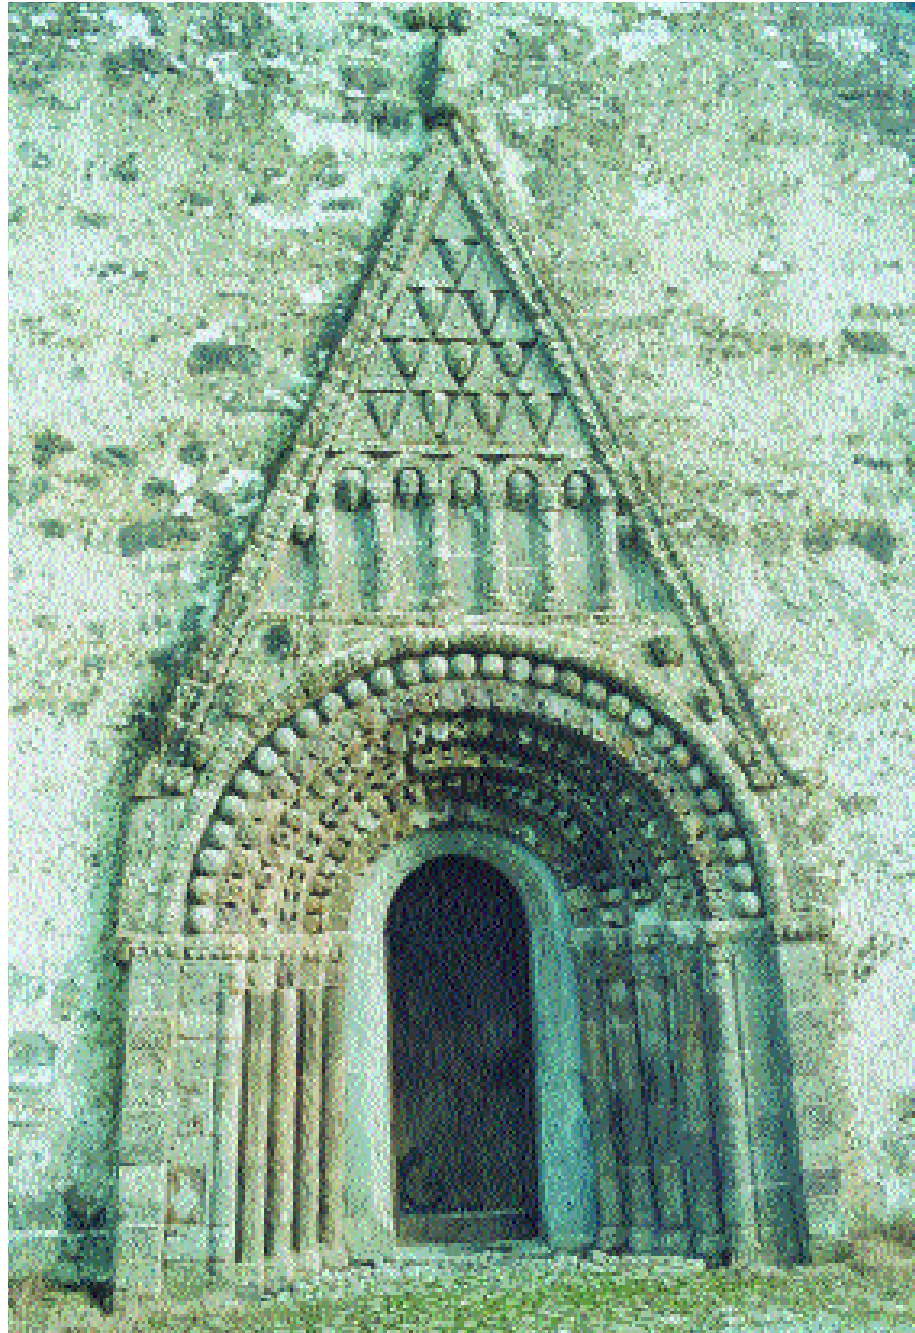
Plate 22: The West Doorway, dating from the 12th century

From present evidence, the doorway dates from the latter part of the 12th century and appears to have been added to an earlier church. While opinions about the exact date and patron of the doorway vary, the latest work (by Tadhg O'Keeffe) suggests a date of c. 1180. Records state that the church was burnt in 1179, the same year in which a synod was held there by St Laurence O'Toole. Installation of the doorway may be connected with these events.

The portal has been much studied over the years. All of the inspections up to c. 1932 record it as being in relatively good condition. In 1936, a chemical 'preservative' known by the trade name Szerelmey was applied to the sandstone on the advice of a diocesan architect. It appears that the rate of decay of the doorway has accelerated since about this time. However, it has not been possible to establish a direct connection between the application of the chemical and the acceleration of decay. The present condition of the doorway is very poor. The surface of the sandstone is badly damaged and is of an extremely friable consistency, with apparent loss of binder in the stone. The inner orders appear to be generally damp, indicating that moisture which may have penetrated the wall over and travelled through voids is exiting in the soffit of the doorhead. The doorway is currently decaying at a very rapid rate, and it has been noted that the surface of the stone work is constantly being degraded by visitors brushing against it involuntarily or touching it. A number of reports on the condition of the doorway have been prepared by Lithan Limited, English Heritage and others (see Appendices).

The doorway is further damaged by the growth of vegetation in the joints and possibly by the presence of lichens which have covered parts of the stonework. The mortar has been washed out from many of the joints in the pediment stones, permitting water which strikes the face of the building to penetrate the carved area and cause additional damage. Unsuitable repairs in cementitious materials which are likely to exacerbate the damage have been carried out in the form of pointing, patching and filling. There is an area of concrete paving directly in front of the doorway, and it is likely that rainwater falling on this area is being directed against the wall. This may be contributing to deterioration at the base of the portal. Rising damp also appears to be contributing to degradation at the base. There is concrete paving inside and outside, and it is likely that this acts as a barrier which prevents the evaporation of ground water, thereby increasing the water content of the soil at the base of the wall and exacerbating the effects of rising damp.

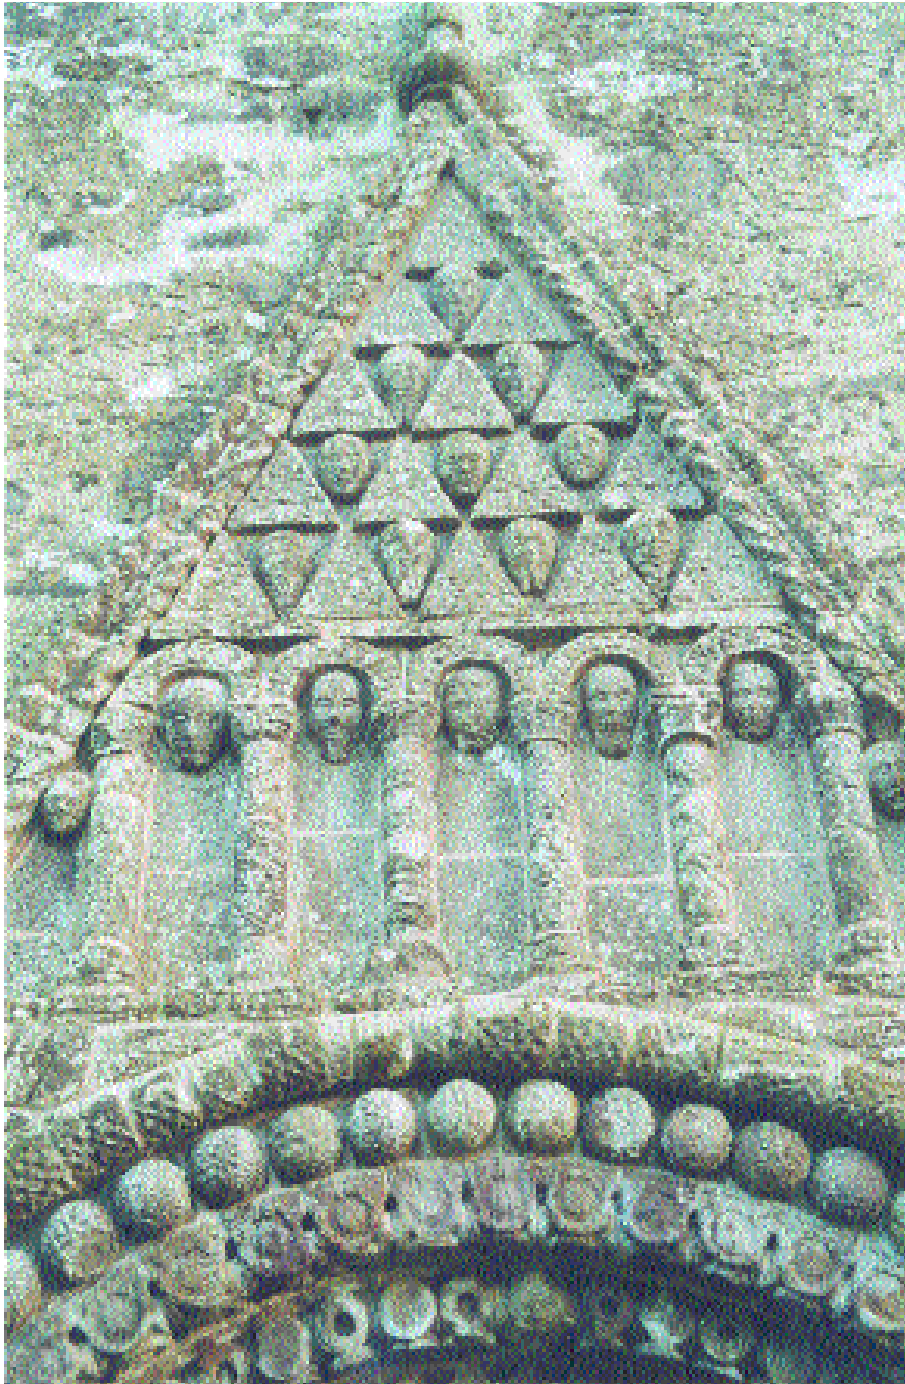
Plate 23: A close-up view of the carvings above the portal

The portal is of the tangent gable type, with an area of diaper ornament containing human heads above an arcade with the doorway below. The portal is carved in sandstone, the exact source of which has not been identified. The doorway consists of seven orders completely covered in carvings, with motifs from a variety of sources, including Scandinavian and western French. The jambs of the orders are inclined in the Hiberno-Romanesque style. There is a later insertion, probably 15th century, of an eighth order in limestone with vertical jambs.

The doorway is typical of late 12th-century work. The nearest examples of the style are to be found at Monaincha and Donaghmore; Leask has suggested that all three could be by the same master stonemason. Many other examples of late 12th-century doorways exist, including the Nun's Chapel at Clonmacnoise, and at Freshford and Roscrea. Clonfert is generally regarded as the high point of Romanesque sculptural art in Ireland. Traces of 'orange' colour were found on the sandstone.

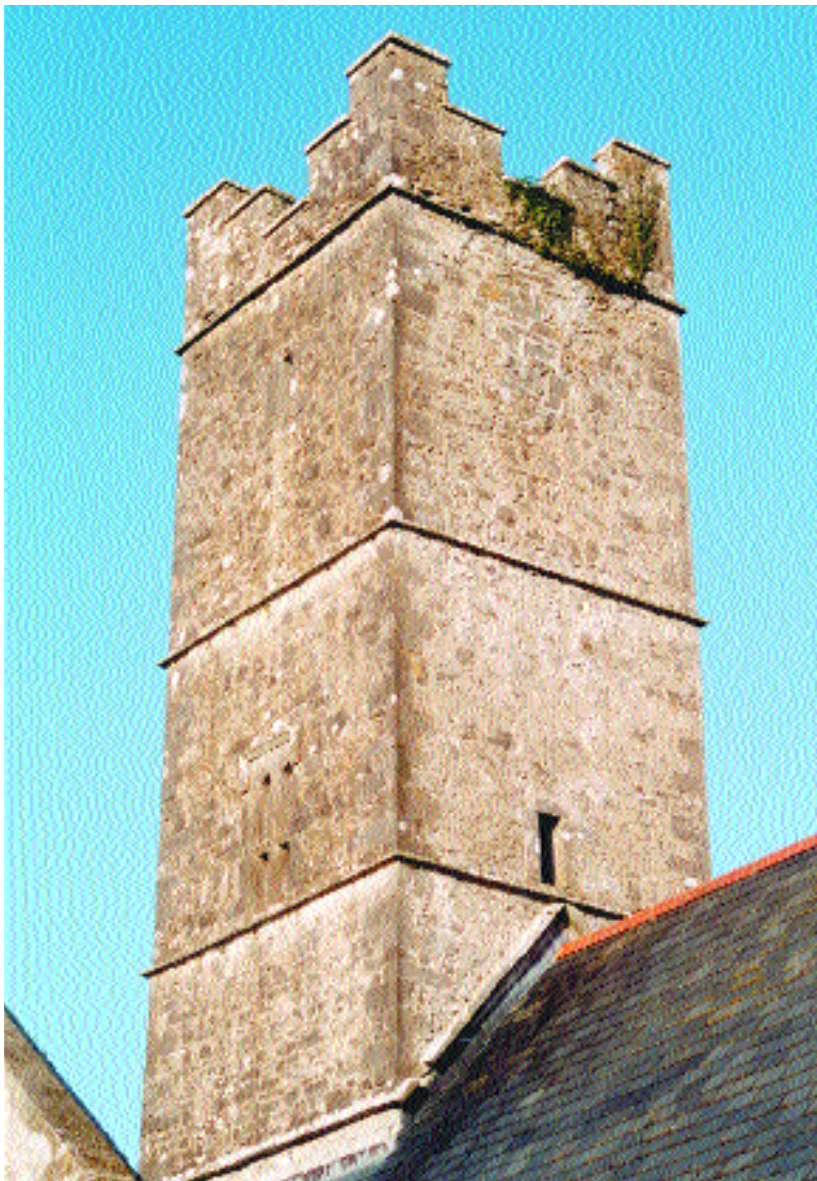
Plate 24: The West Tower

The tower is approximately 25 metres high with a slight batter (*c.* 1 in 60) and is generally considered to date from the 15th century. Although the abbey was Augustinian, it is in the style favoured by the Franciscans. The tower is virtually square (*c.* 4 x 4 metres externally) and has three string courses. Just above the lowest string course, it has double ogee-hooded lancets on the south and west sides, a square-topped hooded lancet on the north side and a square-topped lancet on the east side. Immediately below the parapet string course are single square-headed opes on the south, west and north sides. The parapet, generally taken to be a 19th-century repair, is of the stepped type, although less finely made than those of comparable Franciscan-type towers.

The tower has rotated eastwards by approximately 400mm at the top and appears to have moved as a unit without any major disintegration. This type of movement could be caused by a settlement of *c.* 60-70mm along the east side of the tower base. These towers were normally built near the centre of churches using a different technique, supporting the west and east sides of the tower on screen walls with very small arched openings — similar to the west gable wall of Clonfert. In this case, the wall supporting the east side of the tower is absent and the support is in the form of a triple arch, with buttressing added to the east ends of the tower's north and south walls. This is an awkward structural system and the movement may have occurred when the tower was being erected or the adjacent walls altered (the side arches on the eastern side of the tower appear to be of 19th-century date). Alternatively, the buttressing may be a repair or enhancement of an inadequate structural system. The tower carries remnants of a thin coating of rough-cast lime plaster.

Policy 37.1 A detailed structural assessment of the tower should be carried out to determine why it is out-of-plumb and to ascertain whether the movement is continuing. Should action be necessary, the assessment should propose appropriate measures for repair.

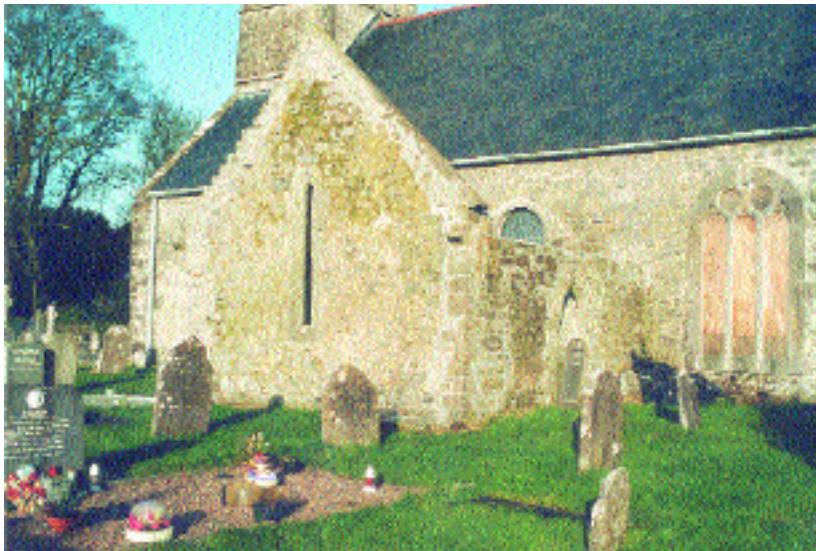
Plate 26: The South Transept, shown after removal of ivy and extensive repair (see Addendum)

The transept has been unroofed for a considerable time, possibly since the destruction of the cathedral in the late 16th century. The walls are in poor condition, particularly the gable wall which has been damaged by heavy growth of ivy and natural weathering. It is possible that burials close to the wall base may have caused a recent collapse of a section of stonework at the south-east corner.

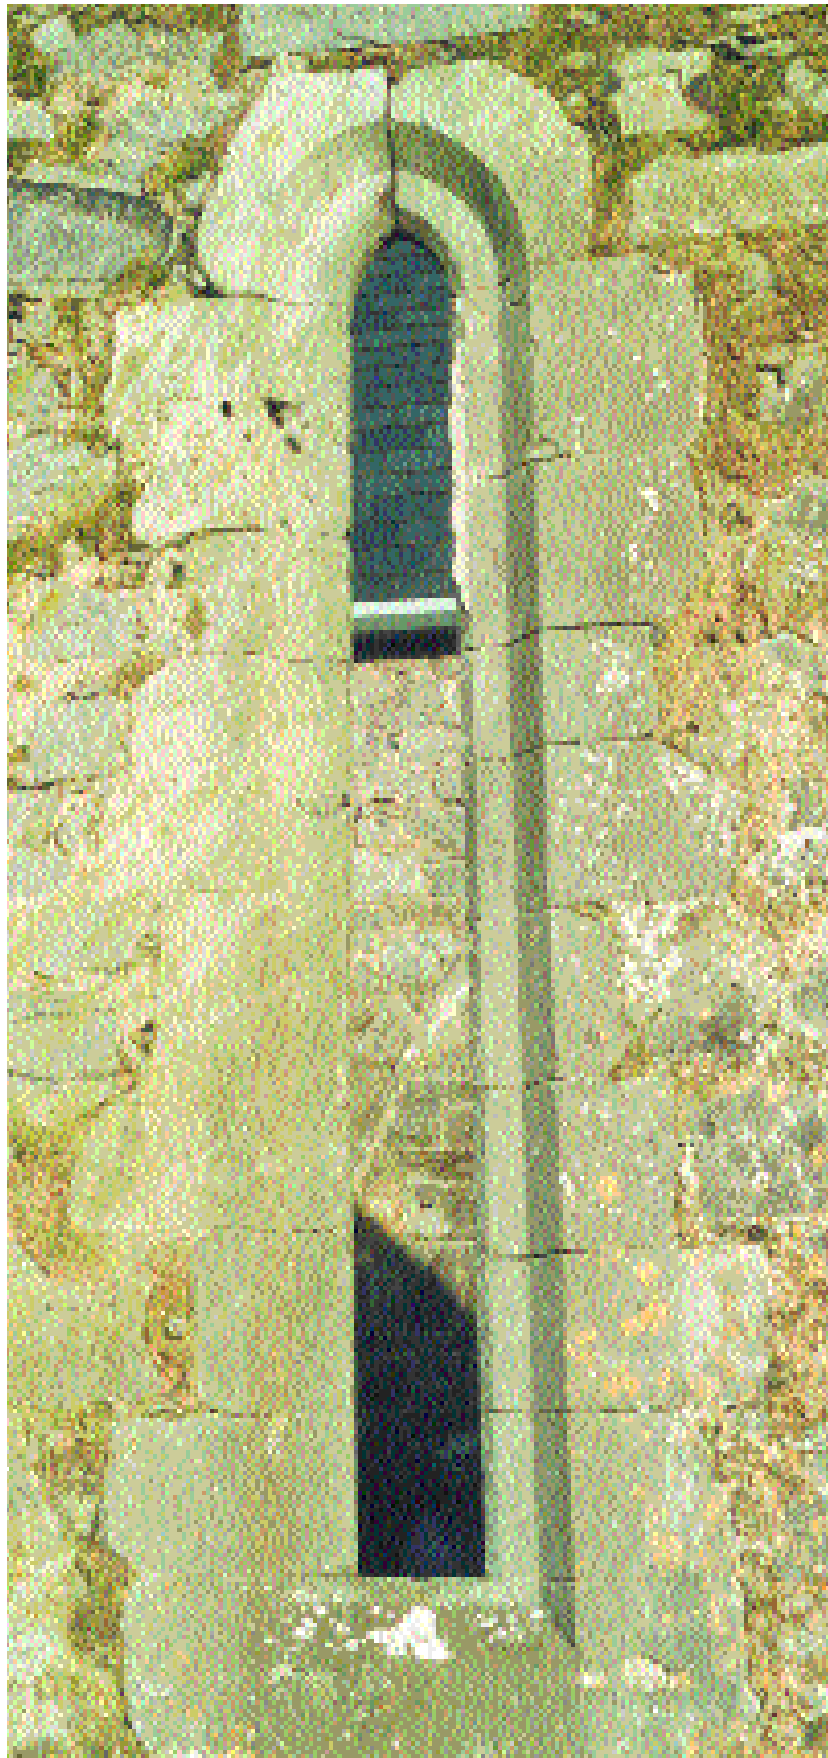
Plate 27: The round-headed lancet suggests a 13th-century date for the South Transept

The south transept is generally considered to be a 13th-century construction because the round-headed lancet of very fine workmanship is in the 13th-century style. The limestone corbels, at eaves level on either side of the gables, are also features considered to be not later than the 13th century. However, some authorities have disputed the date and consider that the filled-in chancel arch, which is of 15th-century date, provides evidence that this is when the transept was built. It is argued that the transept arches on the north and south sides are similar to the chancel arch and the tower arches and that they constitute part of a major re-ordering and reconstruction of the church in the 15th century.

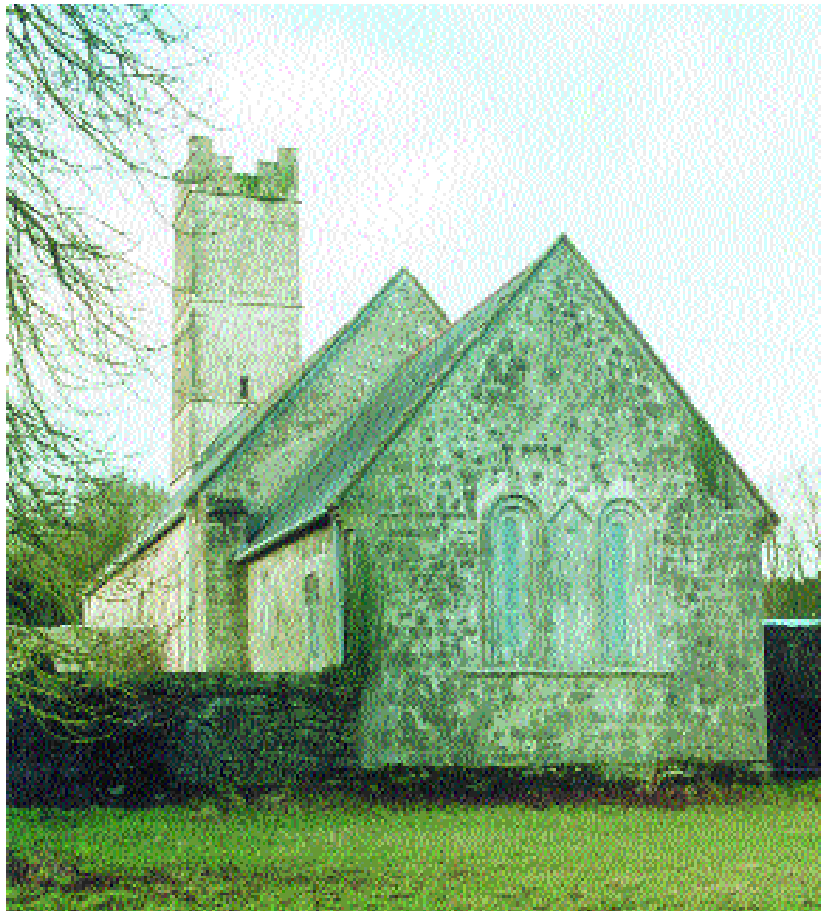
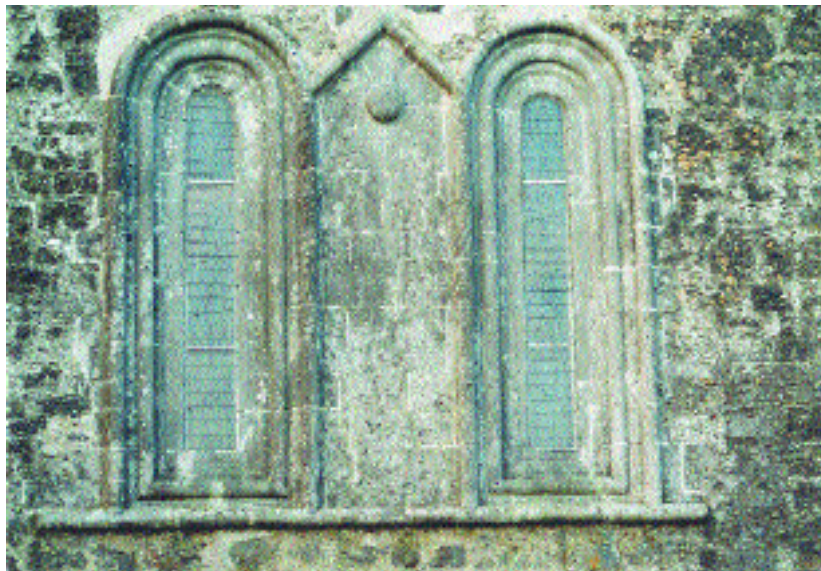
Plates 30 and 31: The East Window: general and close-up views

The east window is a very finely carved and executed example of early 13th-century masonry. In the Transitional style, it is ascribed to the so-called 'School of the West' and more precisely, to a craftsman whose identity is unknown but who is described as the 'Ballintubber Master' (so called because works ascribed to him reach their high point at Ballintubber Abbey). Very similar work has been recognised at several other sites: O'Hynes Church at Kilmacduagh, at Teampaill na Righ in Clonmacnoise, at Boyle Abbey, and at Banagher, County Derry. Other examples of this type of work at Clonfert include the octagonal baptismal font and a fine burial slab found in the south transept. The window is a double round-headed lancet with engaged roll mouldings on the outside, roll moulded cill and a triangular hood uniting the two lancets on a central pier with a roundel under the hood.

An early photograph (c. 1860s) indicates that the glazing was changed from clear leaded glass to stained glass, probably by Canon McLarney at the end of the 19th century. No other changes in the window are apparent since its construction. The window is generally in excellent condition.

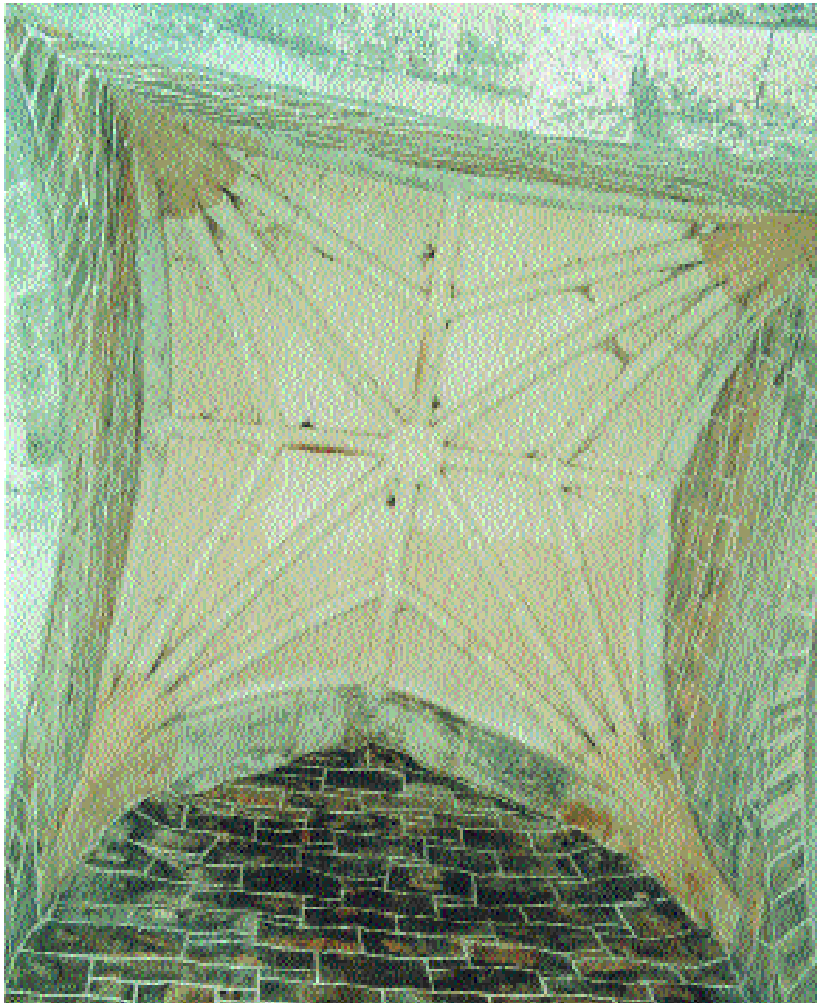
Plate 34: The vestibule groin vault

The vestibule groin vault is probably of 15th-century origin but considerable renovation and repair was carried out by Canon McLarney in the late 19th century. The vault does not support the floor structure above, which is independently supported. Its significance lies in its integral role in the design of the tower which is a typical 15th-century addition to an existing church.

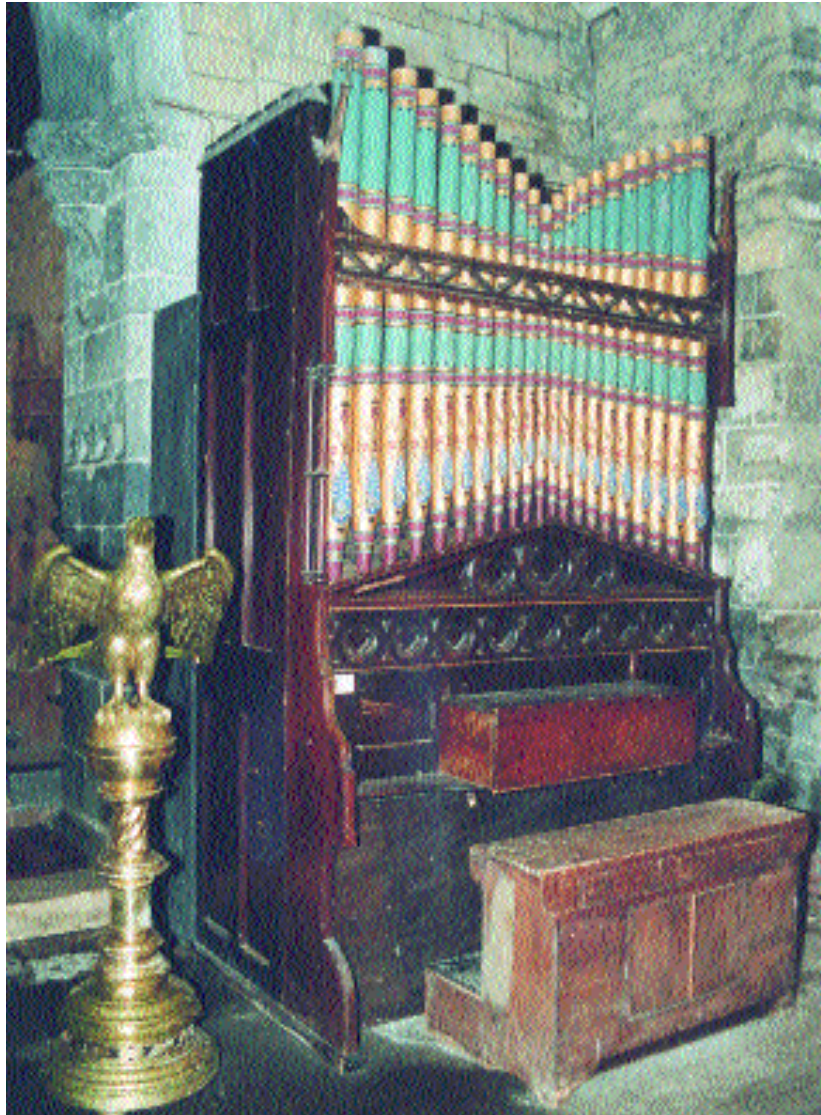
Plate 41: The organ, with the eagle lectern at left

The organ is located at the east end of the nave. Its date and origin are not known, although it was described as being 'comparatively new' in 1884. At present, the organ is in poor condition, suffering from dampness and damage from bat and bird droppings. It should be cleaned and protected, with further investigation to determine the date and origin so that its significance may be established.

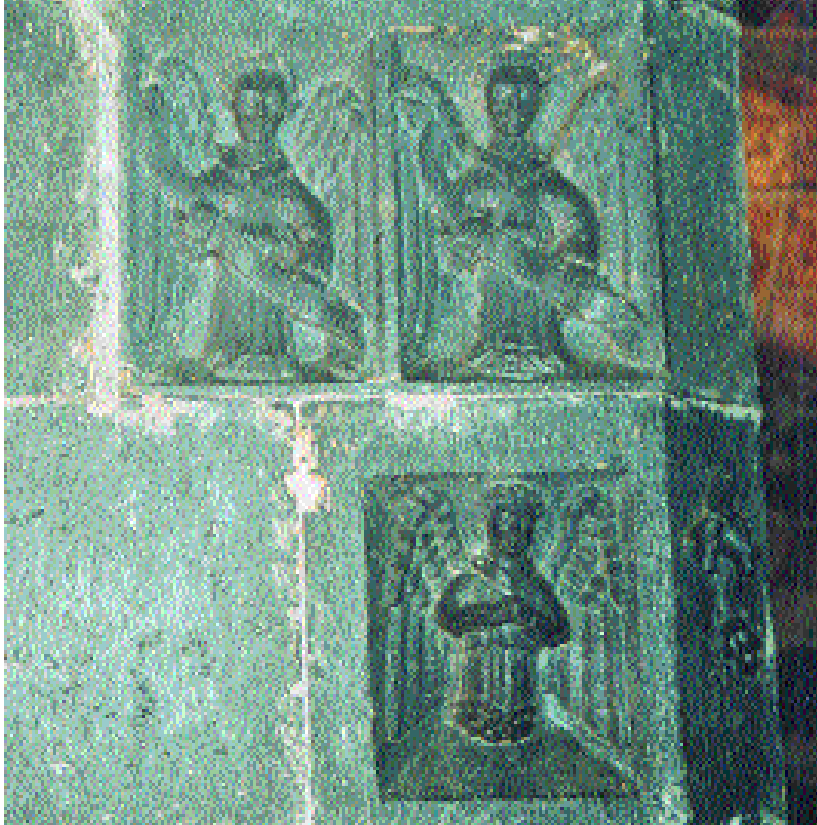
Plate 42: Carvings on the chancel arch: angels

The arch springings sit on capitals densely carved with medieval vegetal and other motifs typical of the 15th century. Some of the arch voussoirs are individually carved with angels, heads, animals and a particularly fine mermaid figure. It has been suggested that the symbolism (of the mermaid) is related to St Brendan's Atlantic journey. However, similar mermaid figures are found elsewhere (*e.g.* at Kilcooly Abbey, County Tipperary). Canon McLarney removed red paint from the stonework of the arch.

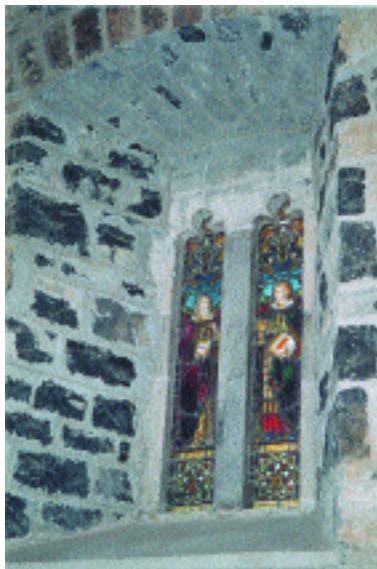
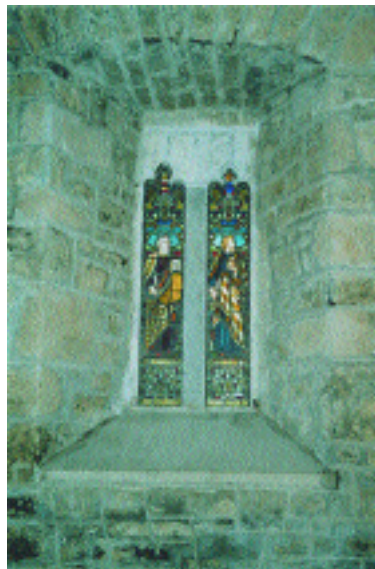
Plates 45 and 46: The two double windows on the south side of the chancel

The chancel windows (apart from the east windows) consist of ogee-headed lights — one double and one single on the north side and two double on the south side.

The windows are in the style of the 15th century but the exterior details are slightly different in each case. The central mullions of the double windows were replaced; Canon McLarney refers to this work. The four stained glass windows on the south side, representing the four Evangelists, were a gift from 'a clergyman who does not wish to be named' in response to an appeal by Canon McLarney. The stained glass on the north side windows was provided in a similar fashion by a Dr Kenny of Treeton, Yorkshire. The glazing was made by Watson and Company of Youghal and is of regional significance.

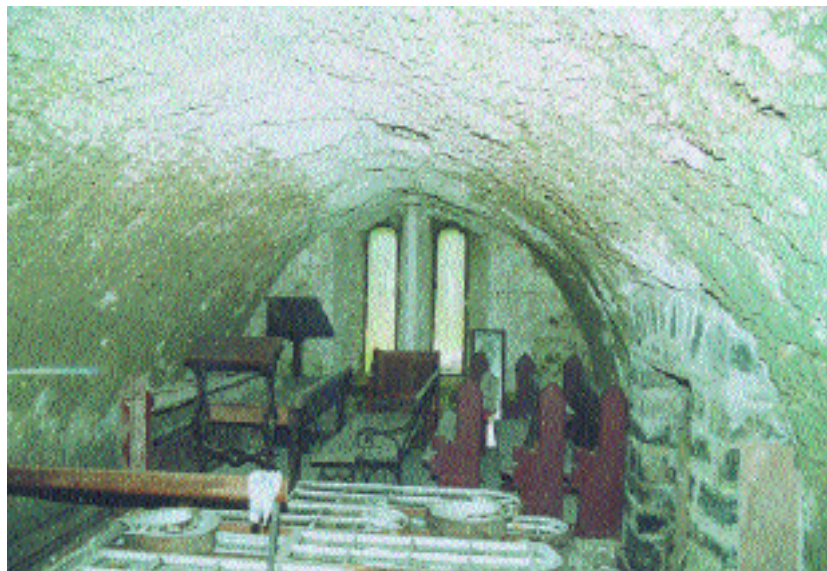
Plate 48: A view of the Vestry

The interior of the vestry is very damp, with green and black moulds on the walls. There is rising damp and ingress of moisture through the barrel-shaped ceiling. The floor is below the level of the ground outside on the north and west sides. There is no ventilation and the air is very humid.

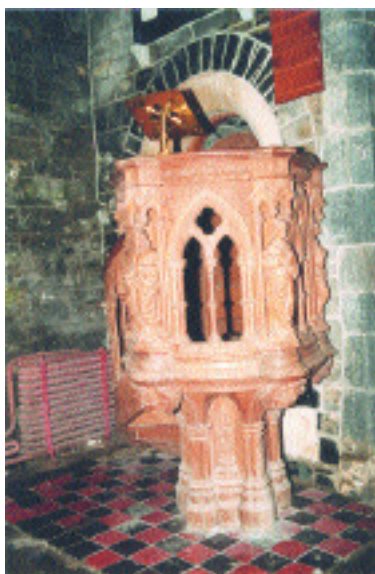
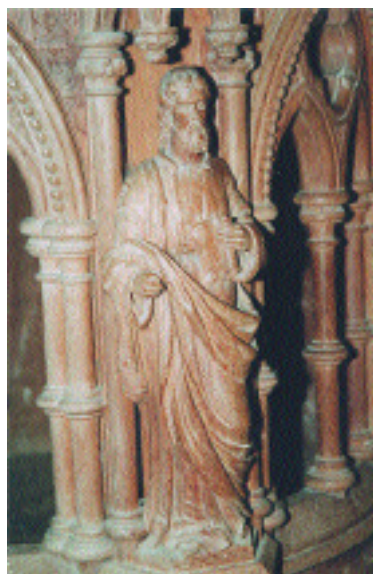
The finely carved ornate oak pulpit with the figures of the four Evangelists is located in the nave and probably dates from c. 1900 — the same date as most of the furniture in the chancel. One of the Evangelists was stolen c. 1985 and has been replaced by a newly carved figure.

Plates 49 and 50: The oak pulpit (left) with a close-up view of one of the carved figures (right)

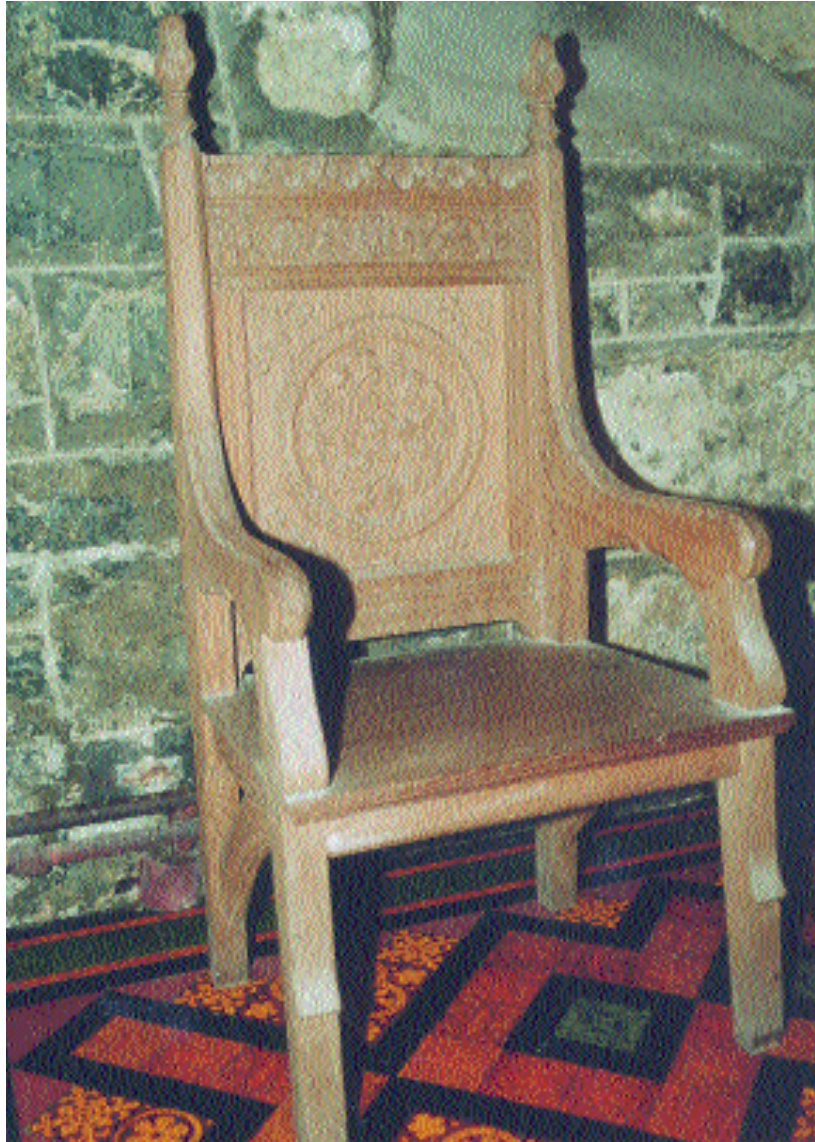
The chancel furniture includes the bishop's throne, Communion table, choir stalls and a carved armchair, all of which date from Canon McLarney's refurbishment. The oak Communion table was made by the boys of the Meath Protestant Industrial School in Blackrock, Dublin. The bishop's throne, carved in oak with a central panel commemorating St Brendan, was donated by a descendant of Bishop Young (1799-1800) in memory of his forebear. The carved oak armchair was made by W. Scott of Enniskillen.

Plate 51: A carved armchair in the chancel. Also note the ornate floor pattern
