ST BRENDAN'S CATHEDRAL CLONFERT COUNTY GALWAY

CONSERVATION PLAN

Prepared by
Dermot Nolan and Pat Ruane
Conservation Consultants

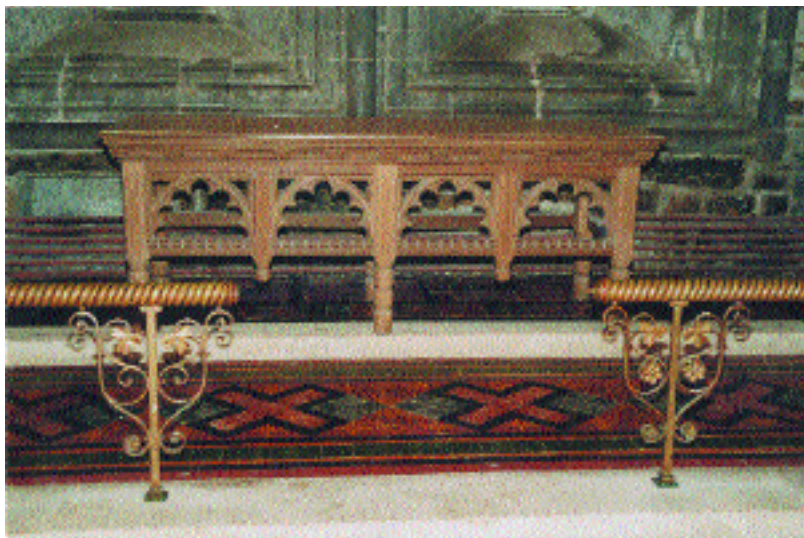
The significance of the brass altar rail lies in its integral part in the reordering of the chancel carried out by Canon McLarney. It was designed by J.F. Fuller, the architect employed by Canon McLarney.

Plate 52: Brass altar rails and the carved Communion table

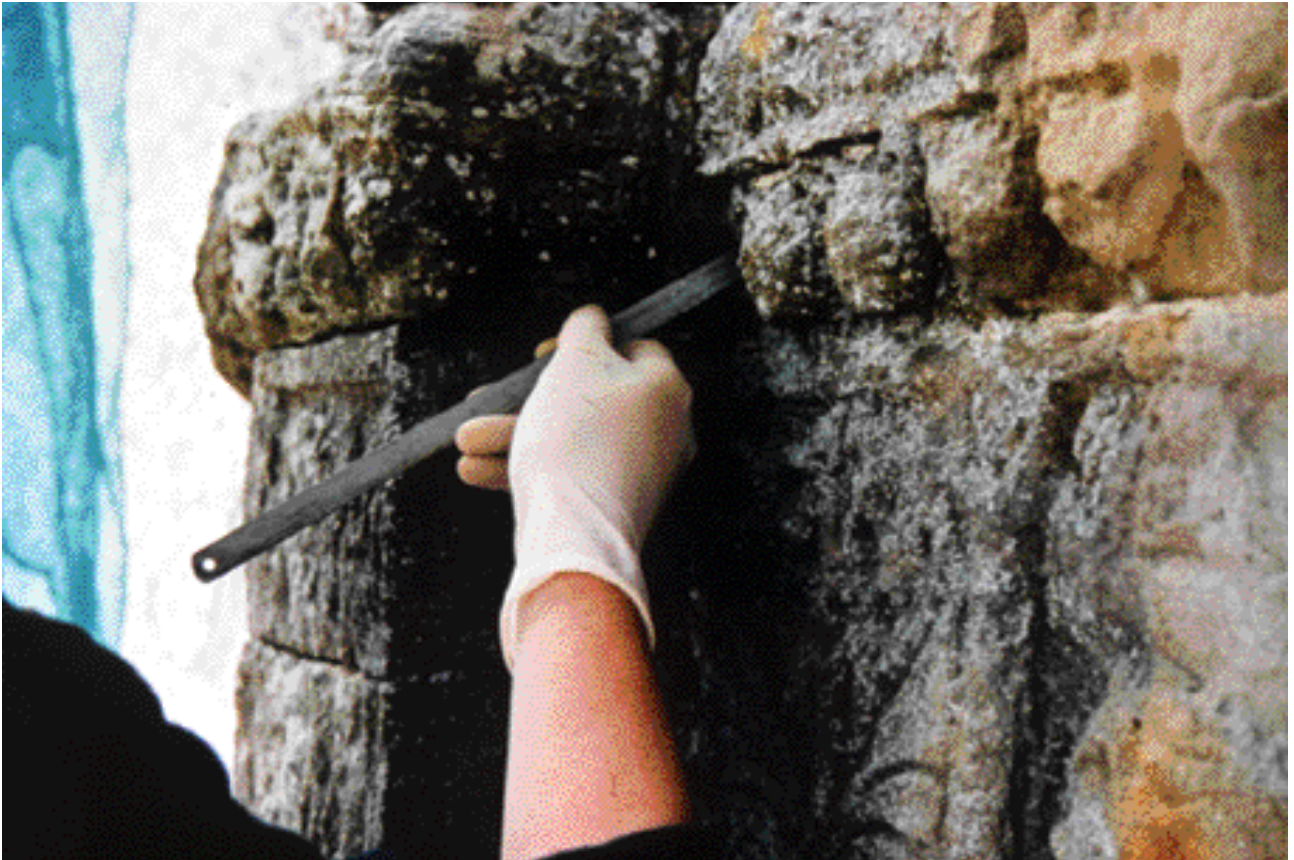
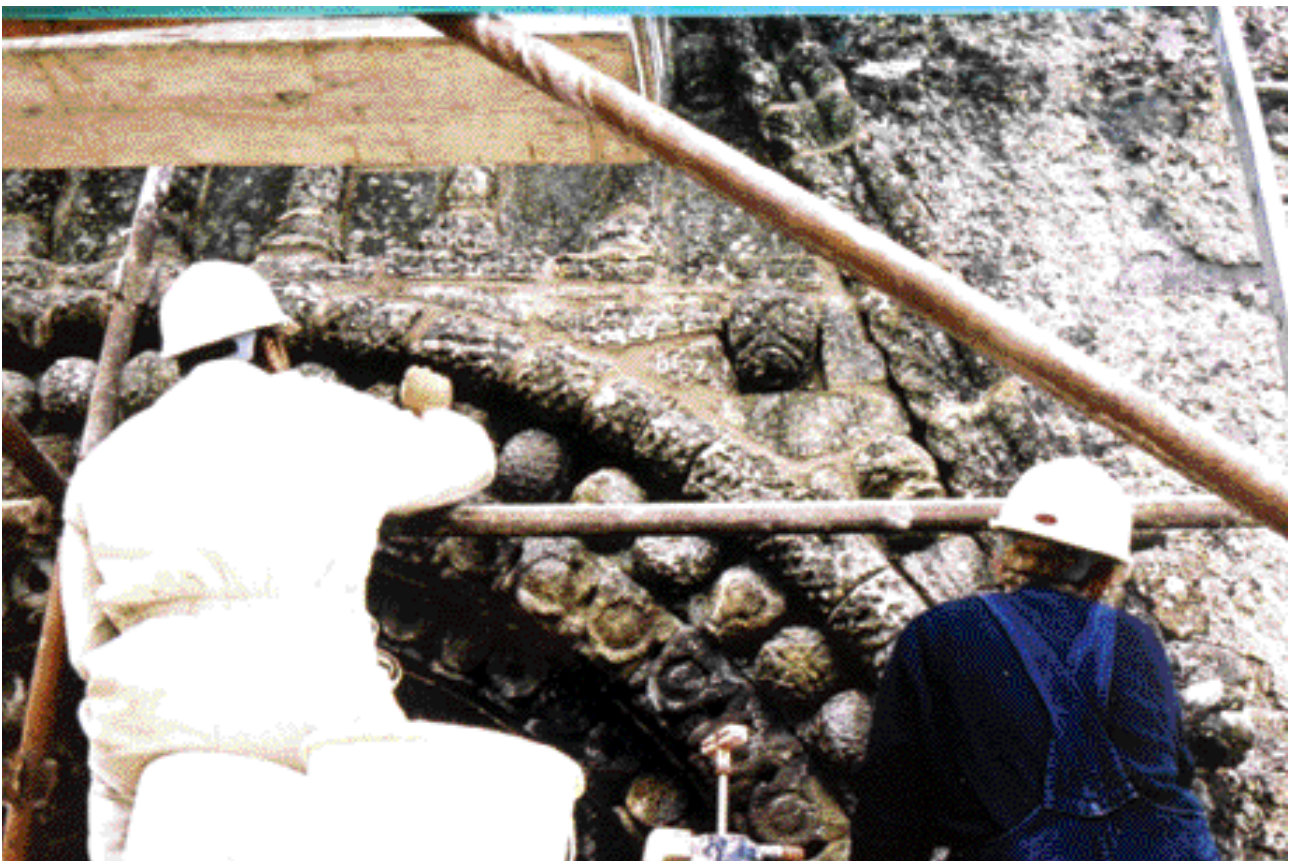
The photographs on page 94 show work on the doorway during Summer 2002.

To determine their exact composition, the stone in the doorway as well as the mortars and renders were analysed and studied by Dr Sara Pavia and Jason Bolton. An extensive search was carried out to find suitable matching sandstone for testing, and when this was found, testing began to establish whether a suitable consolidant could be sourced. Testing for weathering and consolidants continues. In the meantime, Jason Ellis, stone sculptor and conservator, carried out some works to the doorway in the summer of 2002; this included the removal of vegetation and some gentle repairs in lime mortar to improve the condition of the doorway and reduce water penetration as far as possible.

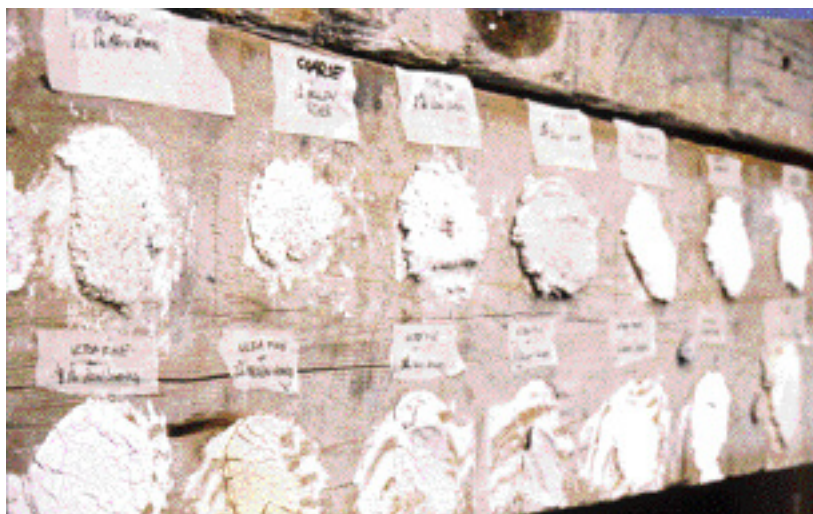
Samples of different mortars are prepared in order to select a suitable match for the doorway
