Rindoon, Co. Roscommon: A Management Plan

Introduction

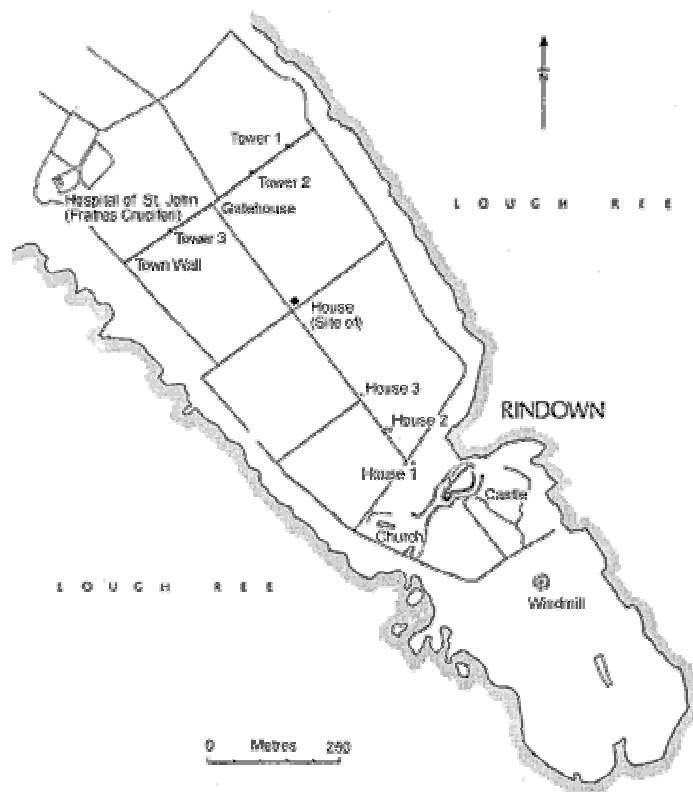
Fig. 1. Rindoon: outline plan showing principal archaeological monuments and field boundaries.

- The site of the Medieval town of Rindoon lies in the fields which are now used for grazing between the castle and the town wall (Fig. 1). The street pattern was almost certainly linear, running from the gatehouse on the town wall to the entrance to the castle. The surviving house foundations lie along this line.

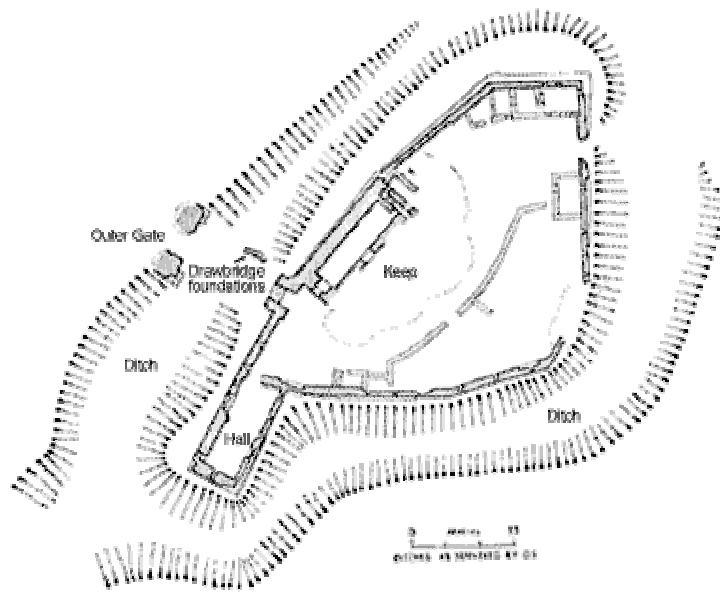
Fig. 7. Ground plan of Rindoon castle.

The castle consists of an ovoid curtain wall with a rectangular extension on the south-west. It is entered through a gatehouse on the north which is overlooked by the keep to the east. Much of the curtain wall and the interior is heavily overgrown with ivy. The foundations of three cottages with the footings of associated buildings and a dividing wall of nineteenth/ early twentieth century date are also present. The earliest part of the castle is the keep (Figs. 32-4), perhaps to be identified with the "stone castle" constructed by Geoffrey de Marisco in 1227. The curtain wall was being constructed in 1233 and it is clearly

an addition to the keep on the east side. The hall, on the west, is an addition to the curtain and is probably to be identified with the new hall mentioned in 1299-1302. The castle seems to have been abandoned in the fourteenth century when it is evident that parts of the curtain wall were demolished. The broken down parts of the curtain were rebuilt in the sixteenth century but the wall was thinner and not as high as in the thirteenth century; it is also characterised by the presence of plain rectangular gun loops. In addition the sixteenth century wall does not always follow the line of its thirteenth century predecessor.

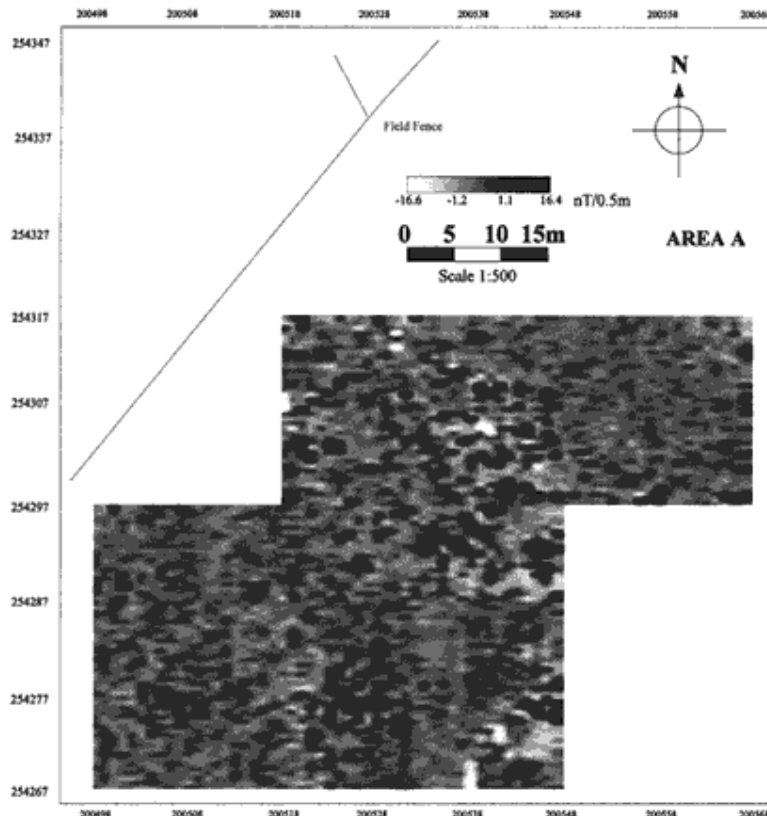
Only very basic processing facilities were applied to the data set (Fig. 12). The data is relatively quiet, but the centre of the survey area exhibited rather noisy values. The data ranges from $-27.5\text{nT}/0.5\text{m}$ to $+51\text{nT}/0.5\text{m}$, but the majority of values lie in the range $-2.5\text{nT}/0.5\text{m}$ to $+2.5\text{nT}/0.5\text{m}$.

Fig. 12. Map of magnetic gradiometry results from Area A-processed data.

It is difficult to identify any distinct anomalous features in the magnetic gradiometry results from Area A. However, a number of subtle positive and negative linear and curvilinear anomalies may be seen in the results, particularly in the south-west quadrant of the survey area. The linear anomalies generally have a north-east to south-west trend and may represent cultivation ridges, however the more distinct linear anomalies are at least 3m apart which may not support the cultivation ridge interpretation. Furthermore, this area had a lot of stone at or just beneath the surface which would also point to lack of cultivation. A number of subtle curvilinear/sub-circular anomalies are also apparent in this area, from 200498E, 254277N to 200518E, 254297N.

The centre part of the survey area is extremely magnetically noisy, particularly north of centre, and this coincides with the greatest concentration of stone observed at or beneath the surface of the site. It is difficult to identify any distinct features, other than a distinct north-west to south-east trending anomaly from 200528E, 254305N to 200544E, 254293N, which measures approximately 15m and a curvilinear anomaly to the east of this at 200546E, 254301N to 200558E, 254309N which has a north-south diameter of approximately 13m. A number of other minor linear and curvilinear anomalies may also be seen in this area.
